2015 Annual Report of the Ground-Level Monitoring Committee

Final

September 2016

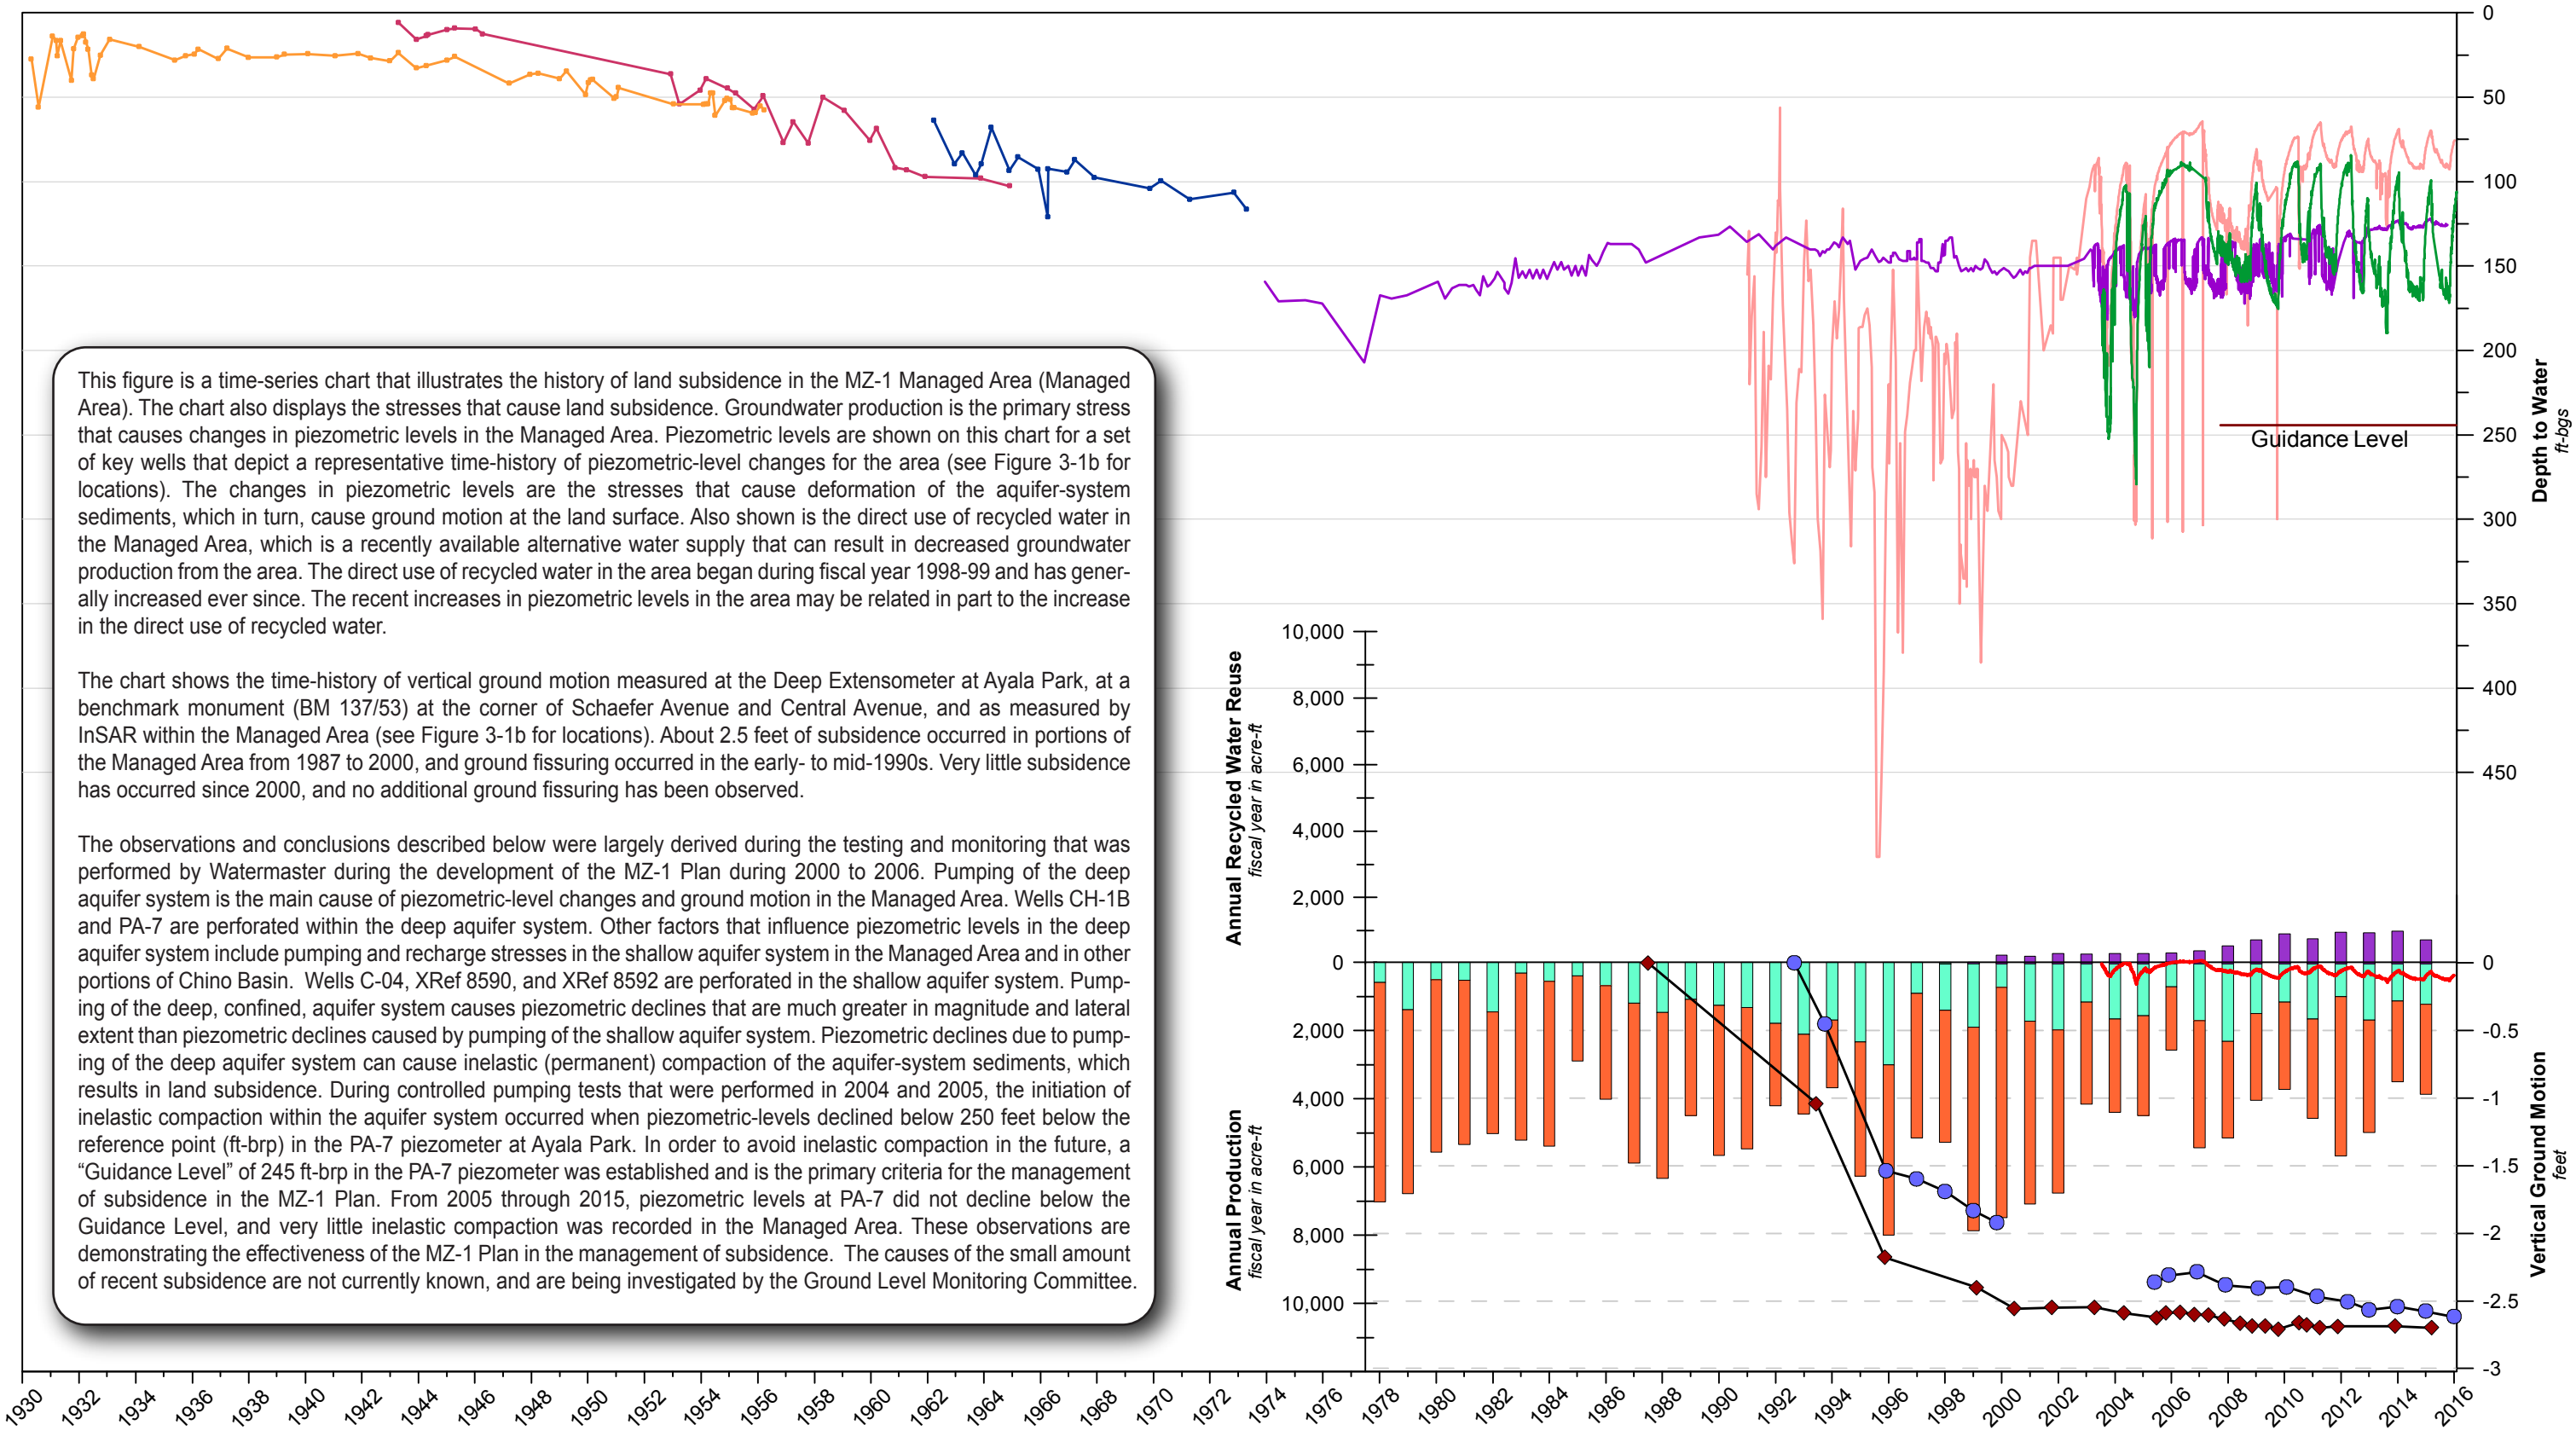
This figure is a time-series chart that illustrates the history of land subsidence in the MZ-1 Managed Area (Managed Area). The chart also displays the stresses that cause land subsidence. Groundwater production is the primary stress that causes changes in piezometric levels in the Managed Area. Piezometric levels are shown on this chart for a set of key wells that depict a representative time-history of piezometric-level changes for the area (see Figure 3-1b for locations). The changes in piezometric levels are the stresses that cause deformation of the aquifer-system sediments, which in turn, cause ground motion at the land surface. Also shown is the direct use of recycled water in the Managed Area, which is a recently available alternative water supply that can result in decreased groundwater production from the area. The direct use of recycled water in the area began during fiscal year 1998-99 and has generally increased ever since. The recent increases in piezometric levels in the area may be related in part to the increase in the direct use of recycled water.

The chart shows the time-history of vertical ground motion measured at the Deep Extensometer at Ayala Park, at a benchmark monument (BM 137/53) at the corner of Schaefer Avenue and Central Avenue, and as measured by InSAR within the Managed Area (see Figure 3-1b for locations). About 2.5 feet of subsidence occurred in portions of the Managed Area from 1987 to 2000, and ground fissuring occurred in the early- to mid-1990s. Very little subsidence has occurred since 2000, and no additional ground fissuring has been observed.

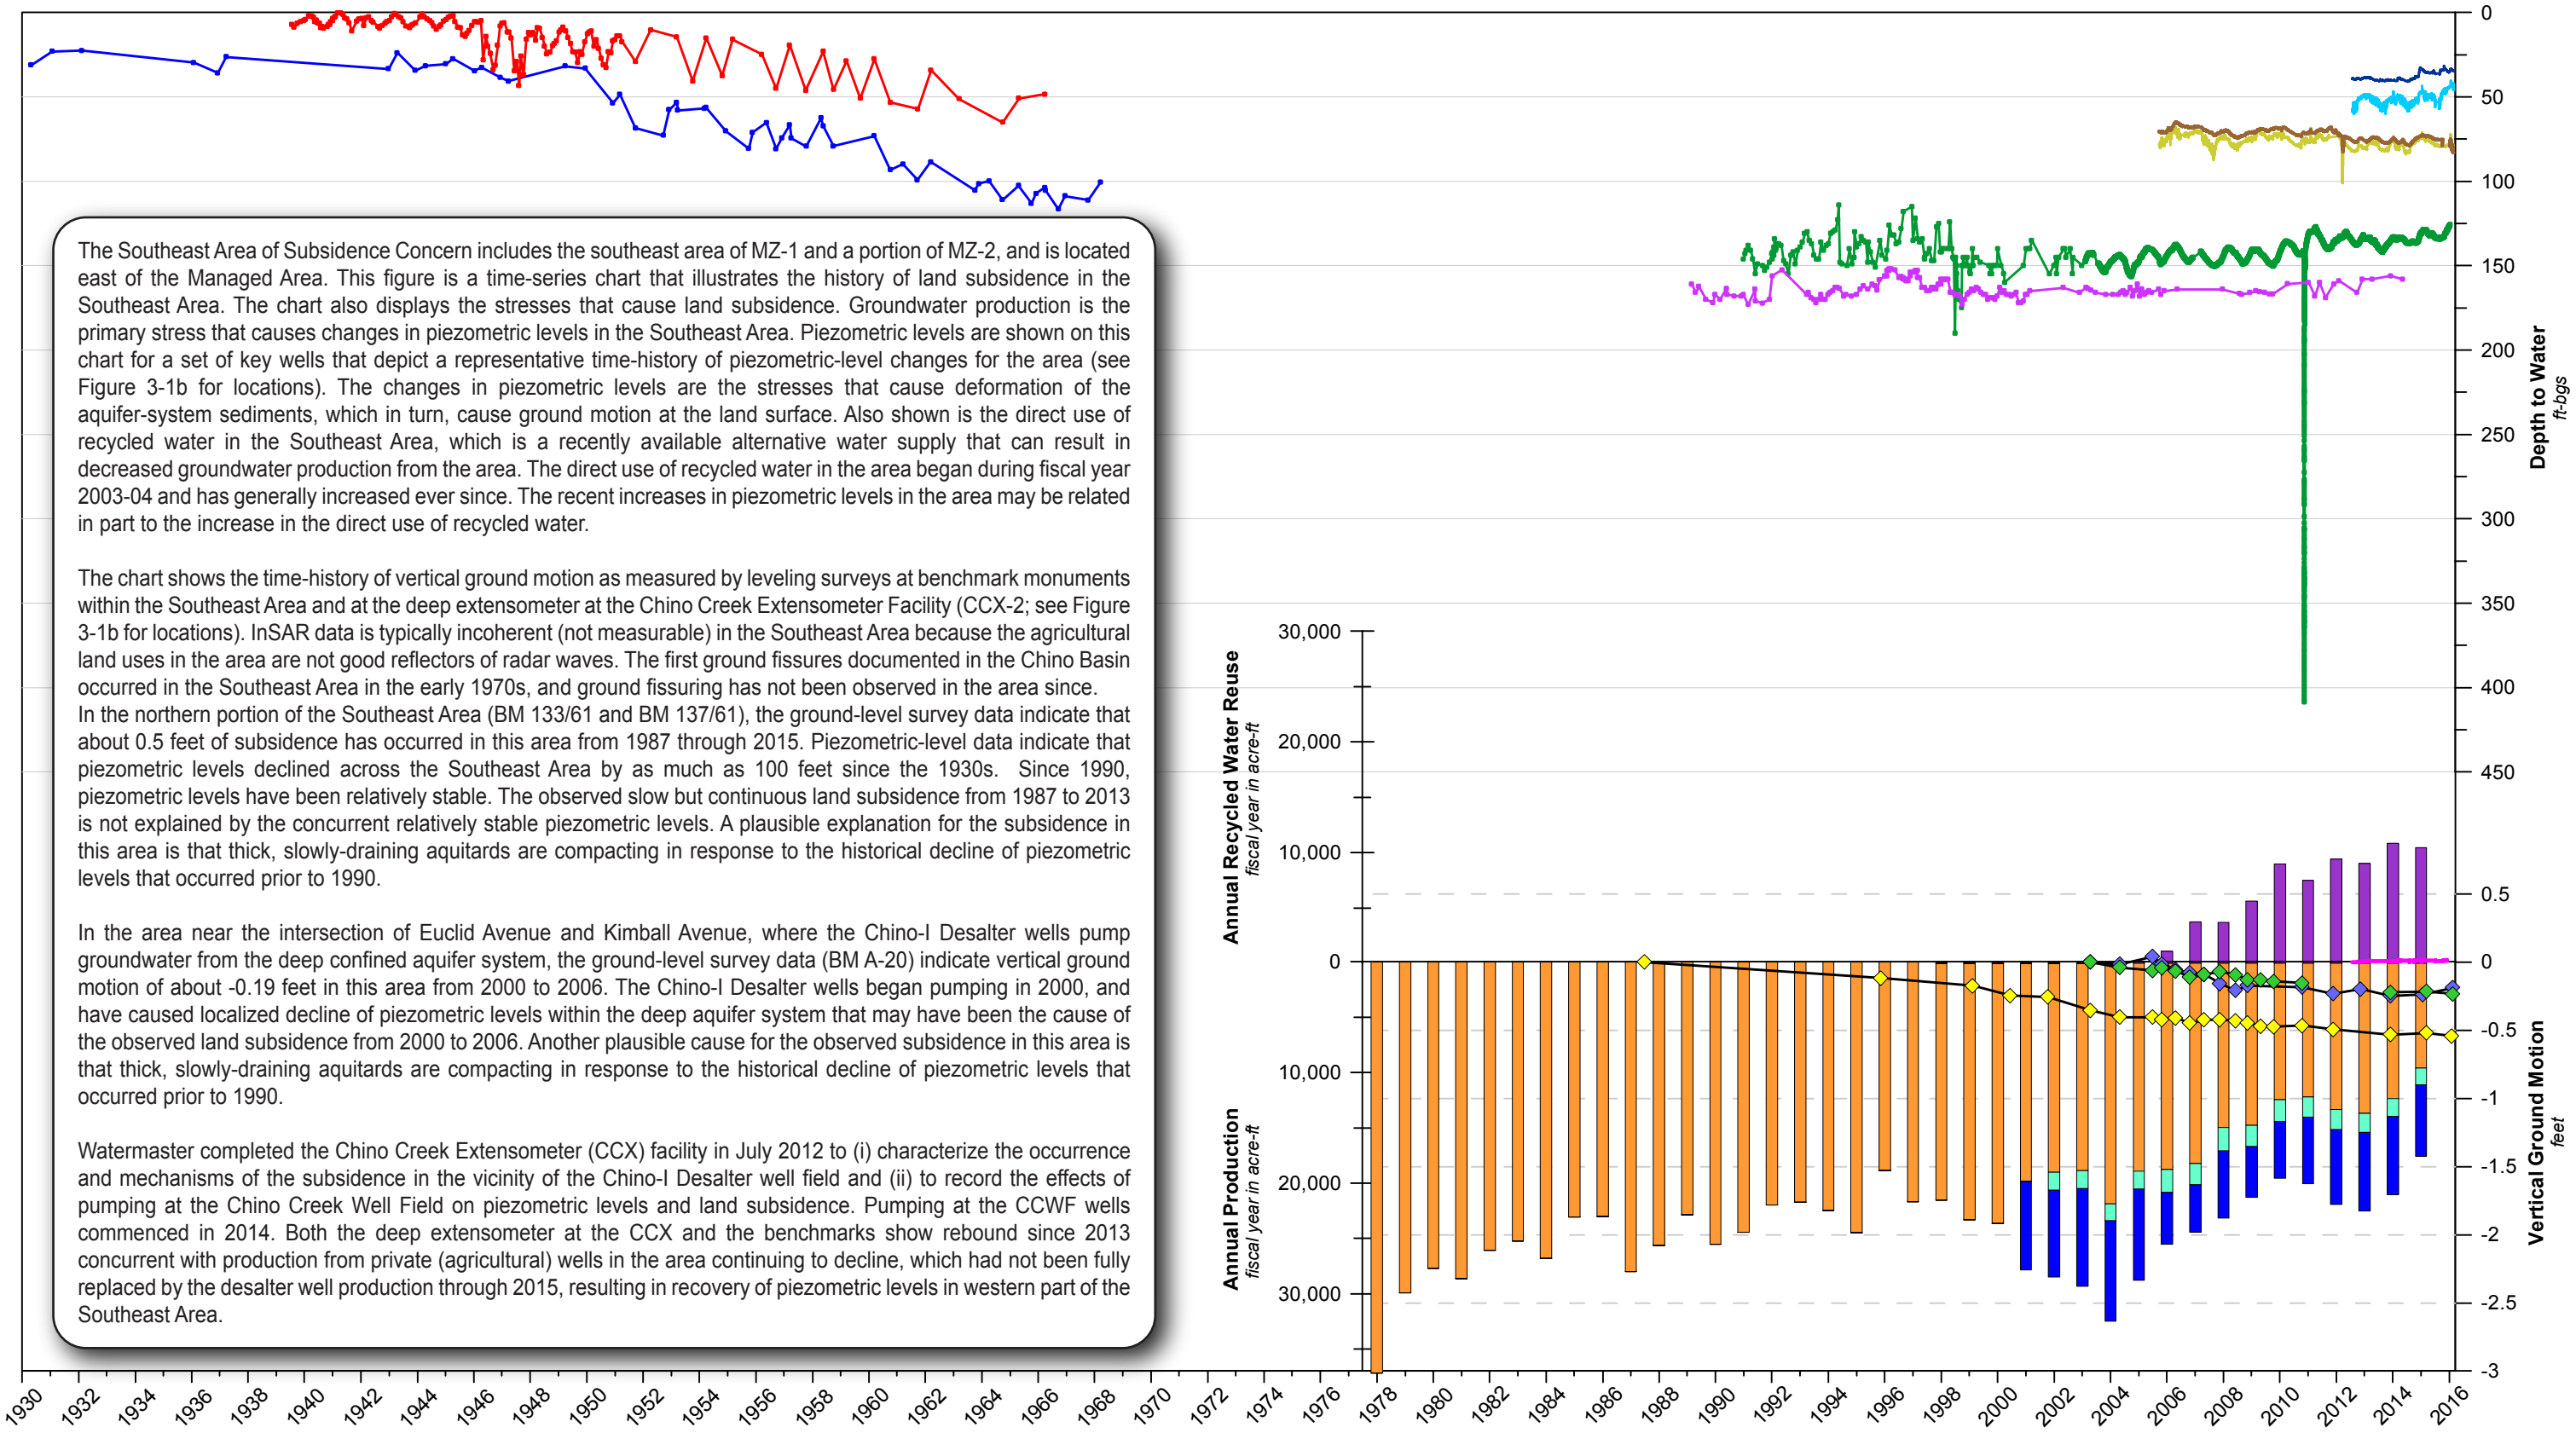
Figure 3-6

The Southeast Area of Subsidence Concern includes the southeast area of MZ-1 and a portion of MZ-2, and is located east of the Managed Area. This figure is a time-series chart that illustrates the history of land subsidence in the Southeast Area. The chart also displays the stresses that cause land subsidence. Groundwater production is the primary stress that causes changes in piezometric levels in the Southeast Area. Piezometric levels are shown on this chart for a set of key wells that depict a representative time-history of piezometric-level changes for the area (see Figure 3-1b for locations). The changes in piezometric levels are the stresses that cause deformation of the aquifer-system sediments, which in turn, cause ground motion at the land surface. Also shown is the direct use of recycled water in the Southeast Area, which is a recently available alternative water supply that can result in decreased groundwater production from the area. The direct use of recycled water in the area began during fiscal year 2003-04 and has generally increased ever since. The recent increases in piezometric levels in the area may be related in part to the increase in the direct use of recycled water.

The chart shows the time-history of vertical ground motion as measured by leveling surveys at benchmark monuments within the Southeast Area and at the deep extensometer at the Chino Creek Extensometer Facility (CCX-2; see Figure 3-1b for locations). InSAR data is typically incoherent (not measurable) in the Southeast Area because the agricultural land uses in the area are not good reflectors of radar waves. The first ground fissures documented in the Chino Basin occurred in the Southeast Area in the early 1970s, and ground fissuring has not been observed in the area since. In the northern portion of the Southeast Area (BM 133/61 and BM 137/61), the ground-level survey data indicate that about 0.5 feet of subsidence has occurred in this area from 1987 through 2015. Piezometric-level data indicate that piezometric levels declined across the Southeast Area by as much as 100 feet since the 1930s. Since 1990, piezometric levels have been relatively stable. The observed slow but continuous land subsidence from 1987 to 2013 is not explained by the concurrent relatively stable piezometric levels. A plausible explanation for the subsidence in this area is that thick, slowly-draining aquitards are compacting in response to the historical decline of piezometric levels that occurred prior to 1990.

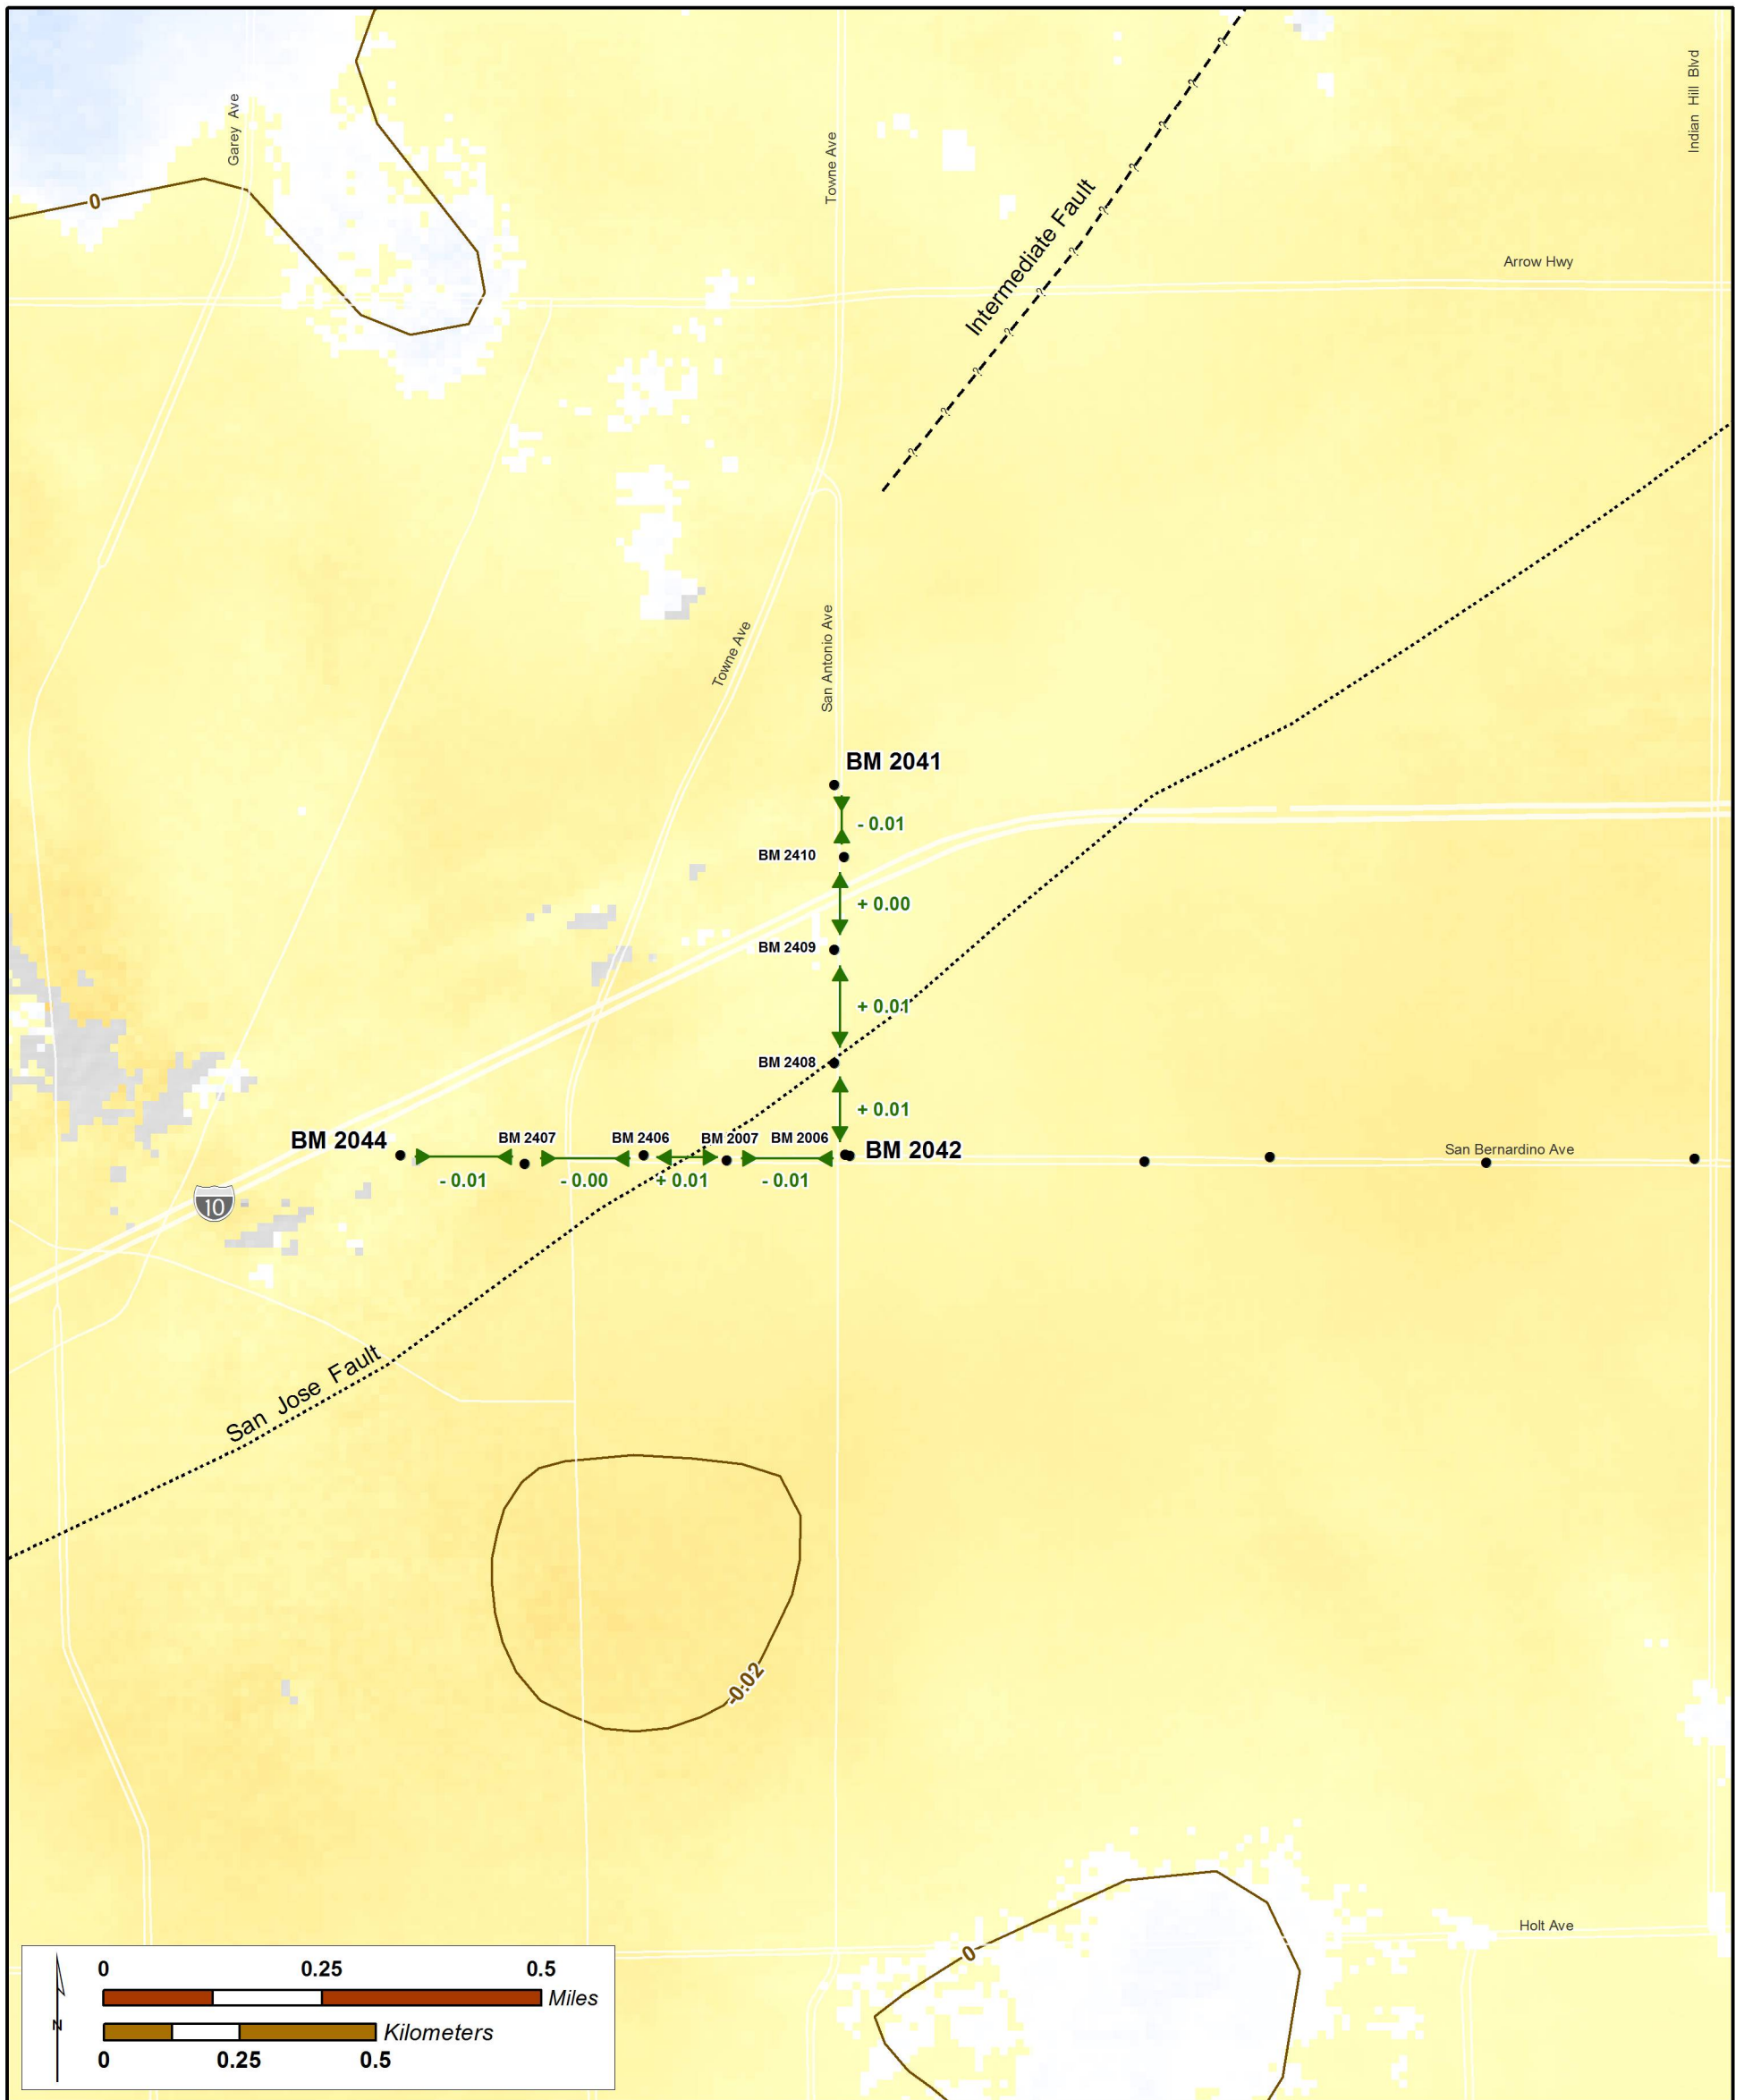
Figure 3-11a

Horizontal ground motion between adjacent benchmarks is shown as extension (+) or compression (-) in either the north-south direction for benchmarks along San Antonio Ave or the east-west direction for benchmarks along San Bernardino Ave.

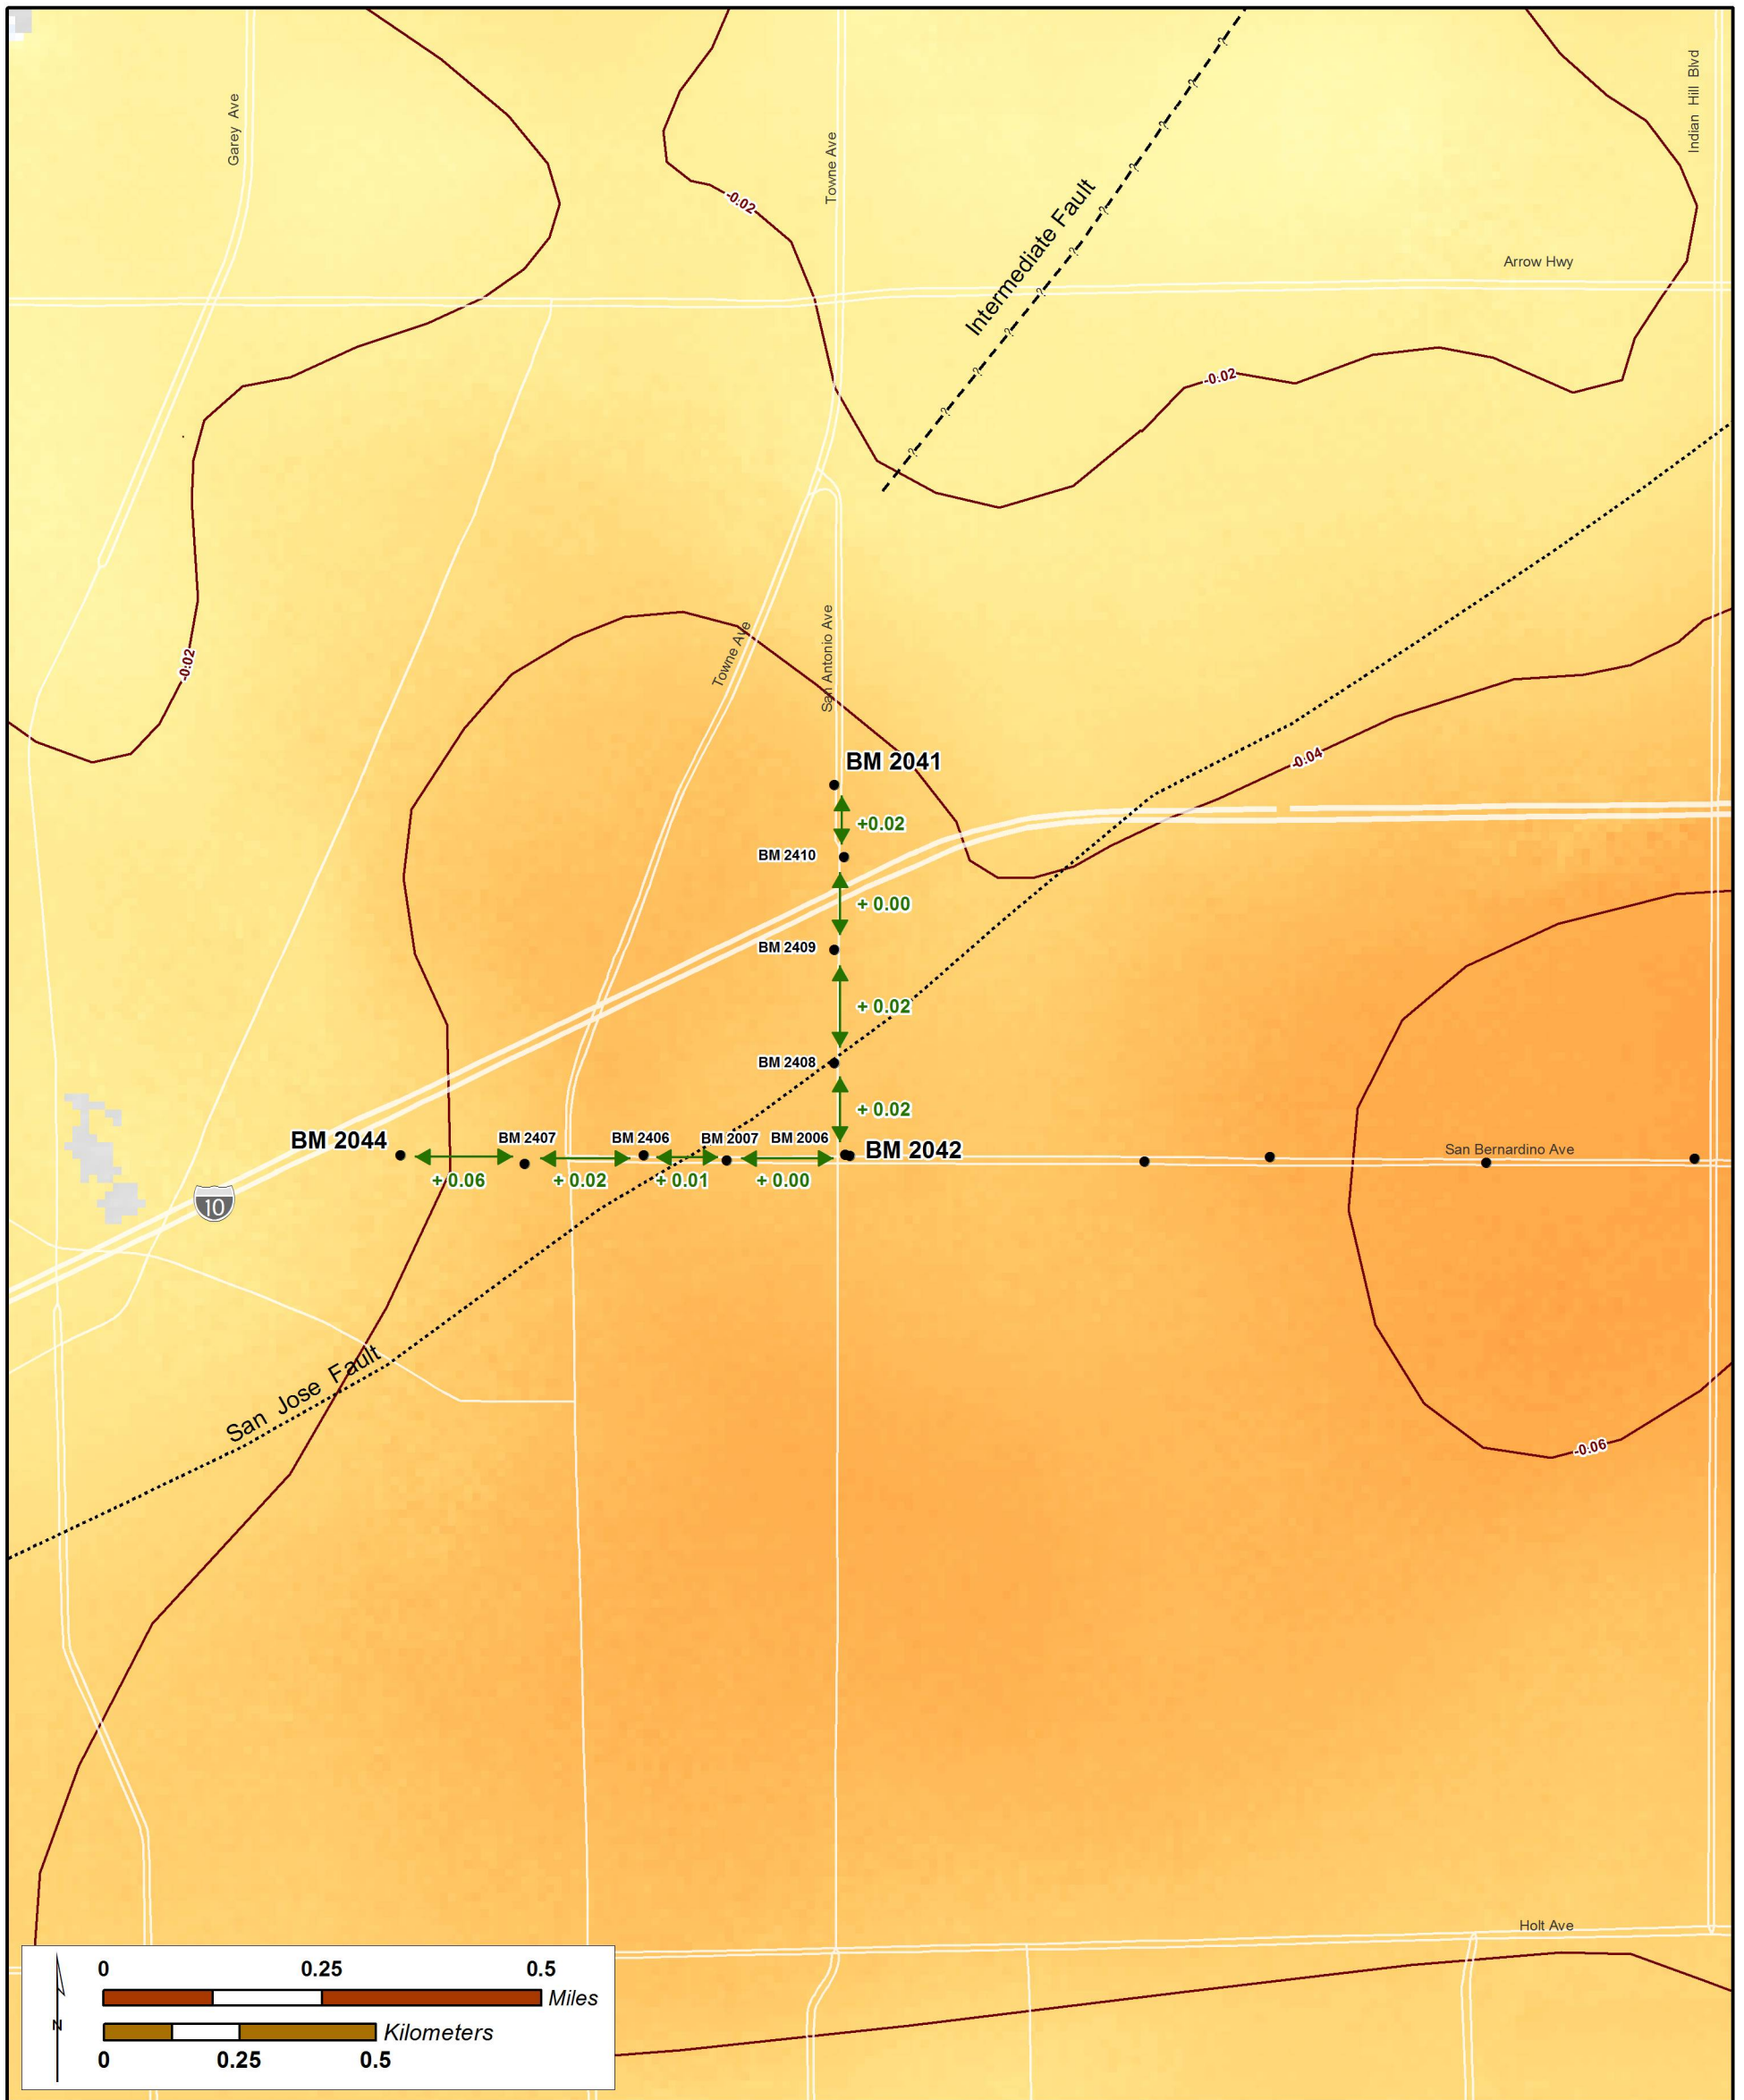
Figure 3-11b

Horizontal ground motion between adjacent benchmarks is shown as extension (+) or compression (-) in either the north-south direction for benchmarks along San Antonio Ave or the east-west direction for benchmarks along San Bernardino Ave.

The standard deviations in the distance measurements for each span for the period of January 2015 to February 2016 range from +/-0.02 to +/-0.03 feet.
