2012 Annual Report of the Land Subsidence Committee

prepared for
Chino Basin Watermaster

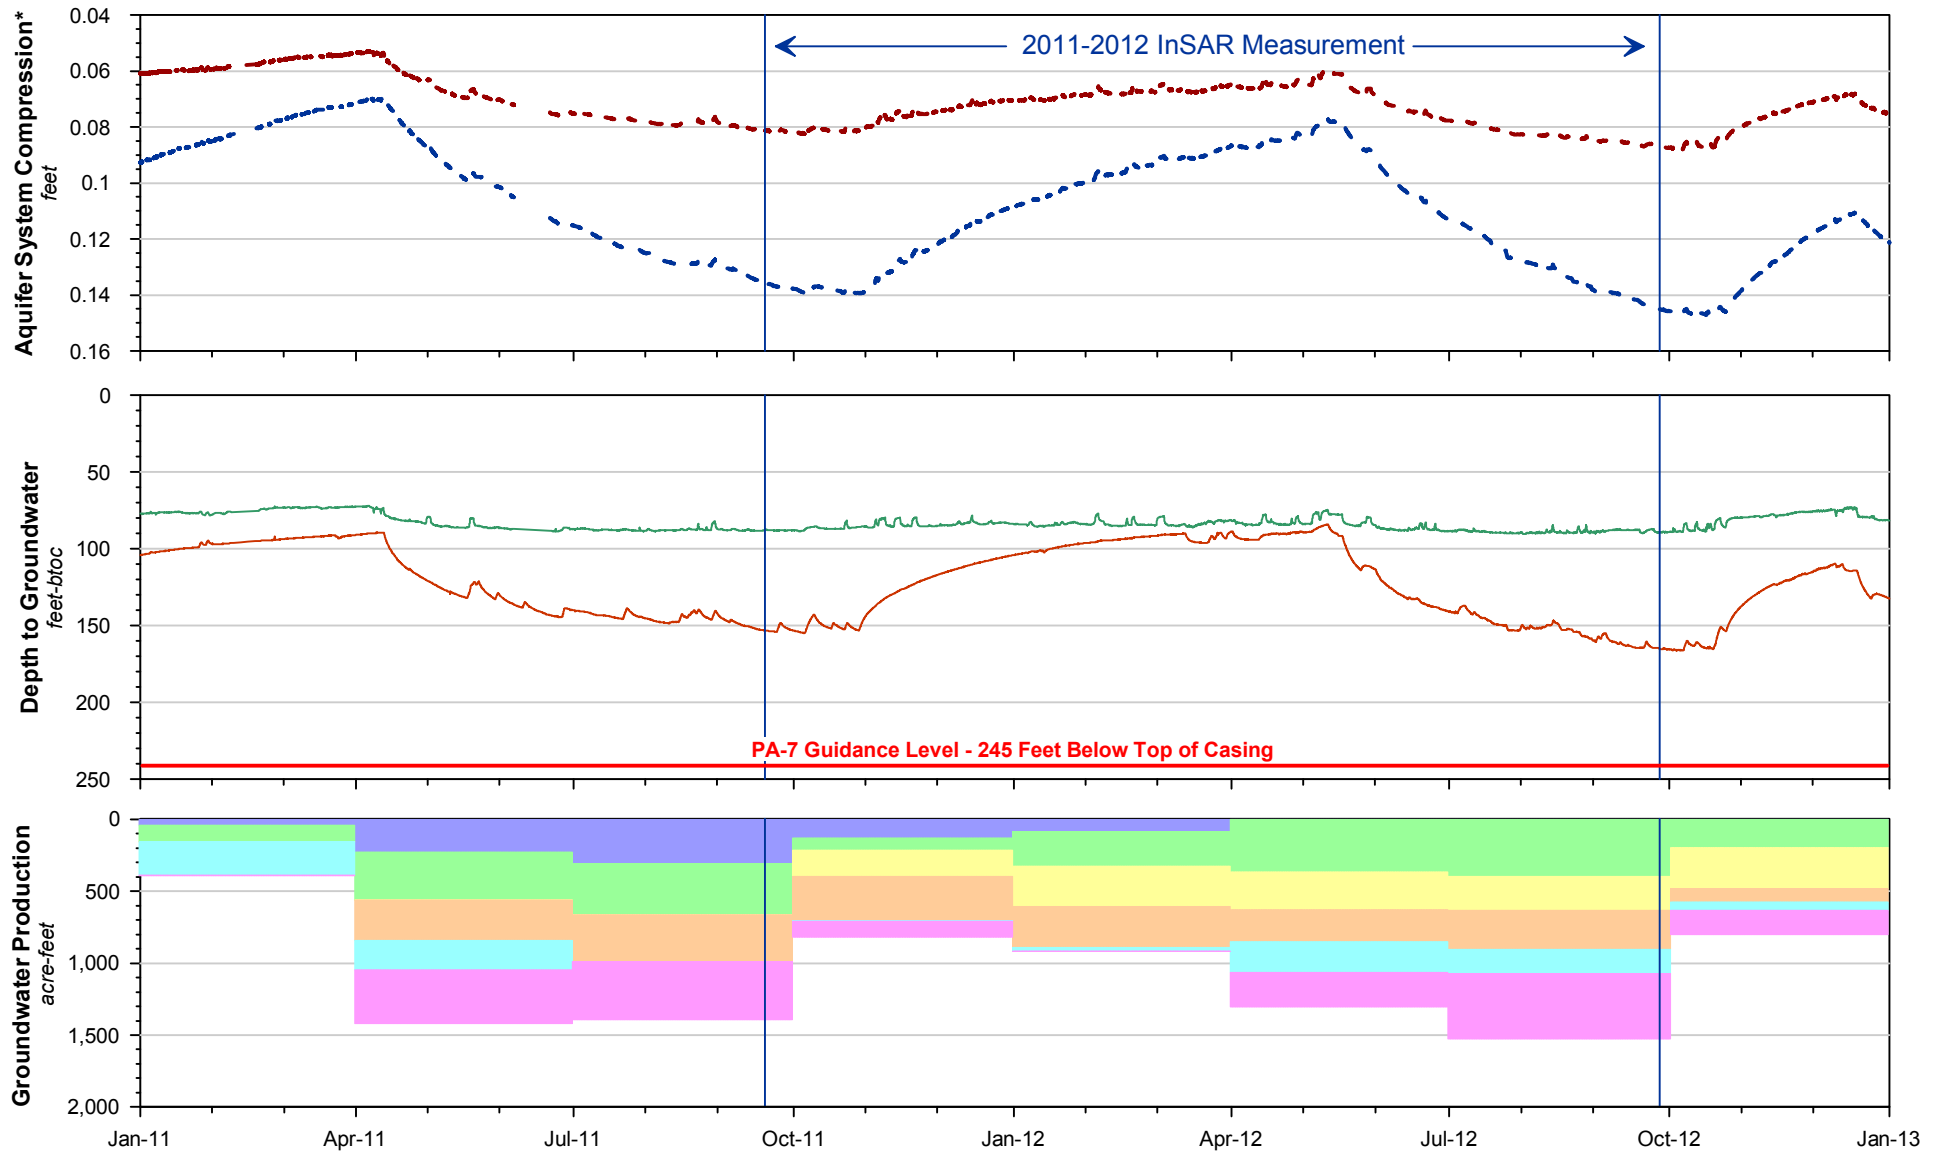
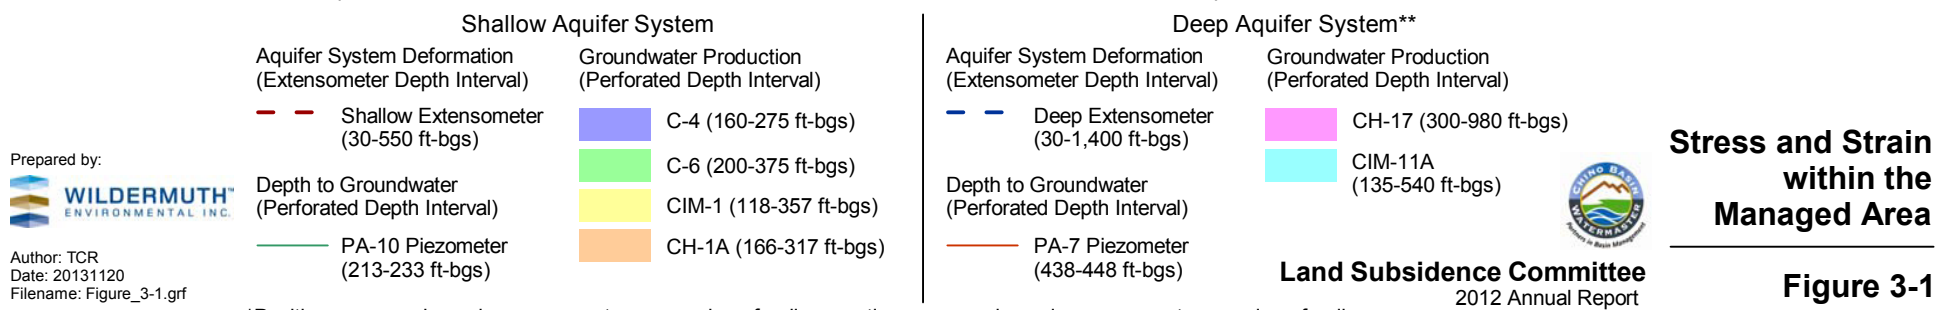
Figure 3-1 includes a time-series chart of the piezometric levels at the Ayala Park Extensometer facility. These data corroborate the conclusions of the IMP and show that pumping from the deep, confined, aquifer system causes groundwater-level drawdown that is much greater in magnitude than drawdown caused by pumping of the shallow aquifer system, even though more pumping occurs from the shallow aquifer system.

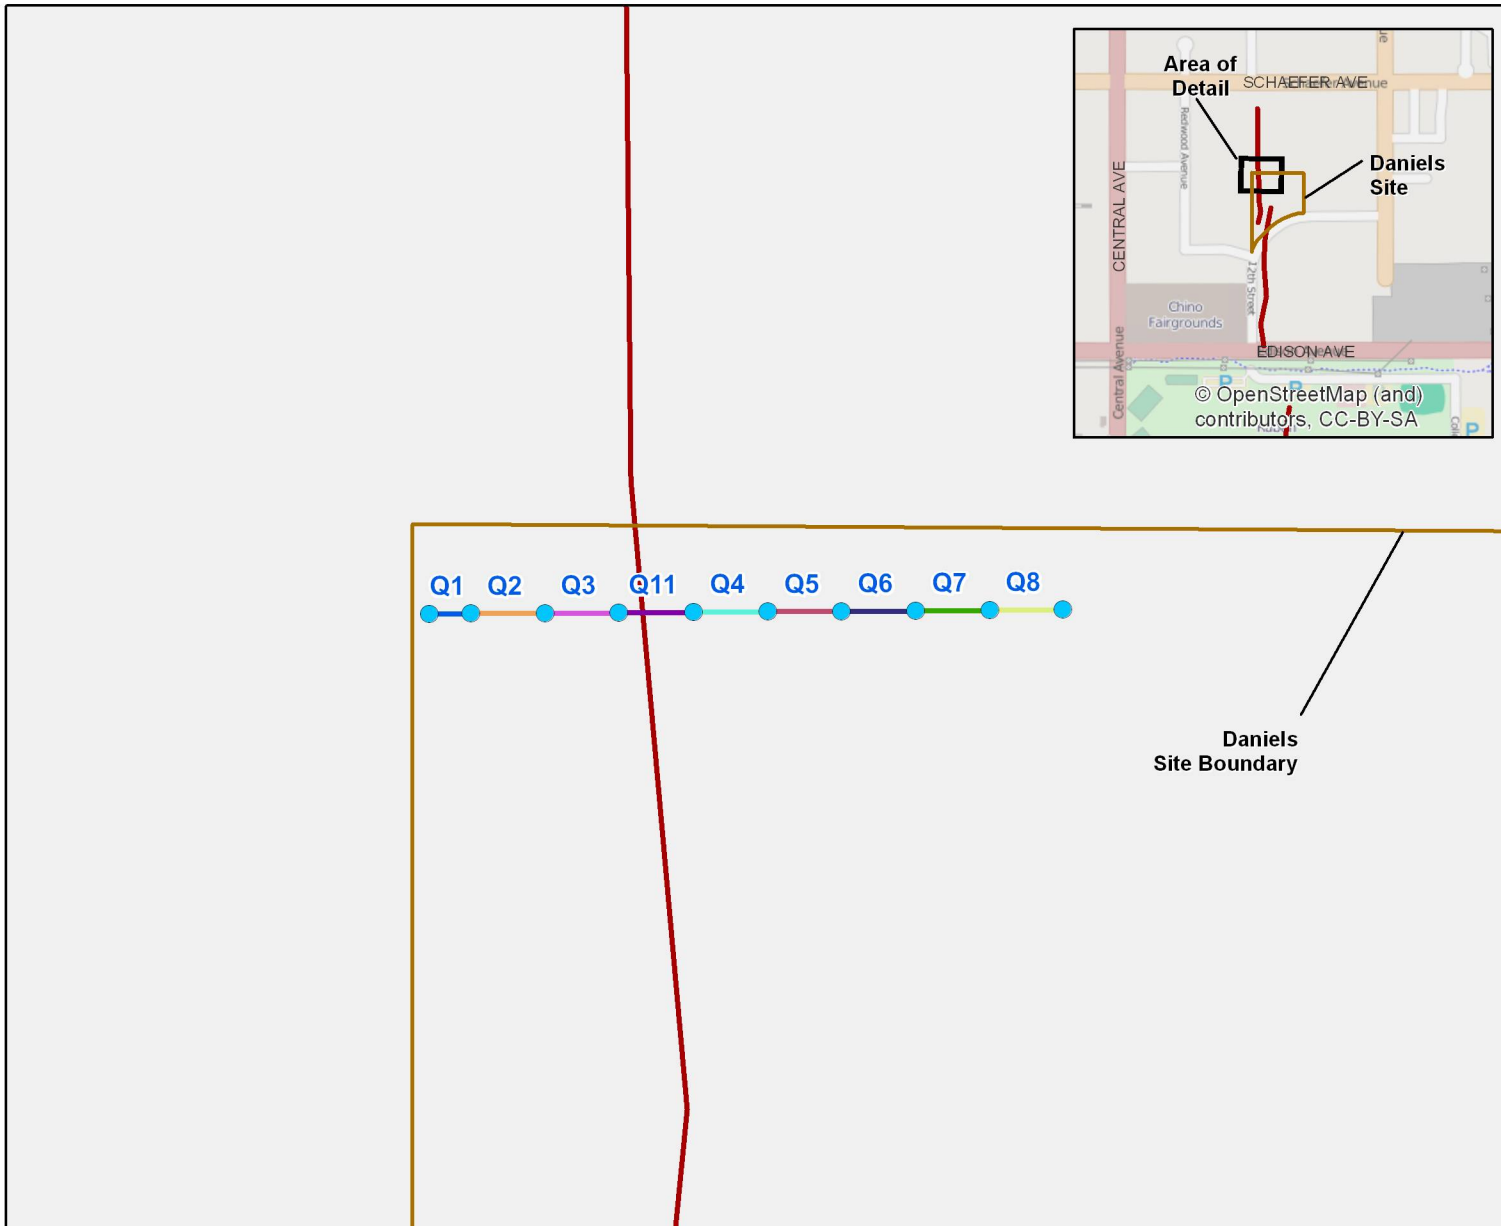
Figure 3-4 is a map of the DHX which measures and records horizontal extension and compression within the shallow soils across the historical fissure zone where it passes north of 12th Street in Chino. The DHX is comprised of nine quartz-tube extensometers that were installed within a trench in an east/west series. The western extensometer is 10-feet long and the other eight extensometers are 20-feet long. The total length of the DHX is about 170 feet. The Q11 extensometer spans the surface rupture of the historical ground fissure.

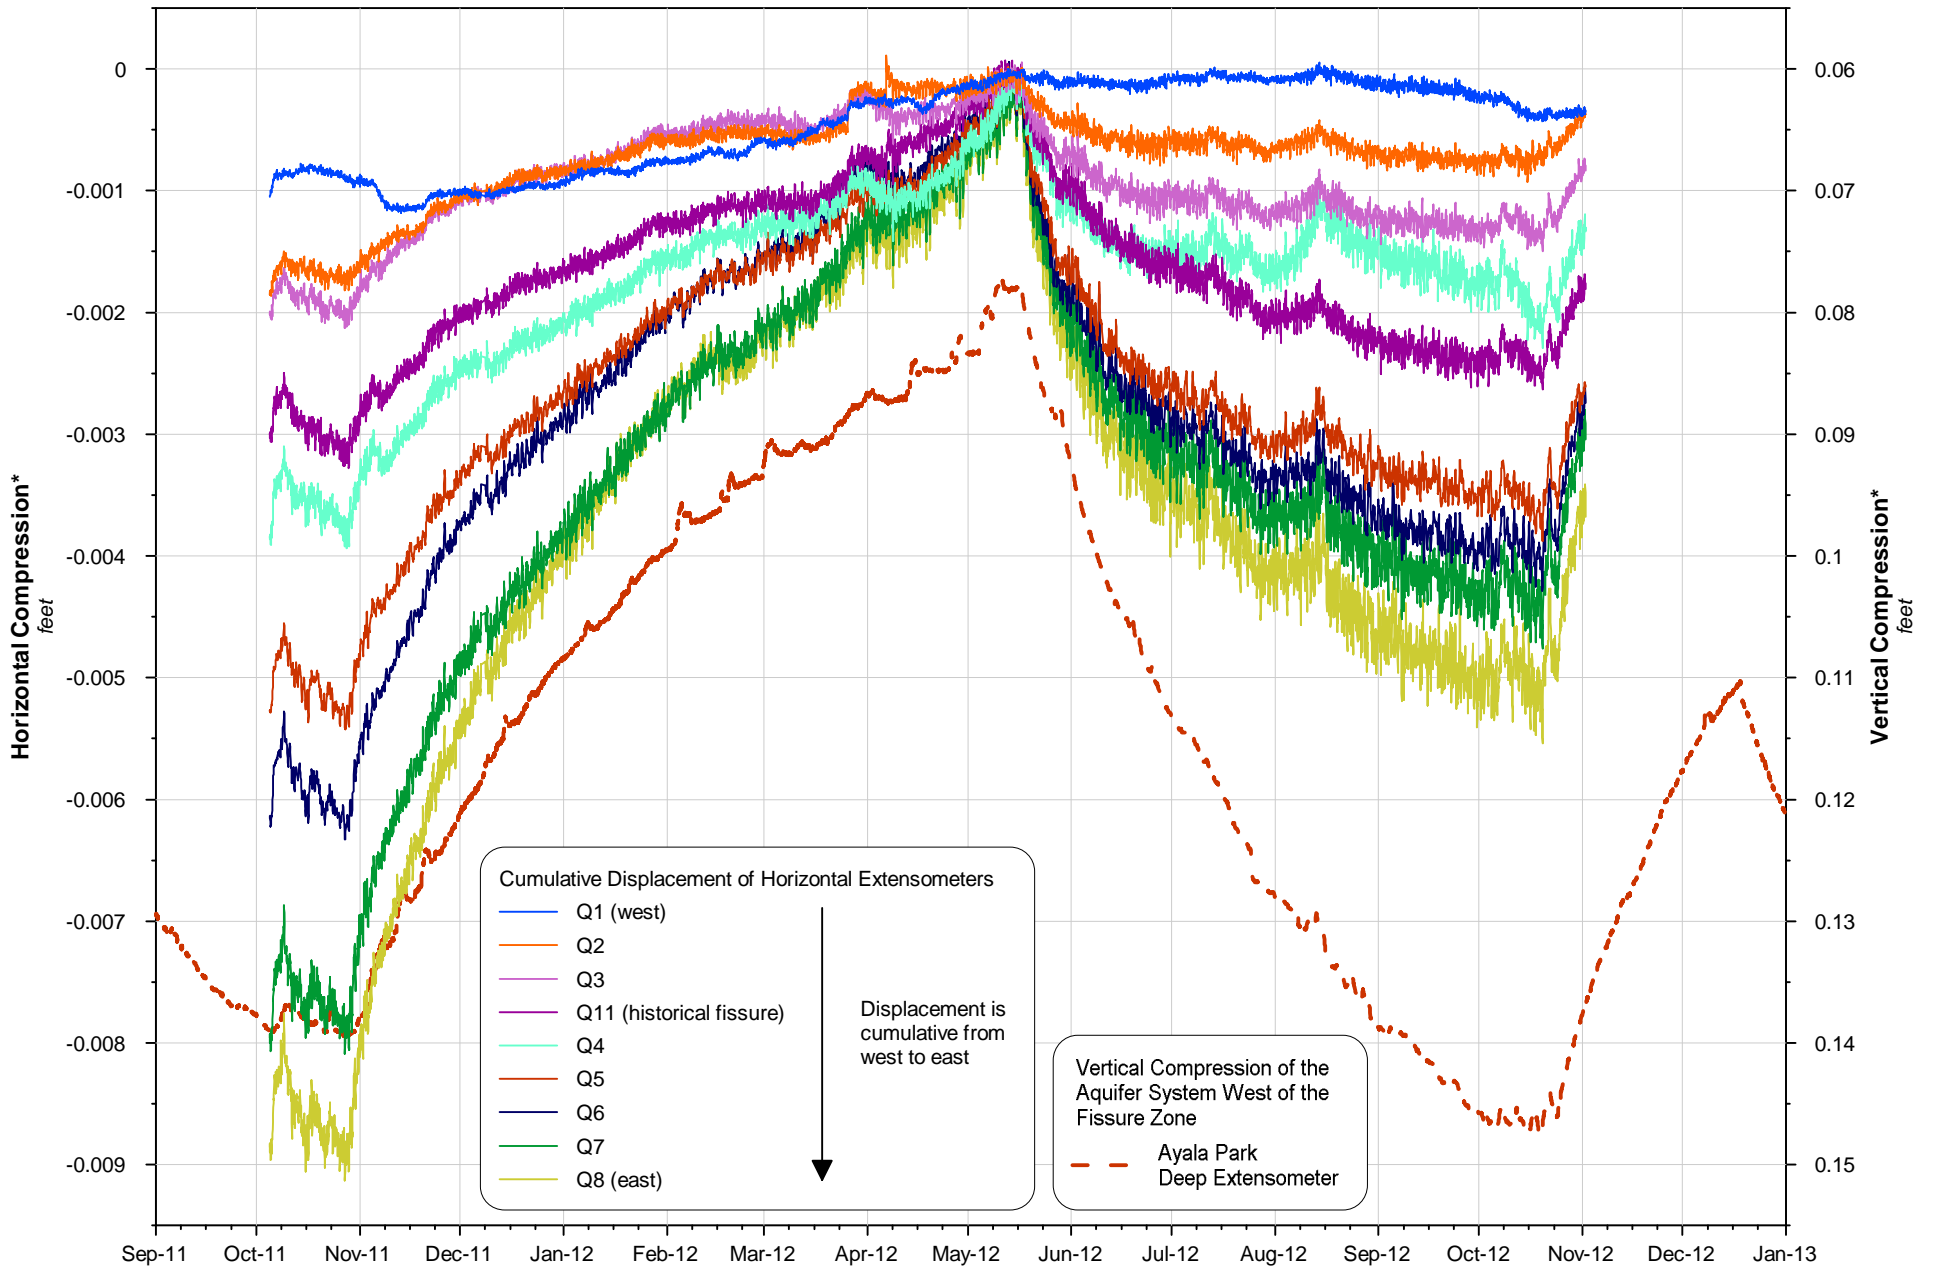
Figure 3-5 is a time-series chart of horizontal deformation across the length of the DHX from west to east. The DHX began recording on October 5, 2011. The extension/compression data shown on Figure 3-5 were set to zero on May 17, 2012, prior to initiation of pumping at CH-17. Also shown on the chart is the vertical compression of the aquifer system as measured by the deep extensometer at the Ayala Park Extensometer facility, which is a measure of the compression and rebound that is occurring west of the fissure zone.

Figure 3-5 generally shows compression across the fissure zone during rebound of the land surface to the west, and extension during subsidence to the west. This pattern of horizontal strain is consistent with the conceptual model of drawdown and compression west of the fissure zone causing differential subsidence and extensional stresses across the fissure zone (and visa versa). The majority of horizontal extensometers show this same pattern, including Q11, but with differing response time and magnitude of deformation. The response of the DHX to changes at the deep extensometer was almost immediate (i.e. response times of less than an hour).

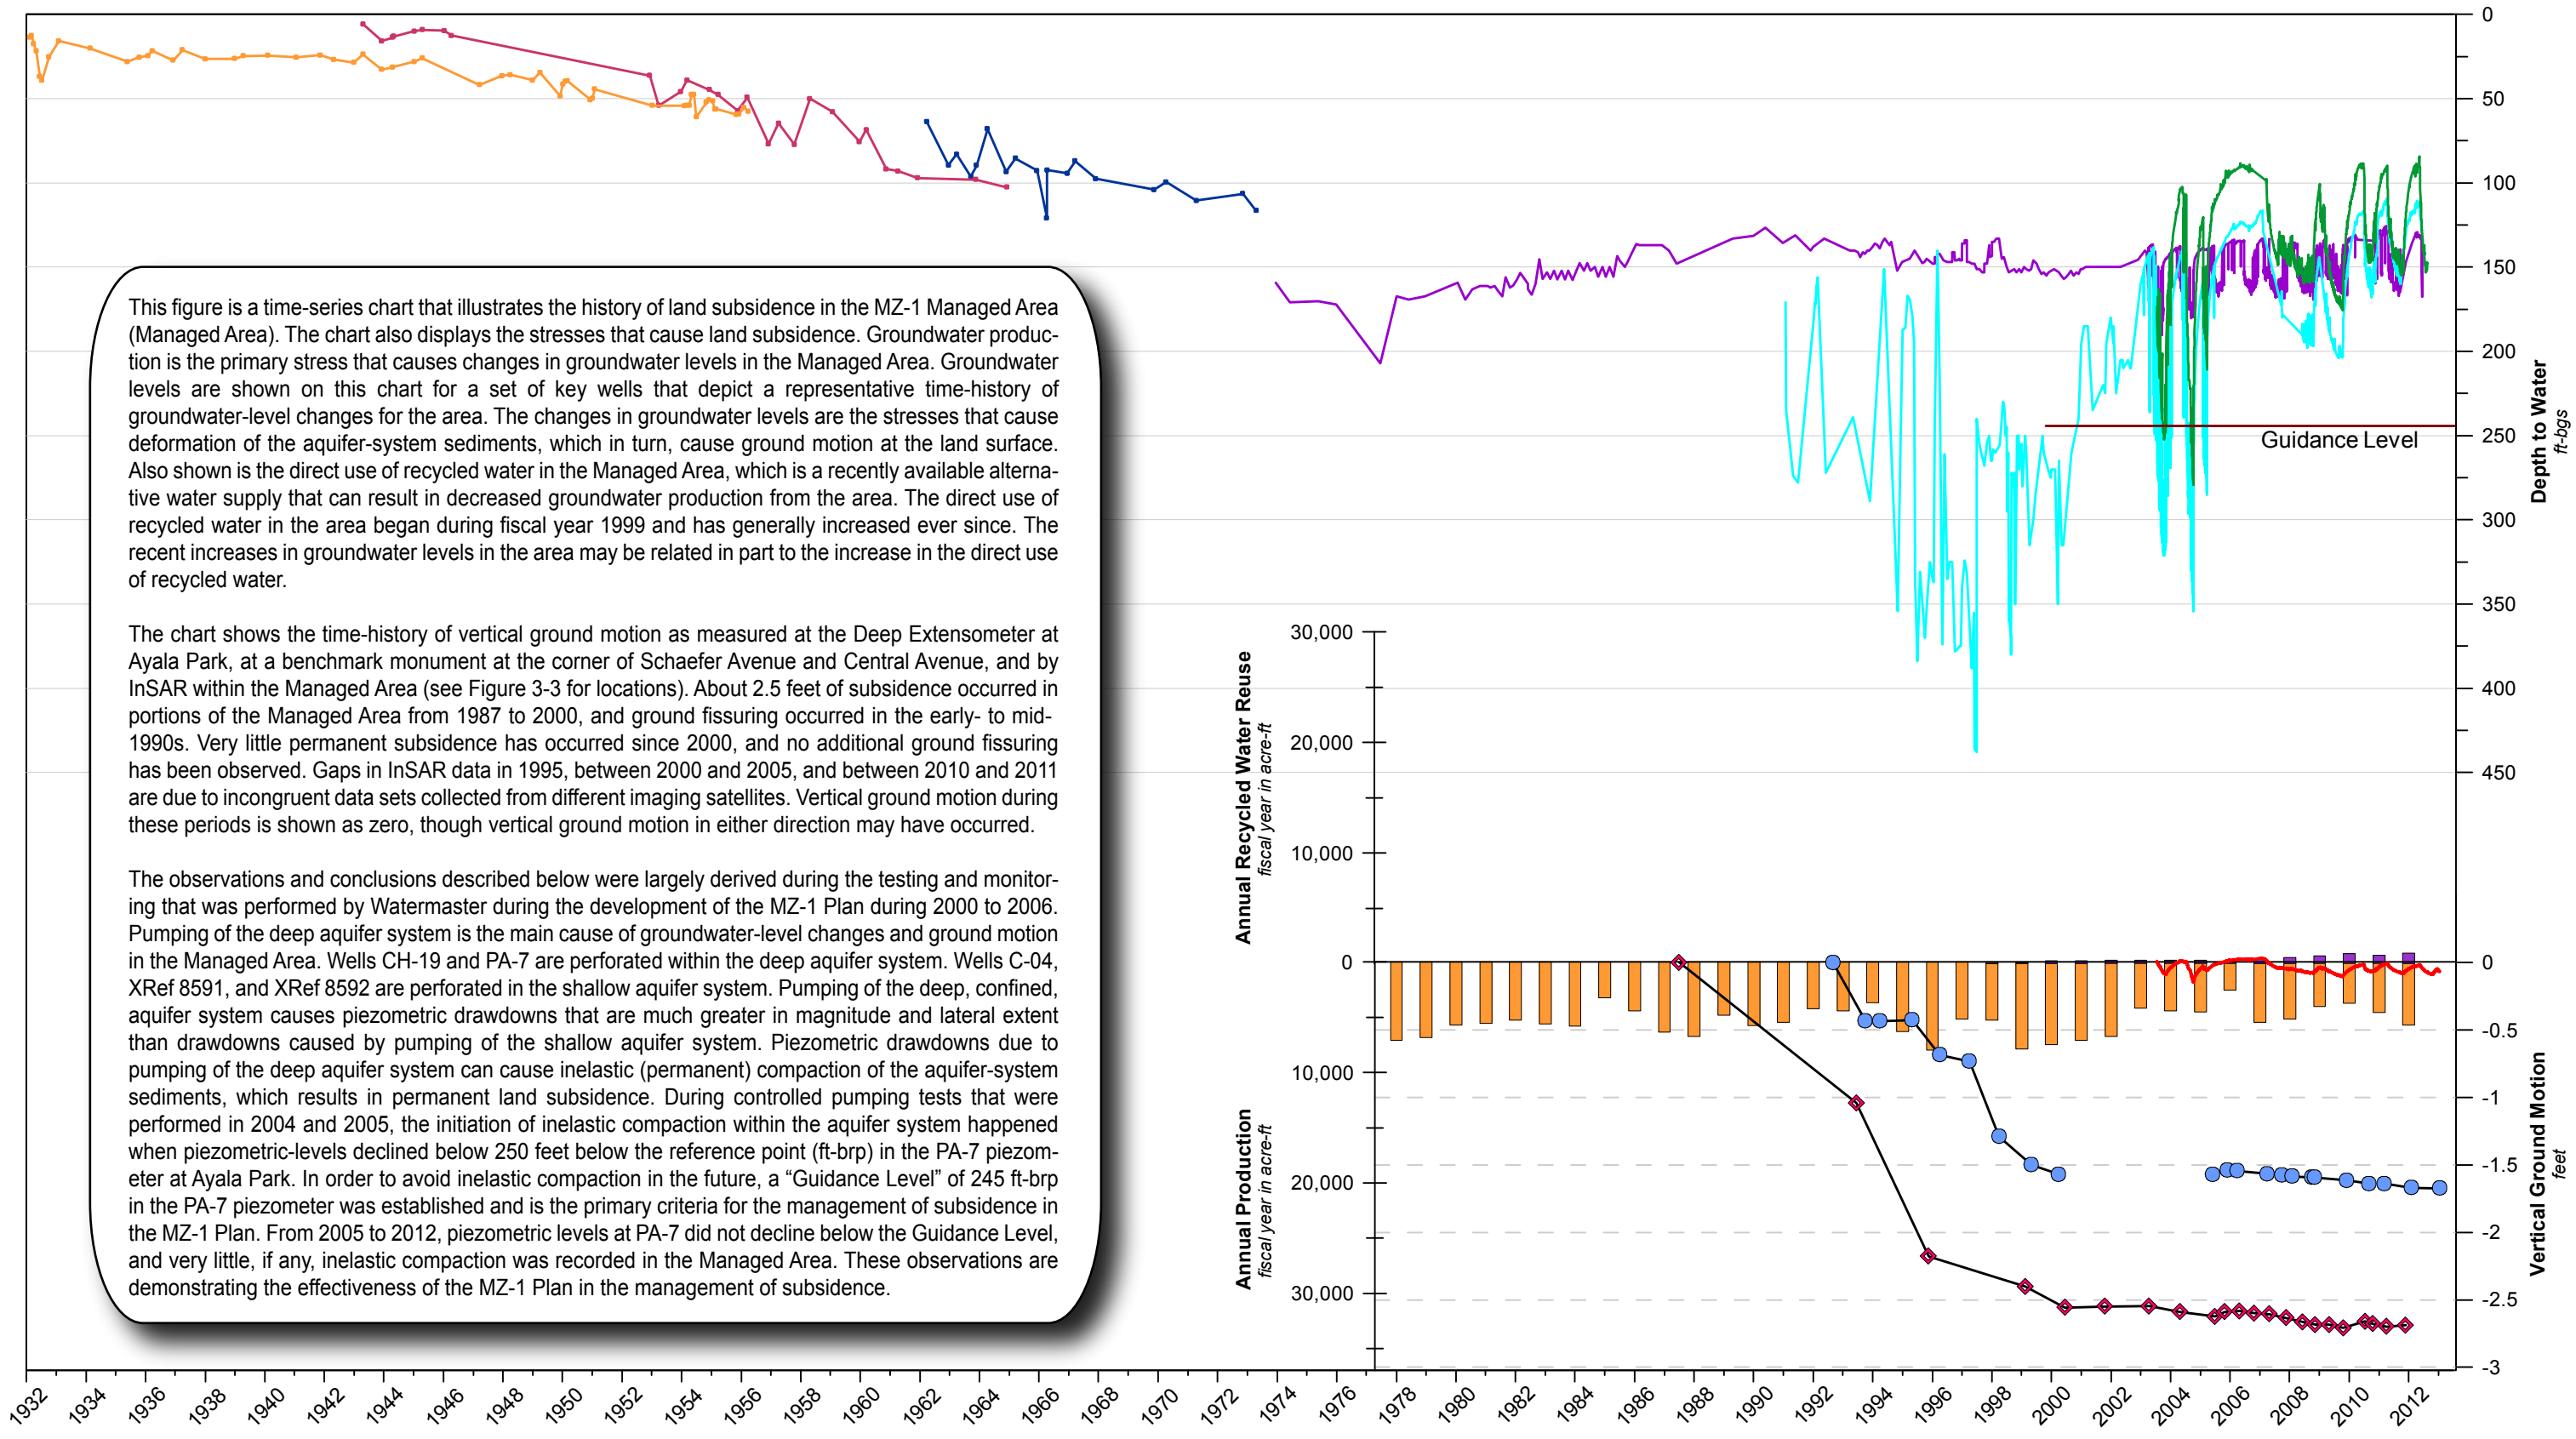
This figure is a time-series chart that illustrates the history of land subsidence in the MZ-1 Managed Area (Managed Area). The chart also displays the stresses that cause land subsidence. Groundwater production is the primary stress that causes changes in groundwater levels in the Managed Area. Groundwater levels are shown on this chart for a set of key wells that depict a representative time-history of groundwater-level changes for the area. The changes in groundwater levels are the stresses that cause deformation of the aquifer-system sediments, which in turn, cause ground motion at the land surface. Also shown is the direct use of recycled water in the Managed Area, which is a recently available alternative water supply that can result in decreased groundwater production from the area. The direct use of recycled water in the area began during fiscal year 1999 and has generally increased ever since. The recent increases in groundwater levels in the area may be related in part to the increase in the direct use of recycled water.

The chart shows the time-history of vertical ground motion as measured at the Deep Extensometer at Ayala Park, at a benchmark monument at the corner of Schaefer Avenue and Central Avenue, and by InSAR within the Managed Area (see Figure 3-3 for locations). About 2.5 feet of subsidence occurred in portions of the Managed Area from 1987 to 2000, and ground fissuring occurred in the early- to mid-1990s. Very little permanent subsidence has occurred since 2000, and no additional ground fissuring has been observed. Gaps in InSAR data in 1995, between 2000 and 2005, and between 2010 and 2011 are due to incongruent data sets collected from different imaging satellites. Vertical ground motion during these periods is shown as zero, though vertical ground motion in either direction may have occurred.

The observations and conclusions described below were largely derived during the testing and monitoring that was performed by Watermaster during the development of the MZ-1 Plan during 2000 to 2006. Pumping of the deep aquifer system is the main cause of groundwater-level changes and ground motion in the Managed Area. Wells CH-19 and PA-7 are perforated within the deep aquifer system. Wells C-04, XRef 8591, and XRef 8592 are perforated in the shallow aquifer system. Pumping of the deep, confined, aquifer system causes piezometric drawdowns that are much greater in magnitude and lateral extent than drawdowns caused by pumping of the shallow aquifer system. Piezometric drawdowns due to pumping of the deep aquifer system can cause inelastic (permanent) compaction of the aquifer-system sediments, which results in permanent land subsidence. During controlled pumping tests that were performed in 2004 and 2005, the initiation of inelastic compaction within the aquifer system happened when piezometric-levels declined below 250 feet below the reference point (ft-brp) in the PA-7 piezometer at Ayala Park. In order to avoid inelastic compaction in the future, a "Guidance Level" of 245 ft-brp in the PA-7 piezometer was established and is the primary criteria for the management of subsidence in the MZ-1 Plan. From 2005 to 2012, piezometric levels at PA-7 did not decline below the Guidance Level, and very little, if any, inelastic compaction was recorded in the Managed Area. These observations are demonstrating the effectiveness of the MZ-1 Plan in the management of subsidence.

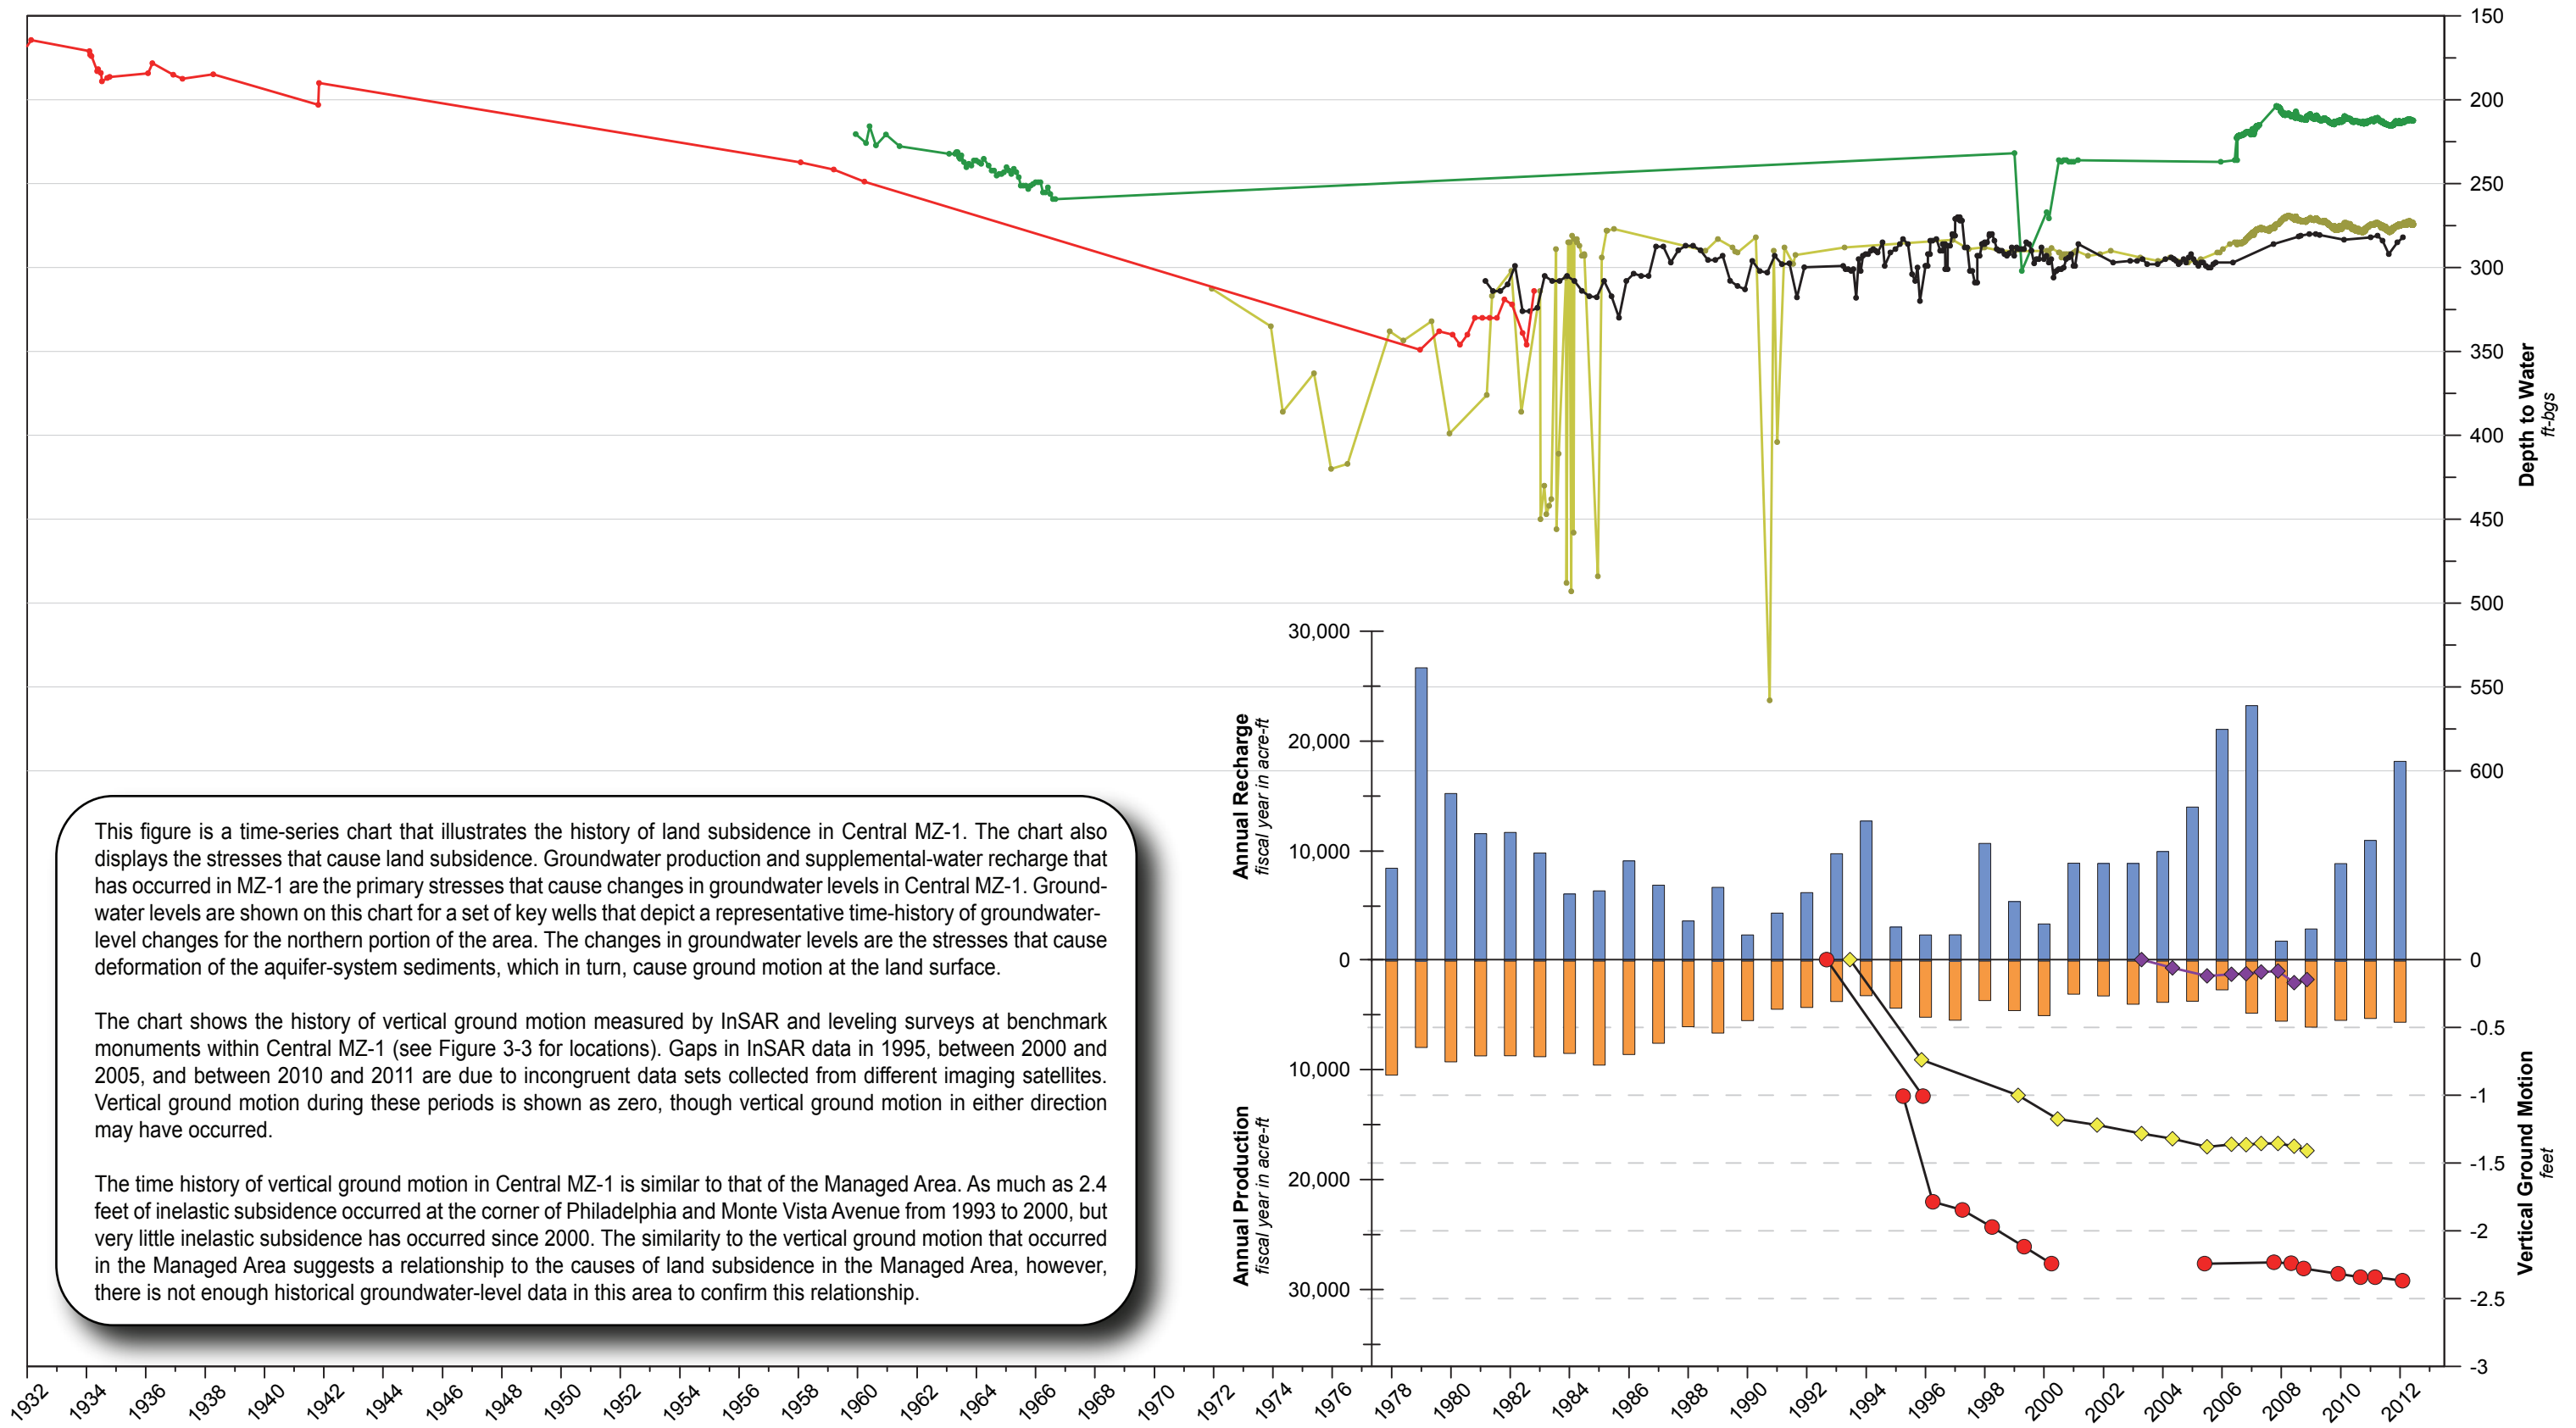
Figure 3-7

This figure is a time-series chart that illustrates the history of land subsidence in Central MZ-1. The chart also displays the stresses that cause land subsidence. Groundwater production and supplemental-water recharge that has occurred in MZ-1 are the primary stresses that cause changes in groundwater levels in Central MZ-1. Groundwater levels are shown on this chart for a set of key wells that depict a representative time-history of groundwater-level changes for the northern portion of the area. The changes in groundwater levels are the stresses that cause deformation of the aquifer-system sediments, which in turn, cause ground motion at the land surface.

The chart shows the history of vertical ground motion measured by InSAR and leveling surveys at benchmark monuments within Central MZ-1 (see Figure 3-3 for locations). Gaps in InSAR data in 1995, between 2000 and 2005, and between 2010 and 2011 are due to incongruent data sets collected from different imaging satellites. Vertical ground motion during these periods is shown as zero, though vertical ground motion in either direction may have occurred.

The time history of vertical ground motion in Central MZ-1 is similar to that of the Managed Area. As much as 2.4 feet of inelastic subsidence occurred at the corner of Philadelphia and Monte Vista Avenue from 1993 to 2000, but very little inelastic subsidence has occurred since 2000. The similarity to the vertical ground motion that occurred in the Managed Area suggests a relationship to the causes of land subsidence in the Managed Area, however, there is not enough historical groundwater-level data in this area to confirm this relationship.

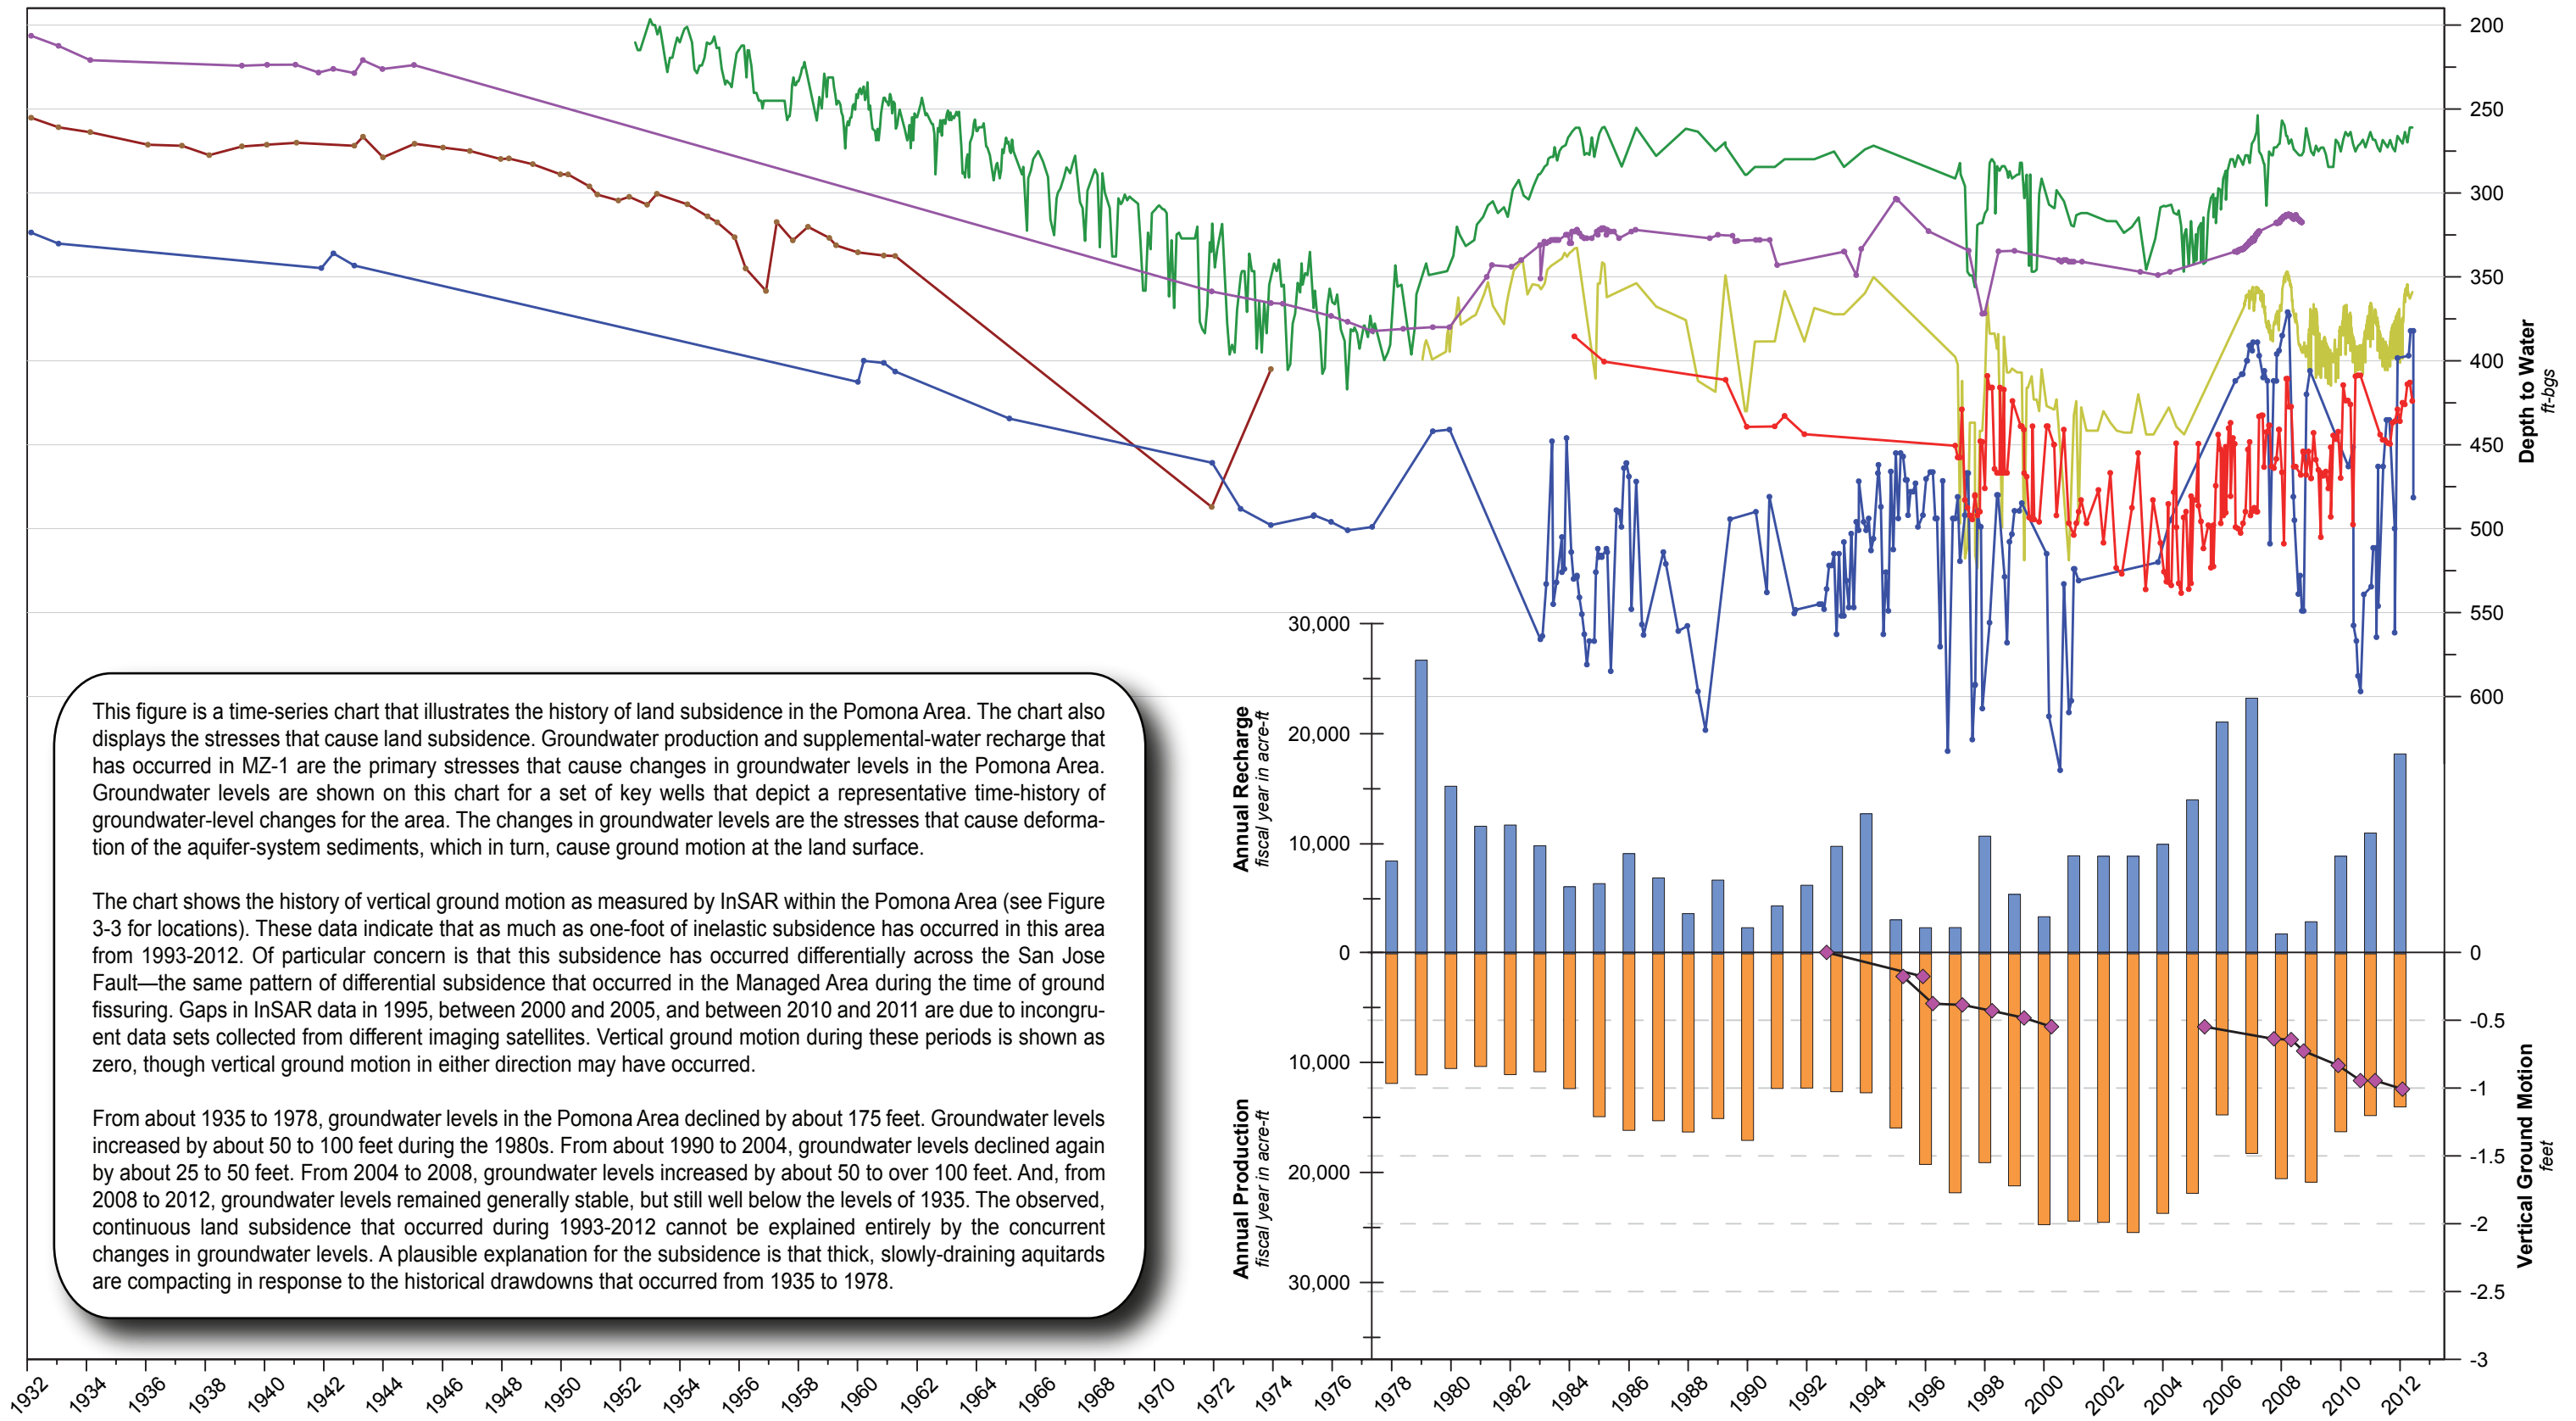
Figure 3-8 provides a comprehensive description and explanation of the history of subsidence in the Pomona Area. The InSAR data on Figure 3-3 indicate that a maximum of about 0.04 feet of land subsidence occurred in this area during the period of fall-2011 to fall-2012. This pattern of subsidence is consistent with the historical time-series of subsidence in this area shown on Figure 3-8, but suggests a decrease in the rate of subsidence. Currently, there are not enough aquifer-system data available to definitively explain the causes of the subsidence in this area or the changes in rate of subsidence.

Of particular concern in the Pomona Area is that the historical and ongoing subsidence has been differential across the San Jose Fault. This is the same spatial pattern of subsidence that lead to the episode of ground fissuring in the Managed Area during the 1990s.
