2012 Annual Report of the Land Subsidence Committee

prepared for
Chino Basin Watermaster

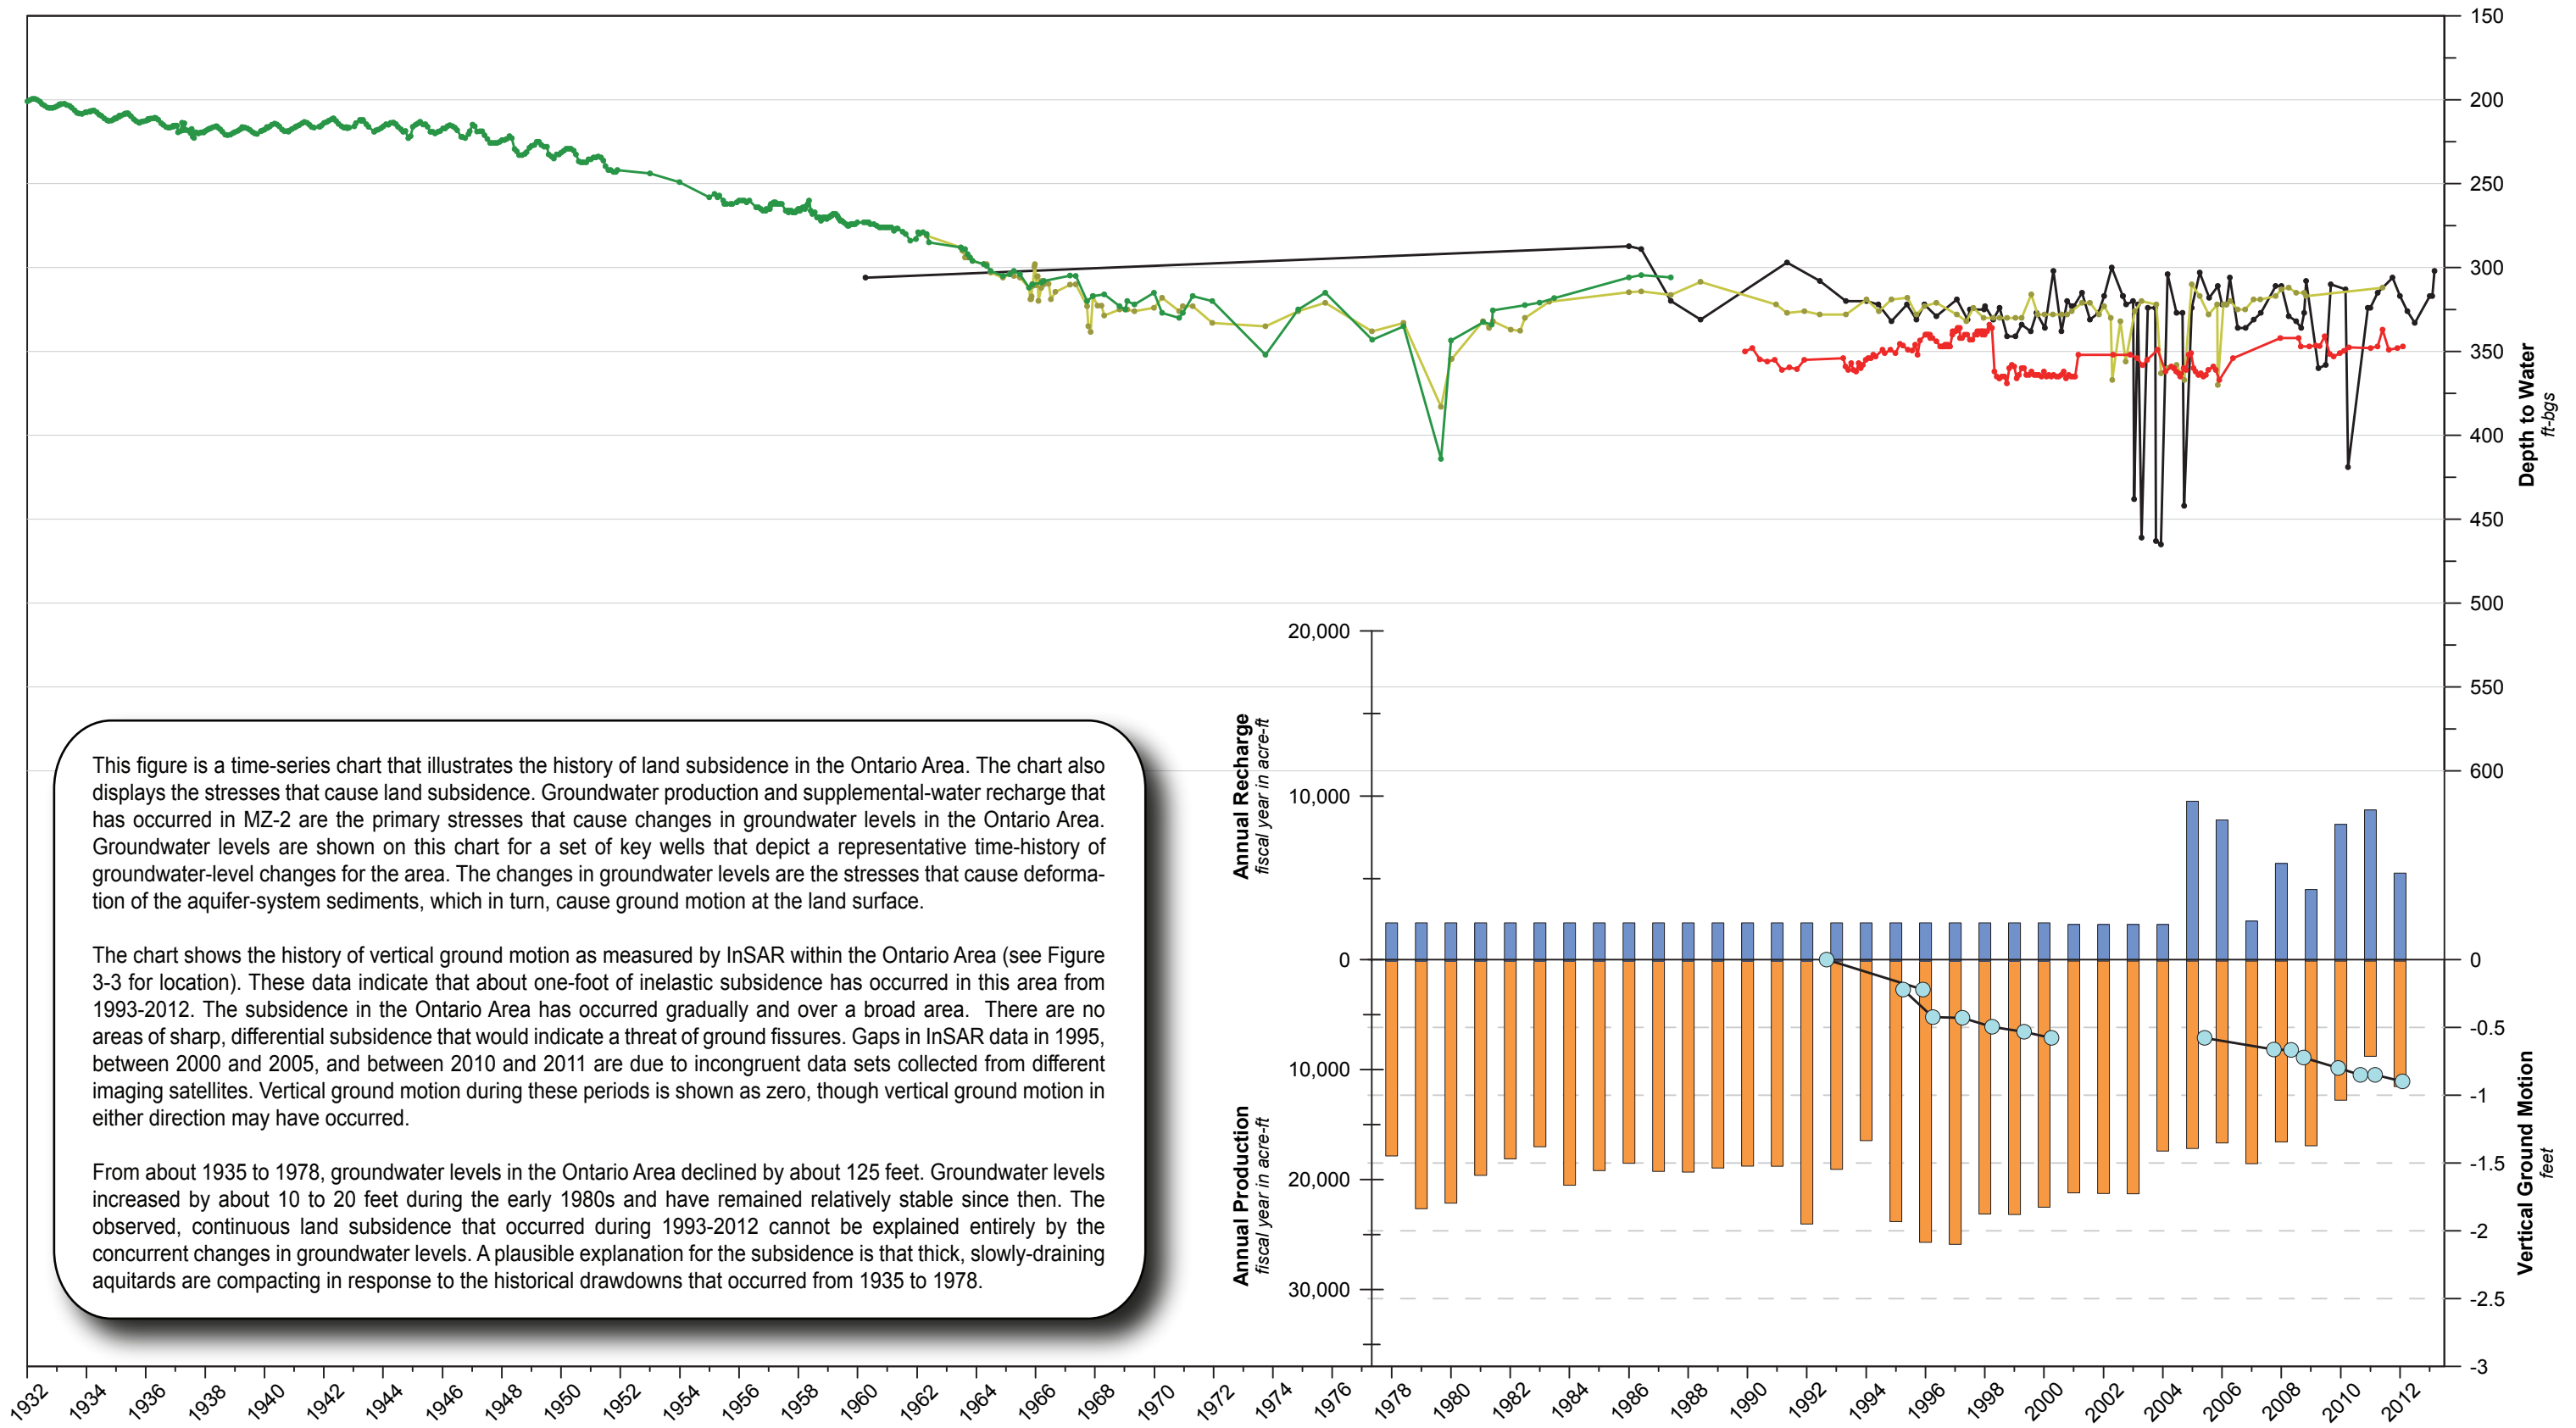
Figure 3-9

This figure is a time-series chart that illustrates the history of land subsidence in the Ontario Area. The chart also displays the stresses that cause land subsidence. Groundwater production and supplemental-water recharge that has occurred in MZ-2 are the primary stresses that cause changes in groundwater levels in the Ontario Area. Groundwater levels are shown on this chart for a set of key wells that depict a representative time-history of groundwater-level changes for the area. The changes in groundwater levels are the stresses that cause deformation of the aquifer-system sediments, which in turn, cause ground motion at the land surface.

The chart shows the history of vertical ground motion as measured by InSAR within the Ontario Area (see Figure 3-3 for location). These data indicate that about one-foot of inelastic subsidence has occurred in this area from 1993-2012. The subsidence in the Ontario Area has occurred gradually and over a broad area. There are no areas of sharp, differential subsidence that would indicate a threat of ground fissures. Gaps in InSAR data in 1995, between 2000 and 2005, and between 2010 and 2011 are due to incongruent data sets collected from different imaging satellites. Vertical ground motion during these periods is shown as zero, though vertical ground motion in either direction may have occurred.

From about 1935 to 1978, groundwater levels in the Ontario Area declined by about 125 feet. Groundwater levels increased by about 10 to 20 feet during the early 1980s and have remained relatively stable since then. The observed, continuous land subsidence that occurred during 1993-2012 cannot be explained entirely by the concurrent changes in groundwater levels. A plausible explanation for the subsidence is that thick, slowly-draining aquitards are compacting in response to the historical drawdowns that occurred from 1935 to 1978.
