The MZ-1 Plan states that Watermaster will produce an annual report that includes the results of ongoing monitoring efforts, interpretations of the data, and recommended adjustment to the MZ-1 Plan, if any. This Annual Report of the Land Subsidence Committee includes results and interpretations for data that were collected during calendar year 2013, and includes recommendations for Watermaster’s Land-Subsidence Monitoring Program for fiscal year 2014-15.

Land Subsidence Committee
 2013 Annual Report

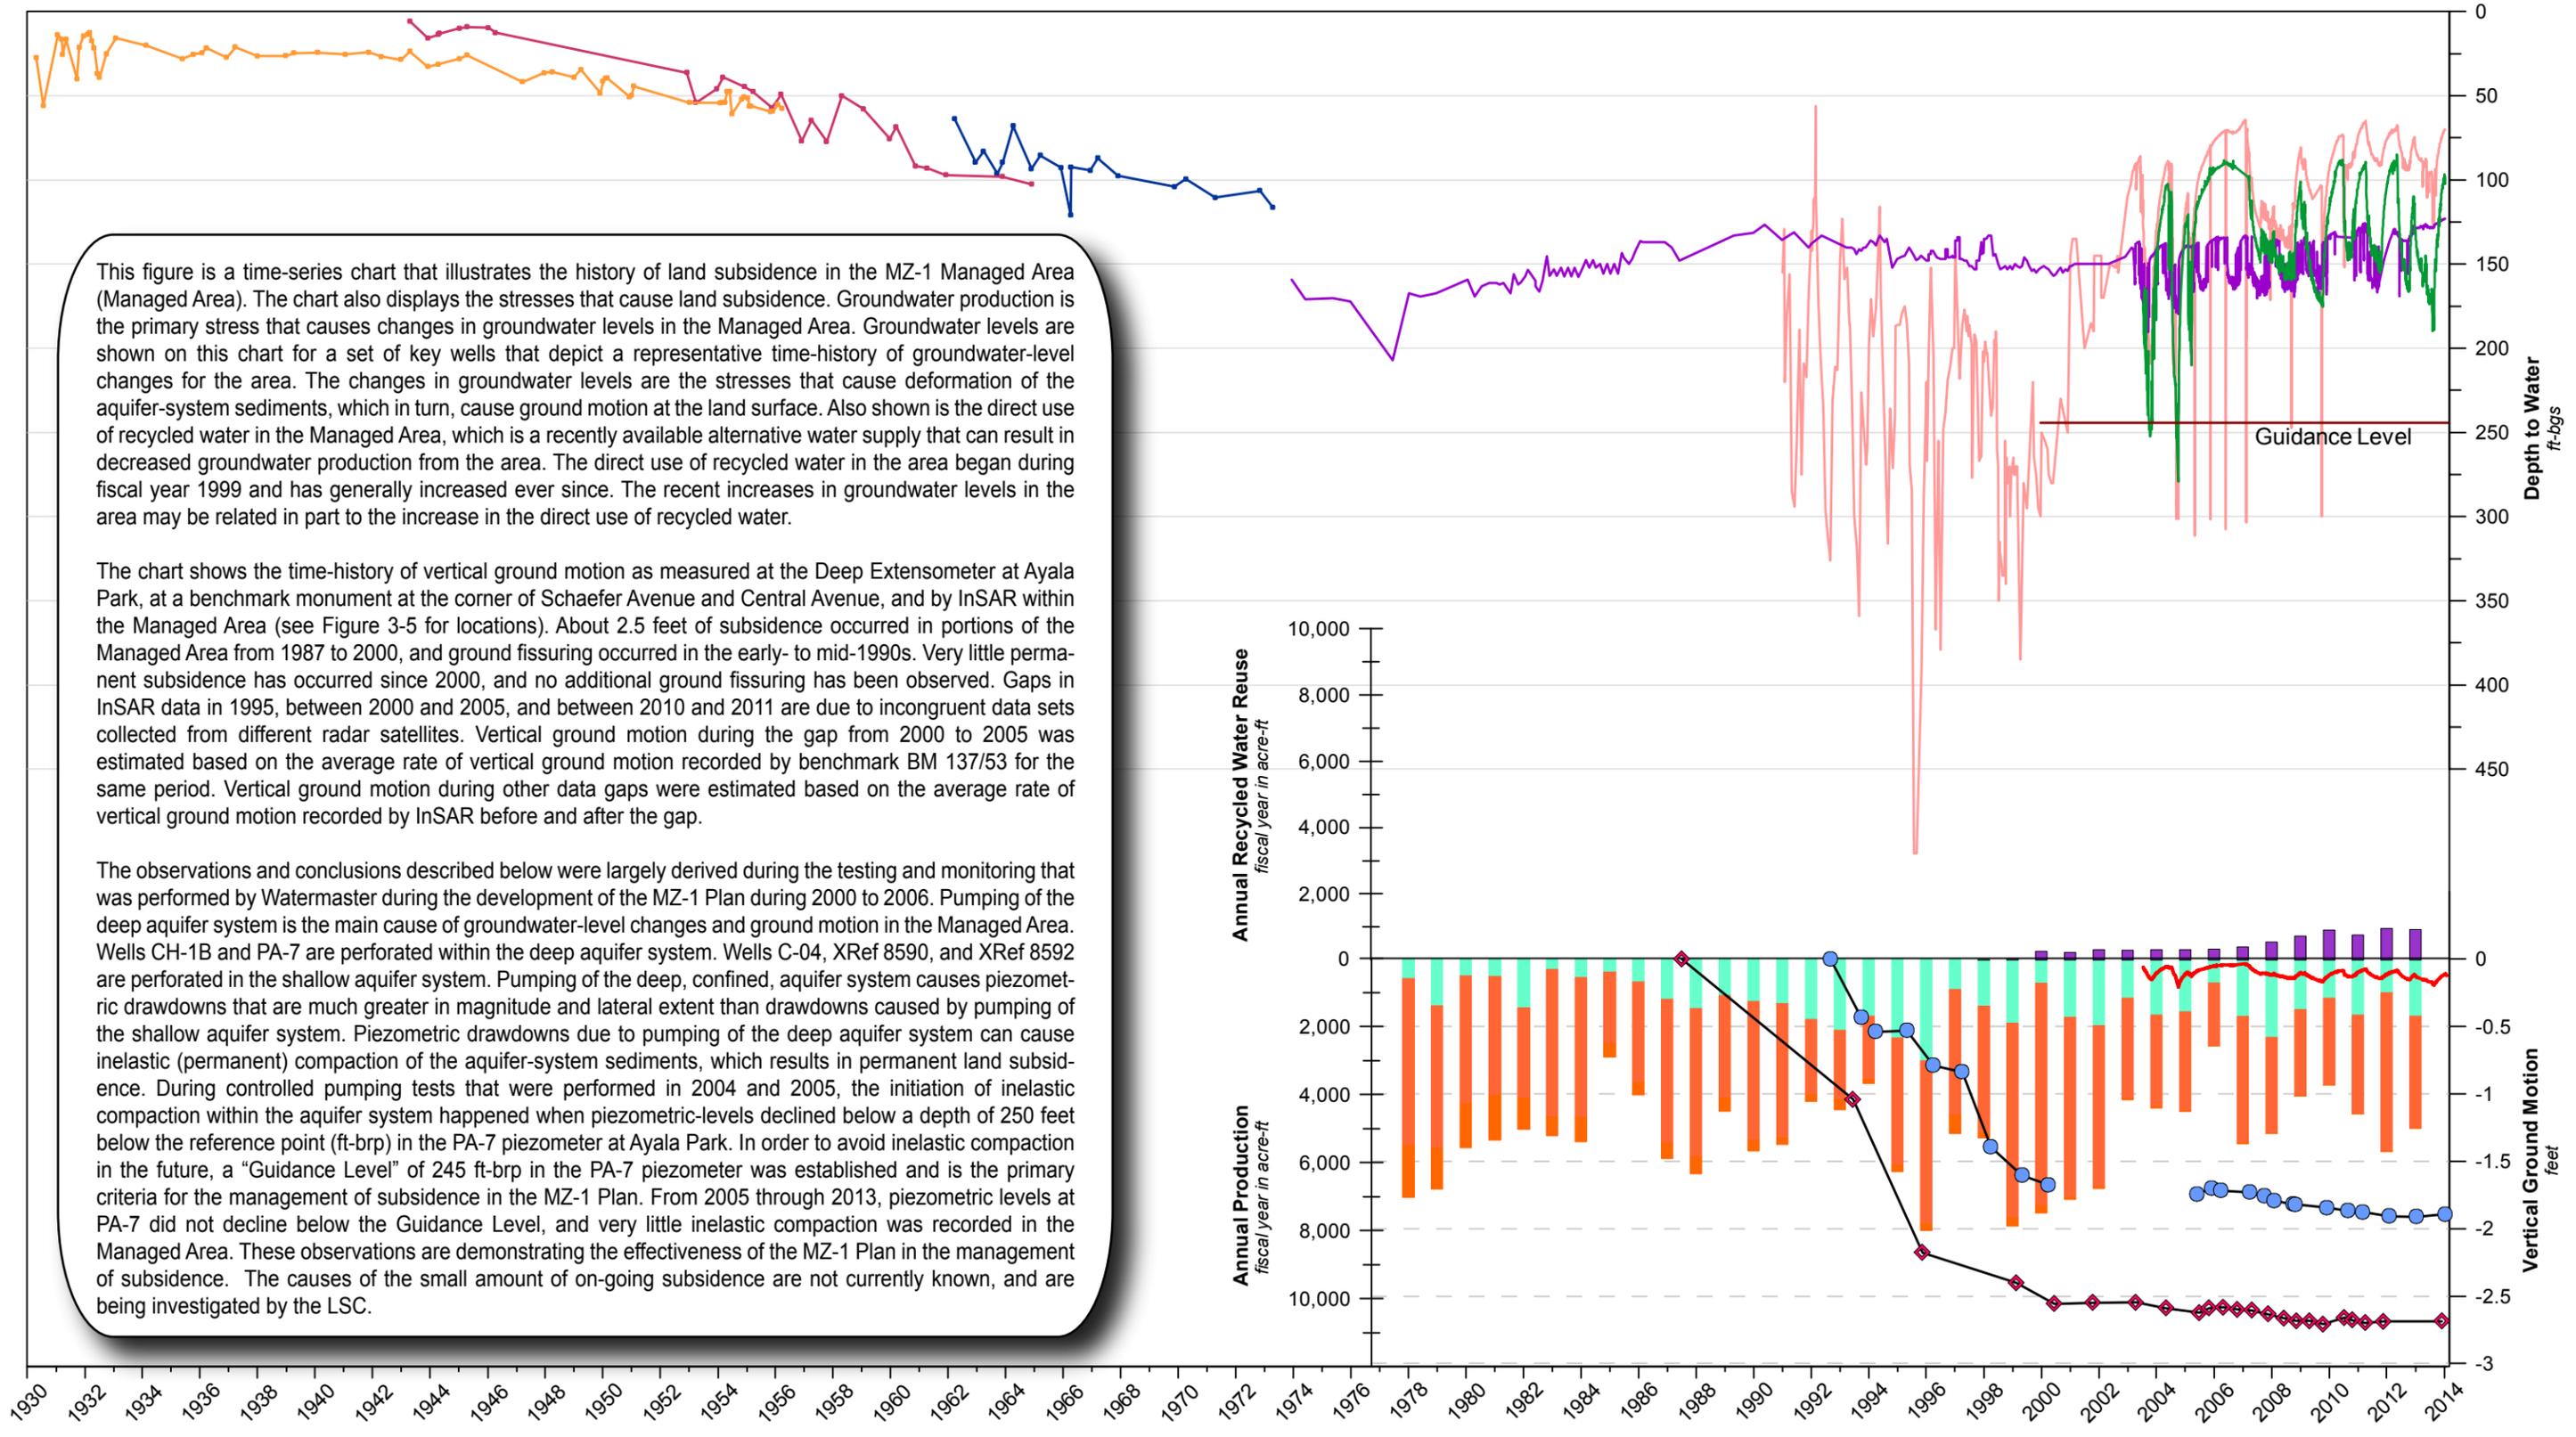
Figure 3-1 provides a description and explanation of the history of land subsidence in the Managed Area. The main observations from this chart are that pumping from the deep aquifer system during the 1990s caused large drawdown and coincided with high rates of land subsidence. About 2.5 ft of subsidence occurred from 1987-1999, and ground fissures opened within the City of Chino in the early 1990s. Since 2000, pumping has decreased, piezometric levels in the deep aquifer system have recovered, and the rate of land subsidence has declined significantly to a rate of about 0.01 ft/yr.

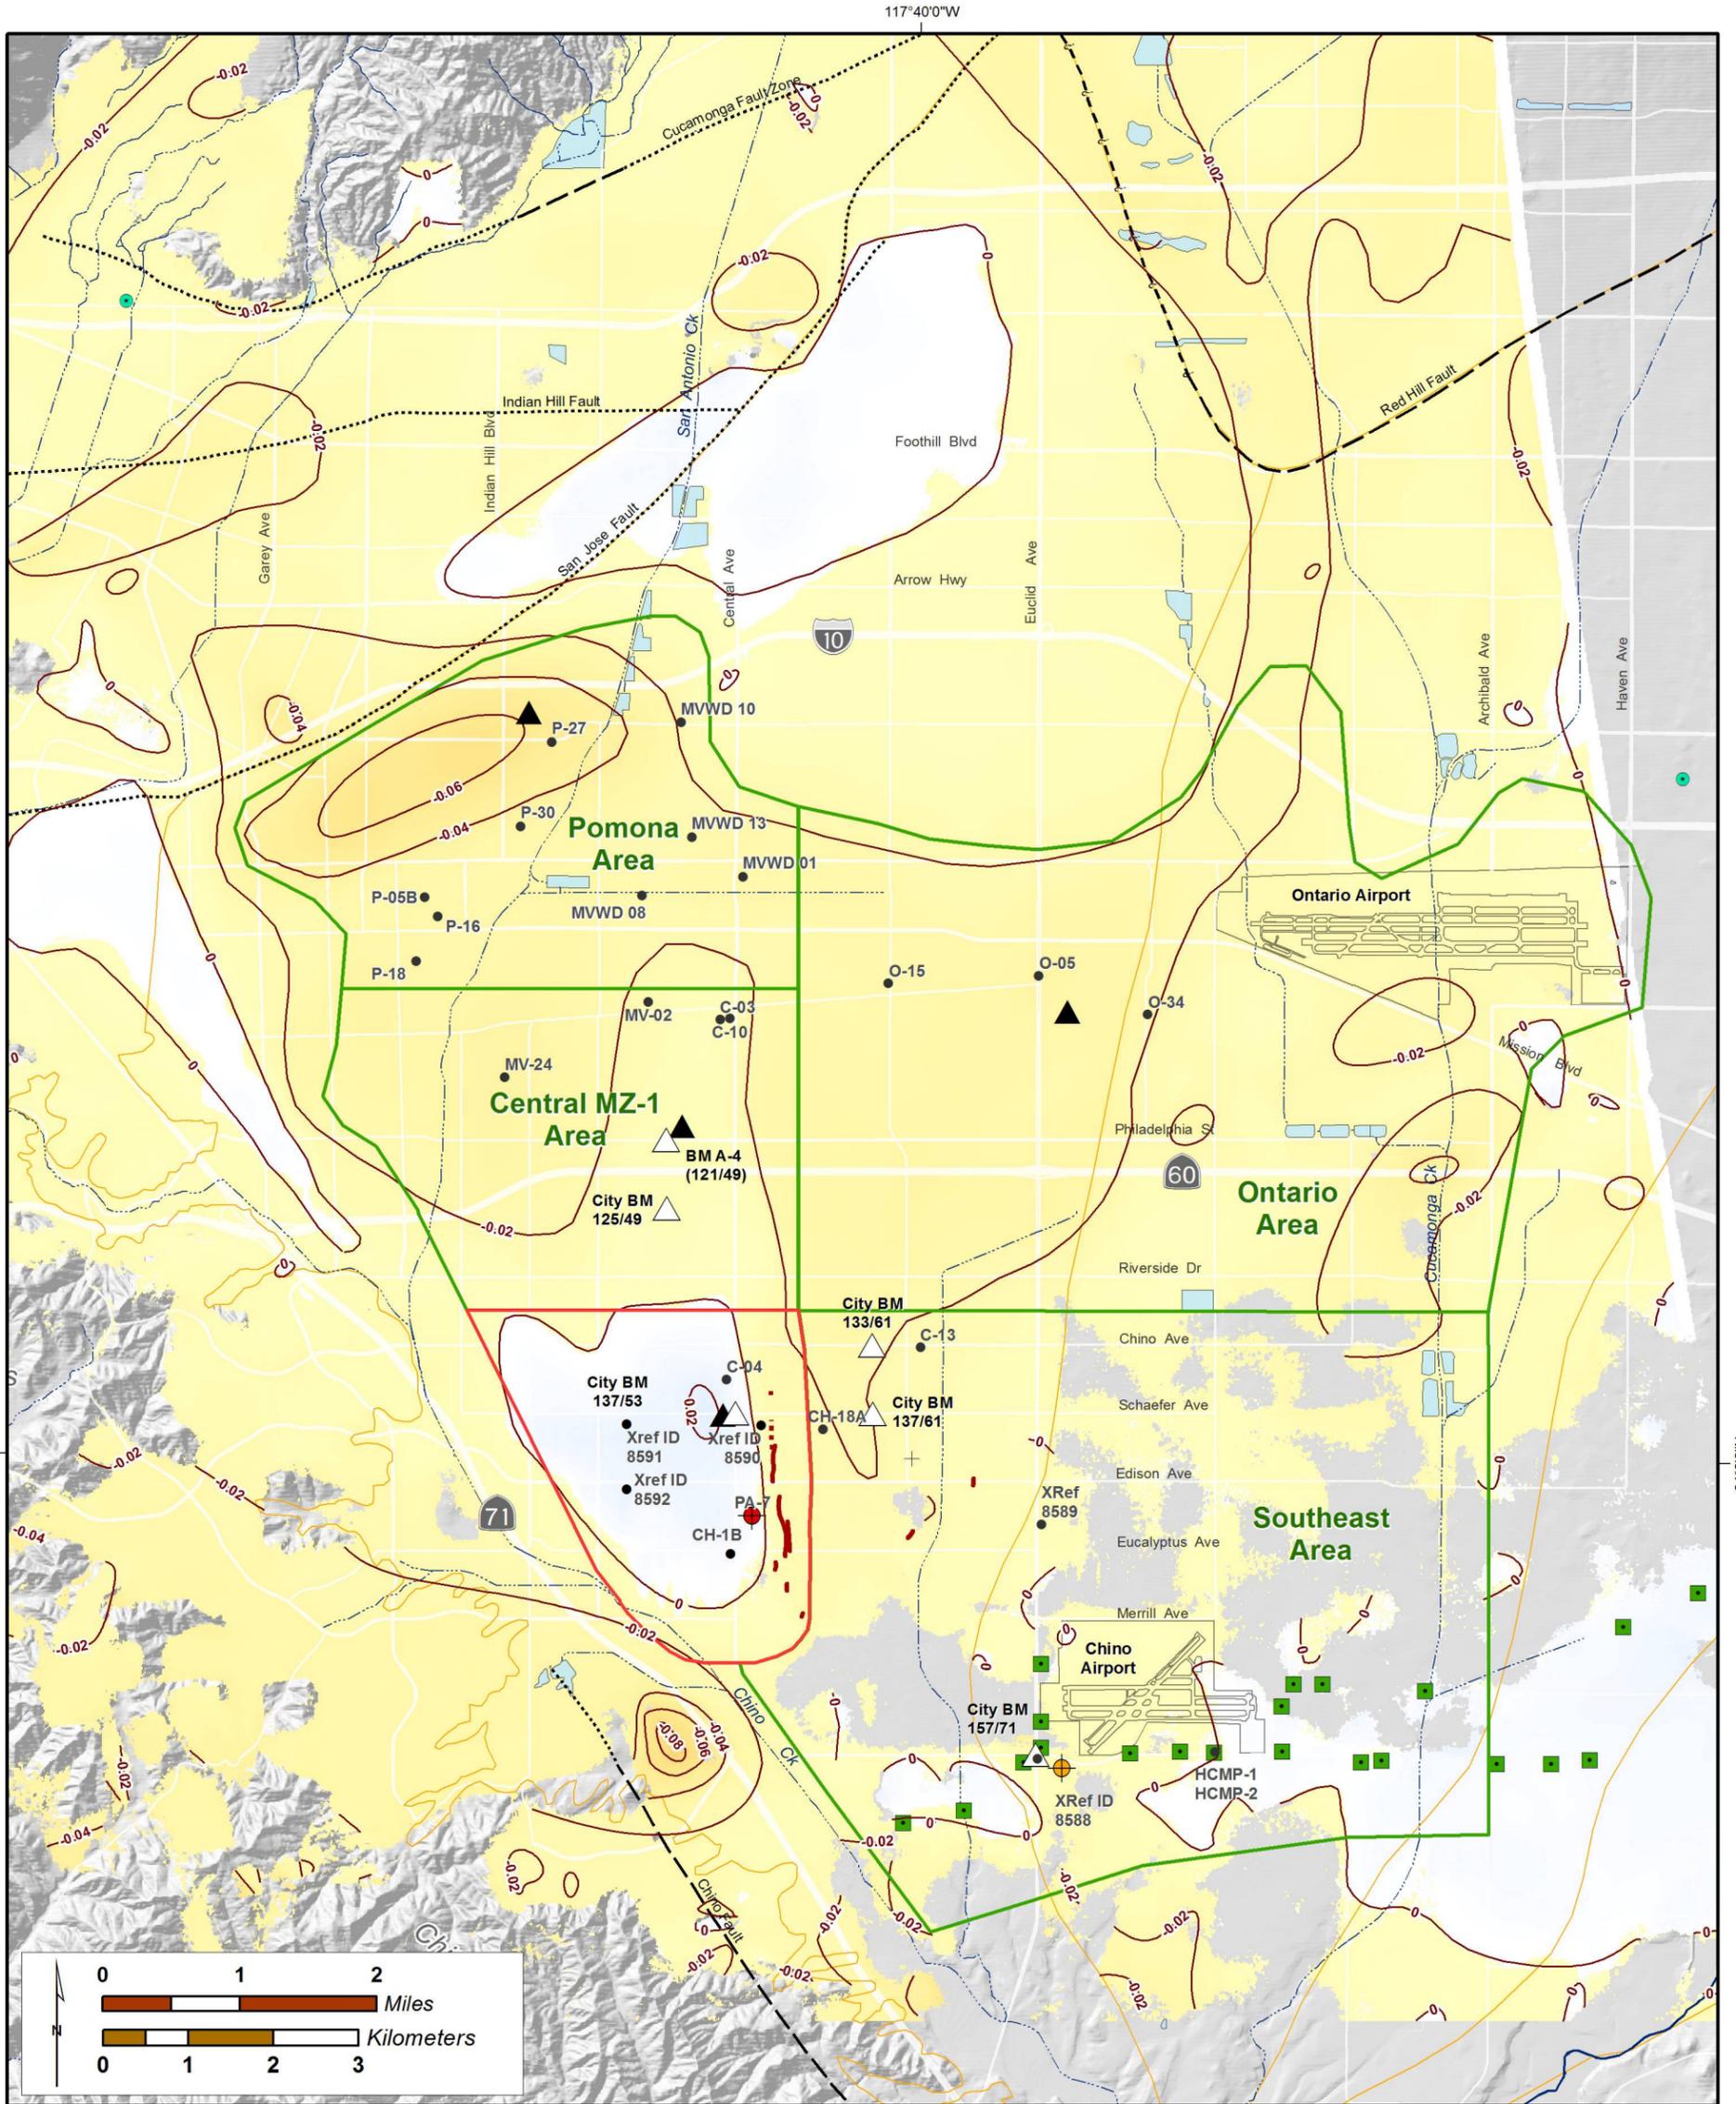
Vertical Ground Motion across Western Chino Basin

- A maximum of about 0.07 feet of subsidence occurred in the *Ontario Area* and the *Central MZ-1 Area* during the period of March 2011 to January 2014. The rate of subsidence is relatively slow, and is not occurring in a differential pattern anywhere that would indicate a threat of ground fissuring.

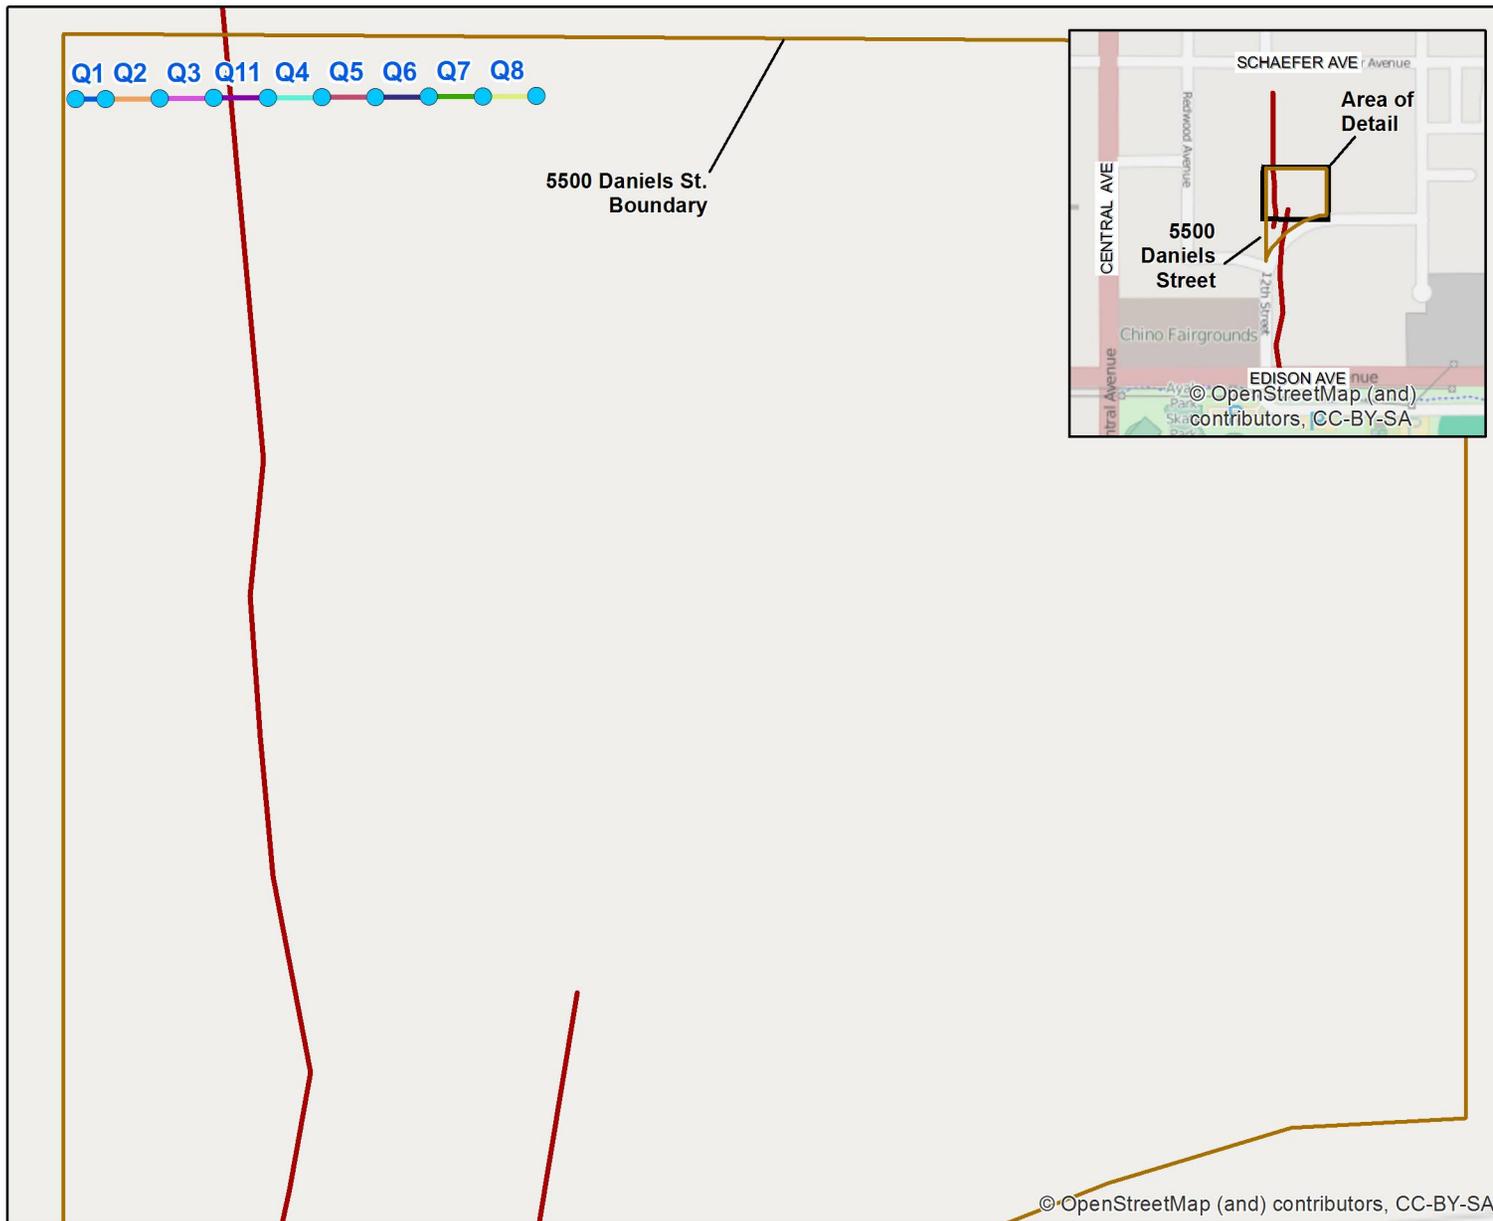
Figure 3-6 is a map of the DHX which measures and records horizontal extension and compression within the shallow soils across the historical fissure zone where it passes north of 12th Street in Chino. The DHX is comprised of nine quartz-tube extensometers that were installed within a trench in an east/west series. The western extensometer is 10-feet long and the other eight extensometers are each 20-feet long. The total length of the DHX is about 170 feet. The Q11 extensometer spans the surface rupture of the historical ground fissure.

- *Repair of the Daniels Horizontal Extensometer.* In March 2014, a portion of the DHX was flooded which damaged parts of the facility. The DHX must be repaired if it is to monitor the fissure zone during the Long-Term Pumping Test.

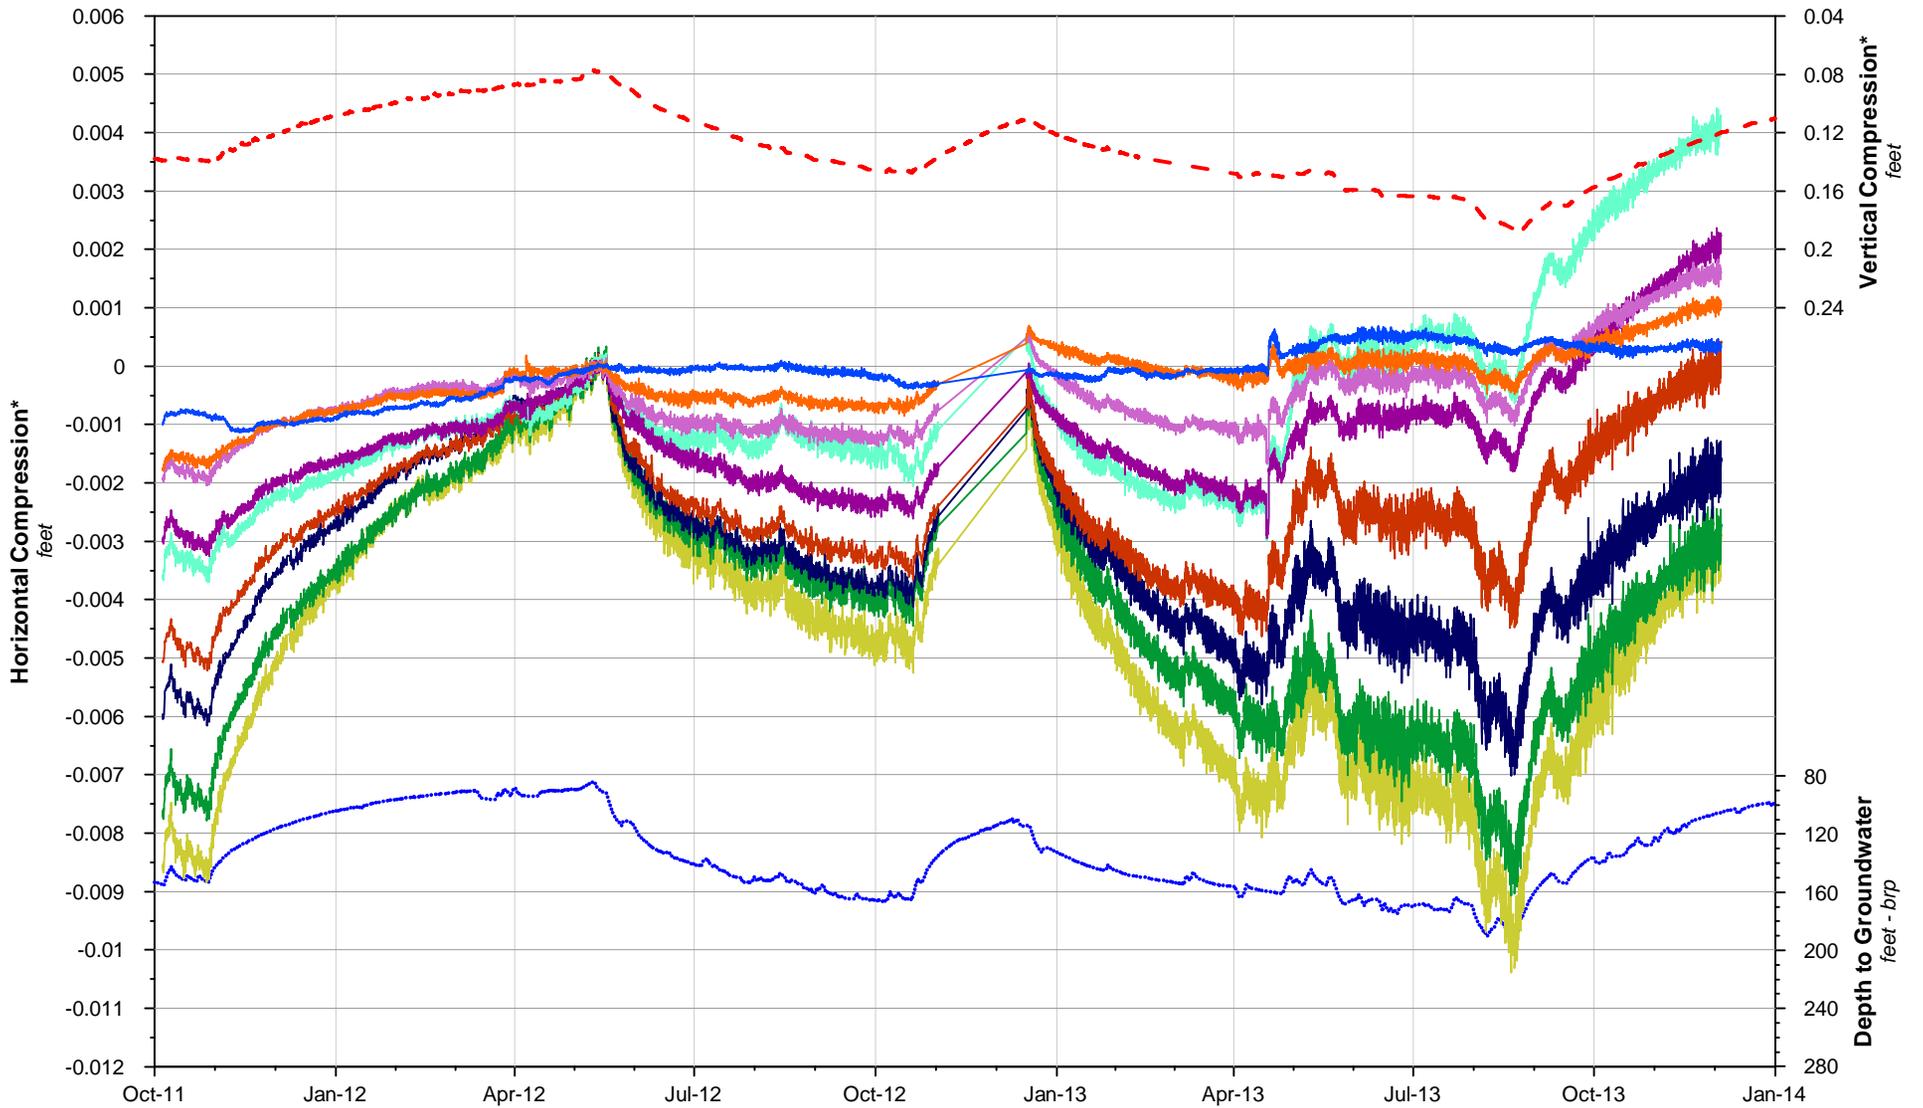
Figure 3-7 generally shows horizontal compression of the soils across the fissure zone during periods of water-level recovery and rebound of the land surface to the west, and horizontal extension during periods of drawdown and subsidence to the west. This pattern of horizontal strain is consistent with the conceptual model of drawdown and differential subsidence west of the fissure zone causing extensional stresses across the fissure zone (and visa versa). The majority of horizontal extensometers in the DHX show this same pattern, but with differing response time and magnitude of deformation. The response of the DHX to changes in piezometric levels and aquifer-system deformation recorded at Ayala Park was almost immediate (i.e. response times of less than an hour). These observations indicate the DHX functioning as planned, and is measuring and recording the horizontal strain in the shallow soils in response to hydraulic stresses (pumping and piezometric changes) that are occurring in the Managed Area.

Figures 3-7 and 3-8 indicate that from January 2013 to December 2013 net horizontal compression also occurred at the horizontal extensometers west of and across the surface rupture of the historical ground fissure (Q1 through Q4) and at Q8, the eastern most extensometer. However, Q5 continued extension throughout the year even as vertical rebound of the aquifer system at Ayala Park was occurring between August 2013 and December 2013. And, there was a net extension at Q6 and Q7, though some compression
