The exhibits in this section show the state of ground-level subsidence in the Chino Basin, using data from the Chino Basin ground-level monitoring program that was designed to minimize and/or abate land subsidence.

CHINO BASIN WATERMASTER
 Water in Basin Management
 2010 State of the Basin
 Ground-Level Monitoring

Historical Land Surface Deformation in Management Zone 1

2010 State of the Basin
 Ground-Level Monitoring

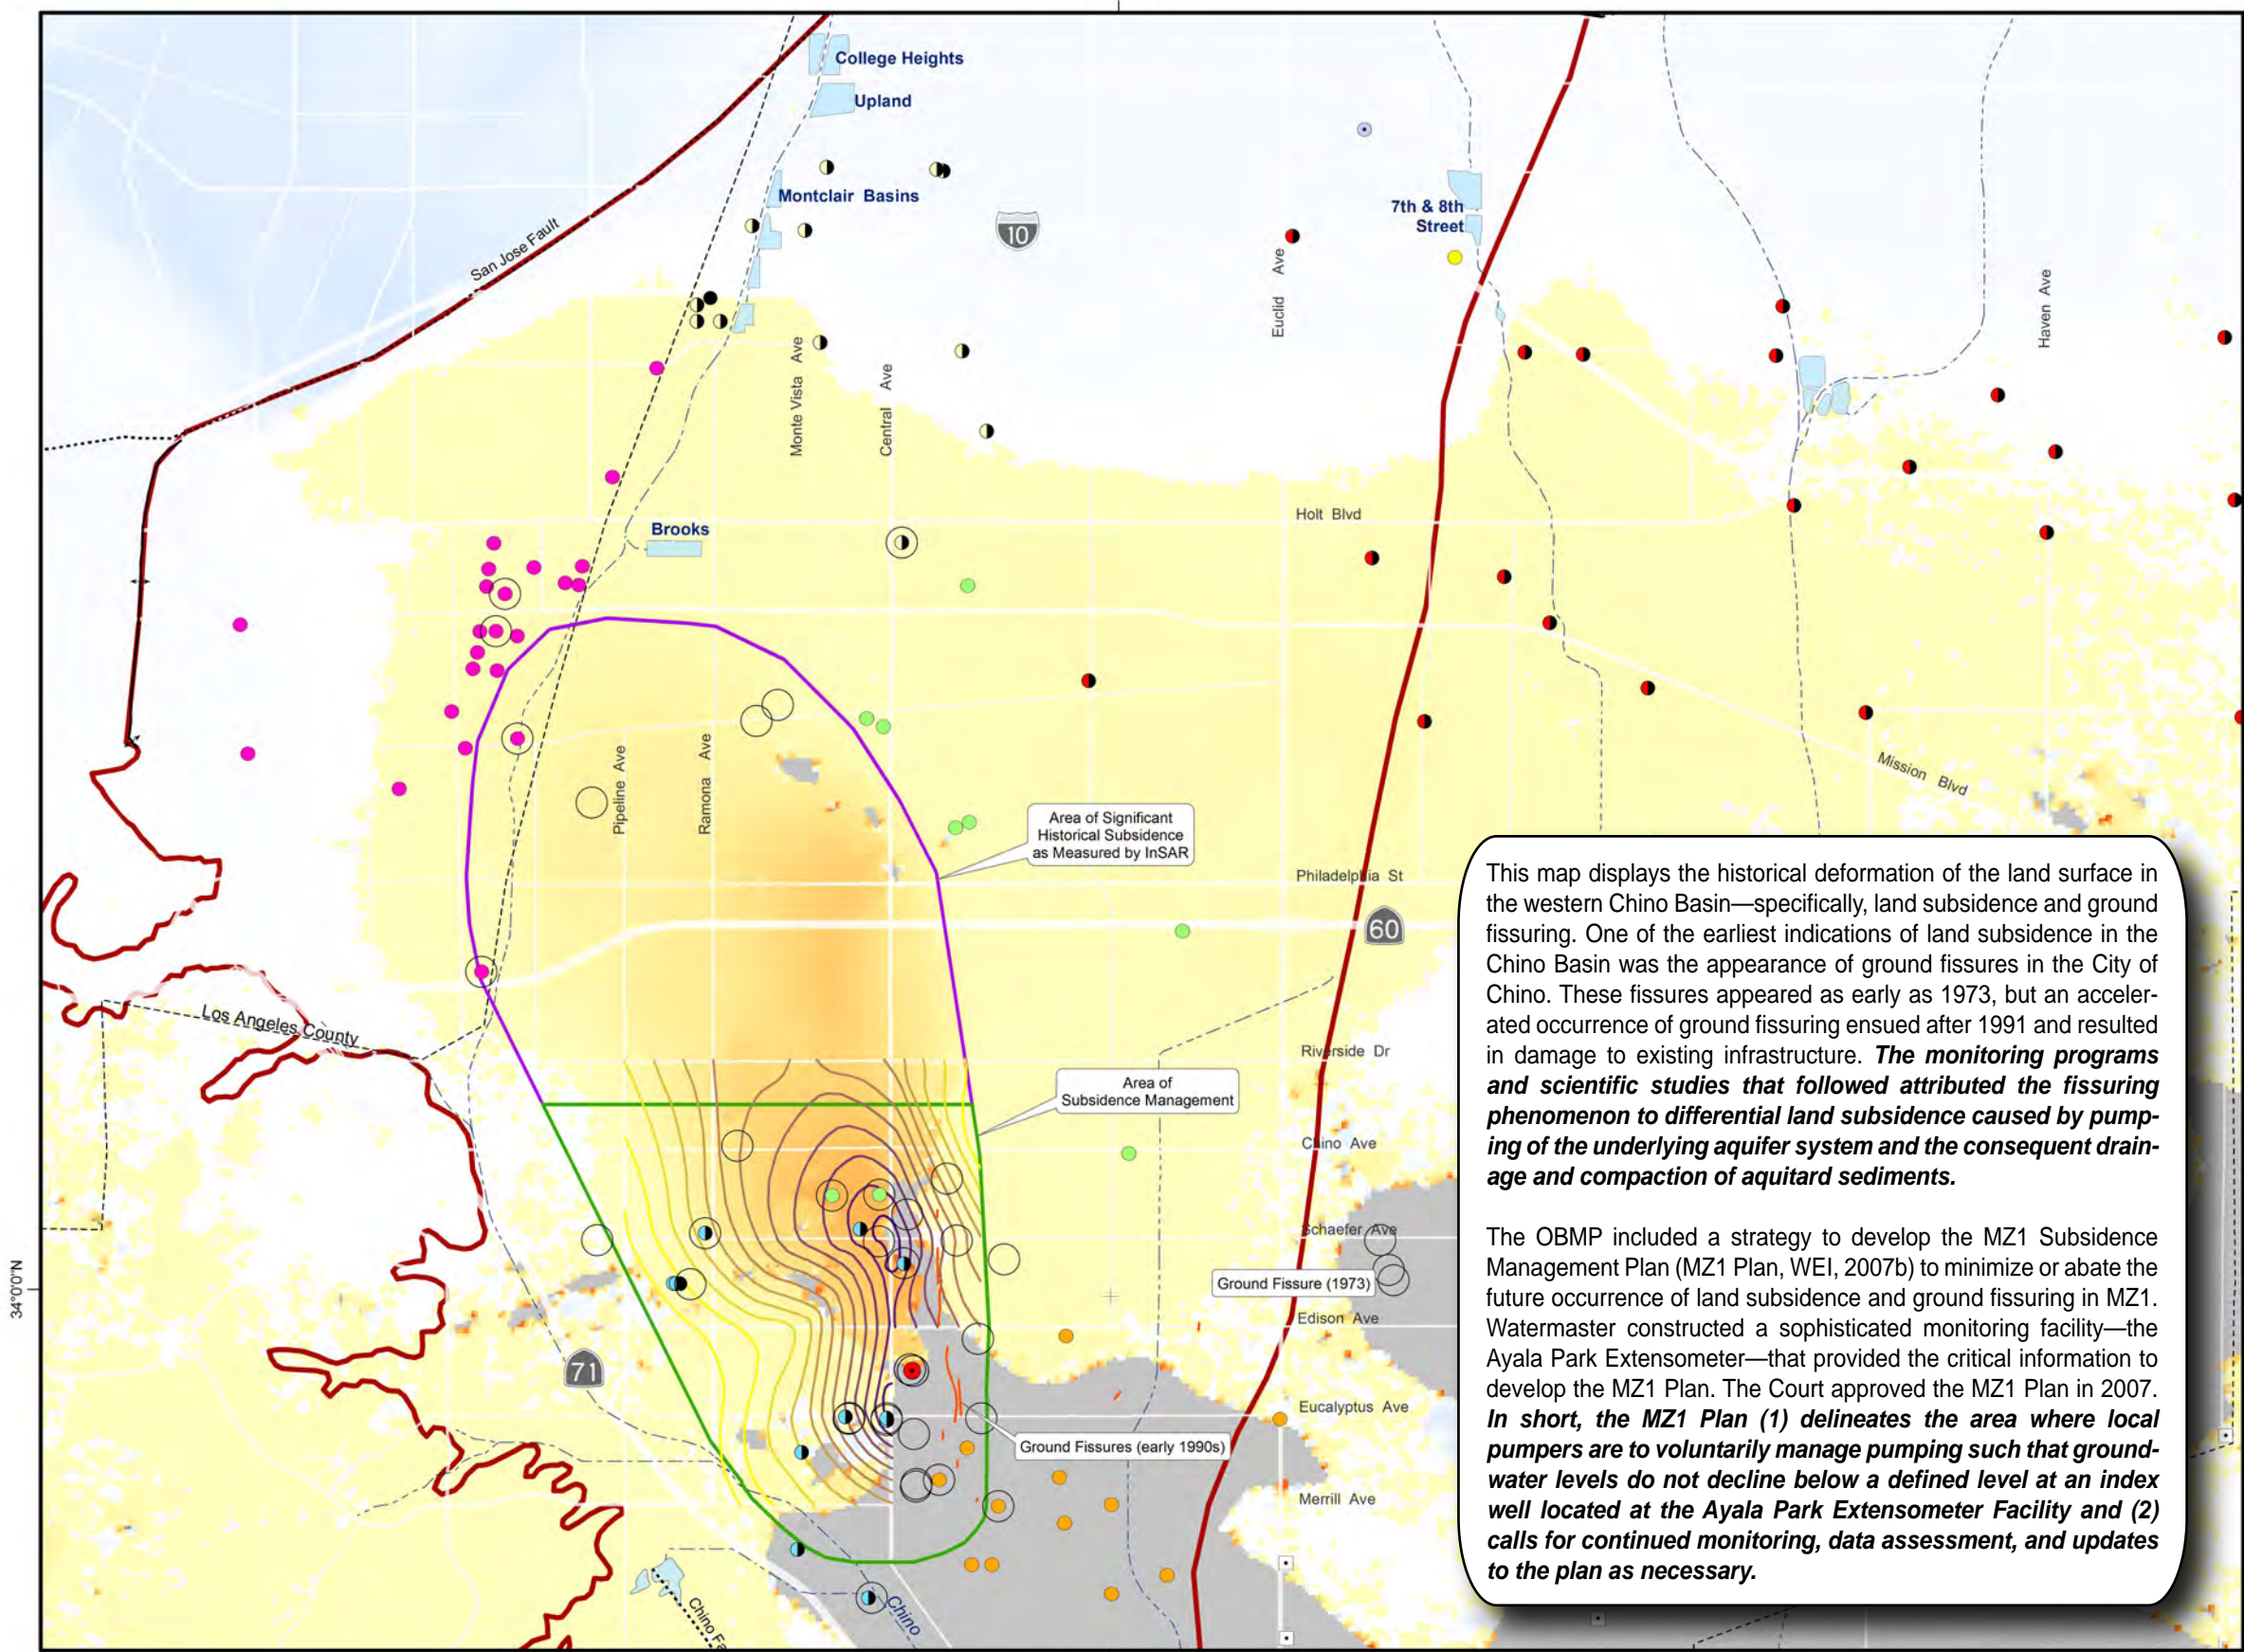
This map displays the historical deformation of the land surface in the western Chino Basin—specifically, land subsidence and ground fissuring. One of the earliest indications of land subsidence in the Chino Basin was the appearance of ground fissures in the City of Chino. These fissures appeared as early as 1973, but an accelerated occurrence of ground fissuring ensued after 1991 and resulted in damage to existing infrastructure. **The monitoring programs and scientific studies that followed attributed the fissuring phenomenon to differential land subsidence caused by pumping of the underlying aquifer system and the consequent drainage and compaction of aquitard sediments.**

The OBMP included a strategy to develop the MZ1 Subsidence Management Plan (MZ1 Plan, WEI, 2007b) to minimize or abate the future occurrence of land subsidence and ground fissuring in MZ1. Watermaster constructed a sophisticated monitoring facility—the Ayala Park Extensometer—that provided the critical information to develop the MZ1 Plan. The Court approved the MZ1 Plan in 2007. **In short, the MZ1 Plan (1) delineates the area where local pumpers are to voluntarily manage pumping such that groundwater levels do not decline below a defined level at an index well located at the Ayala Park Extensometer Facility and (2) calls for continued monitoring, data assessment, and updates to the plan as necessary.**

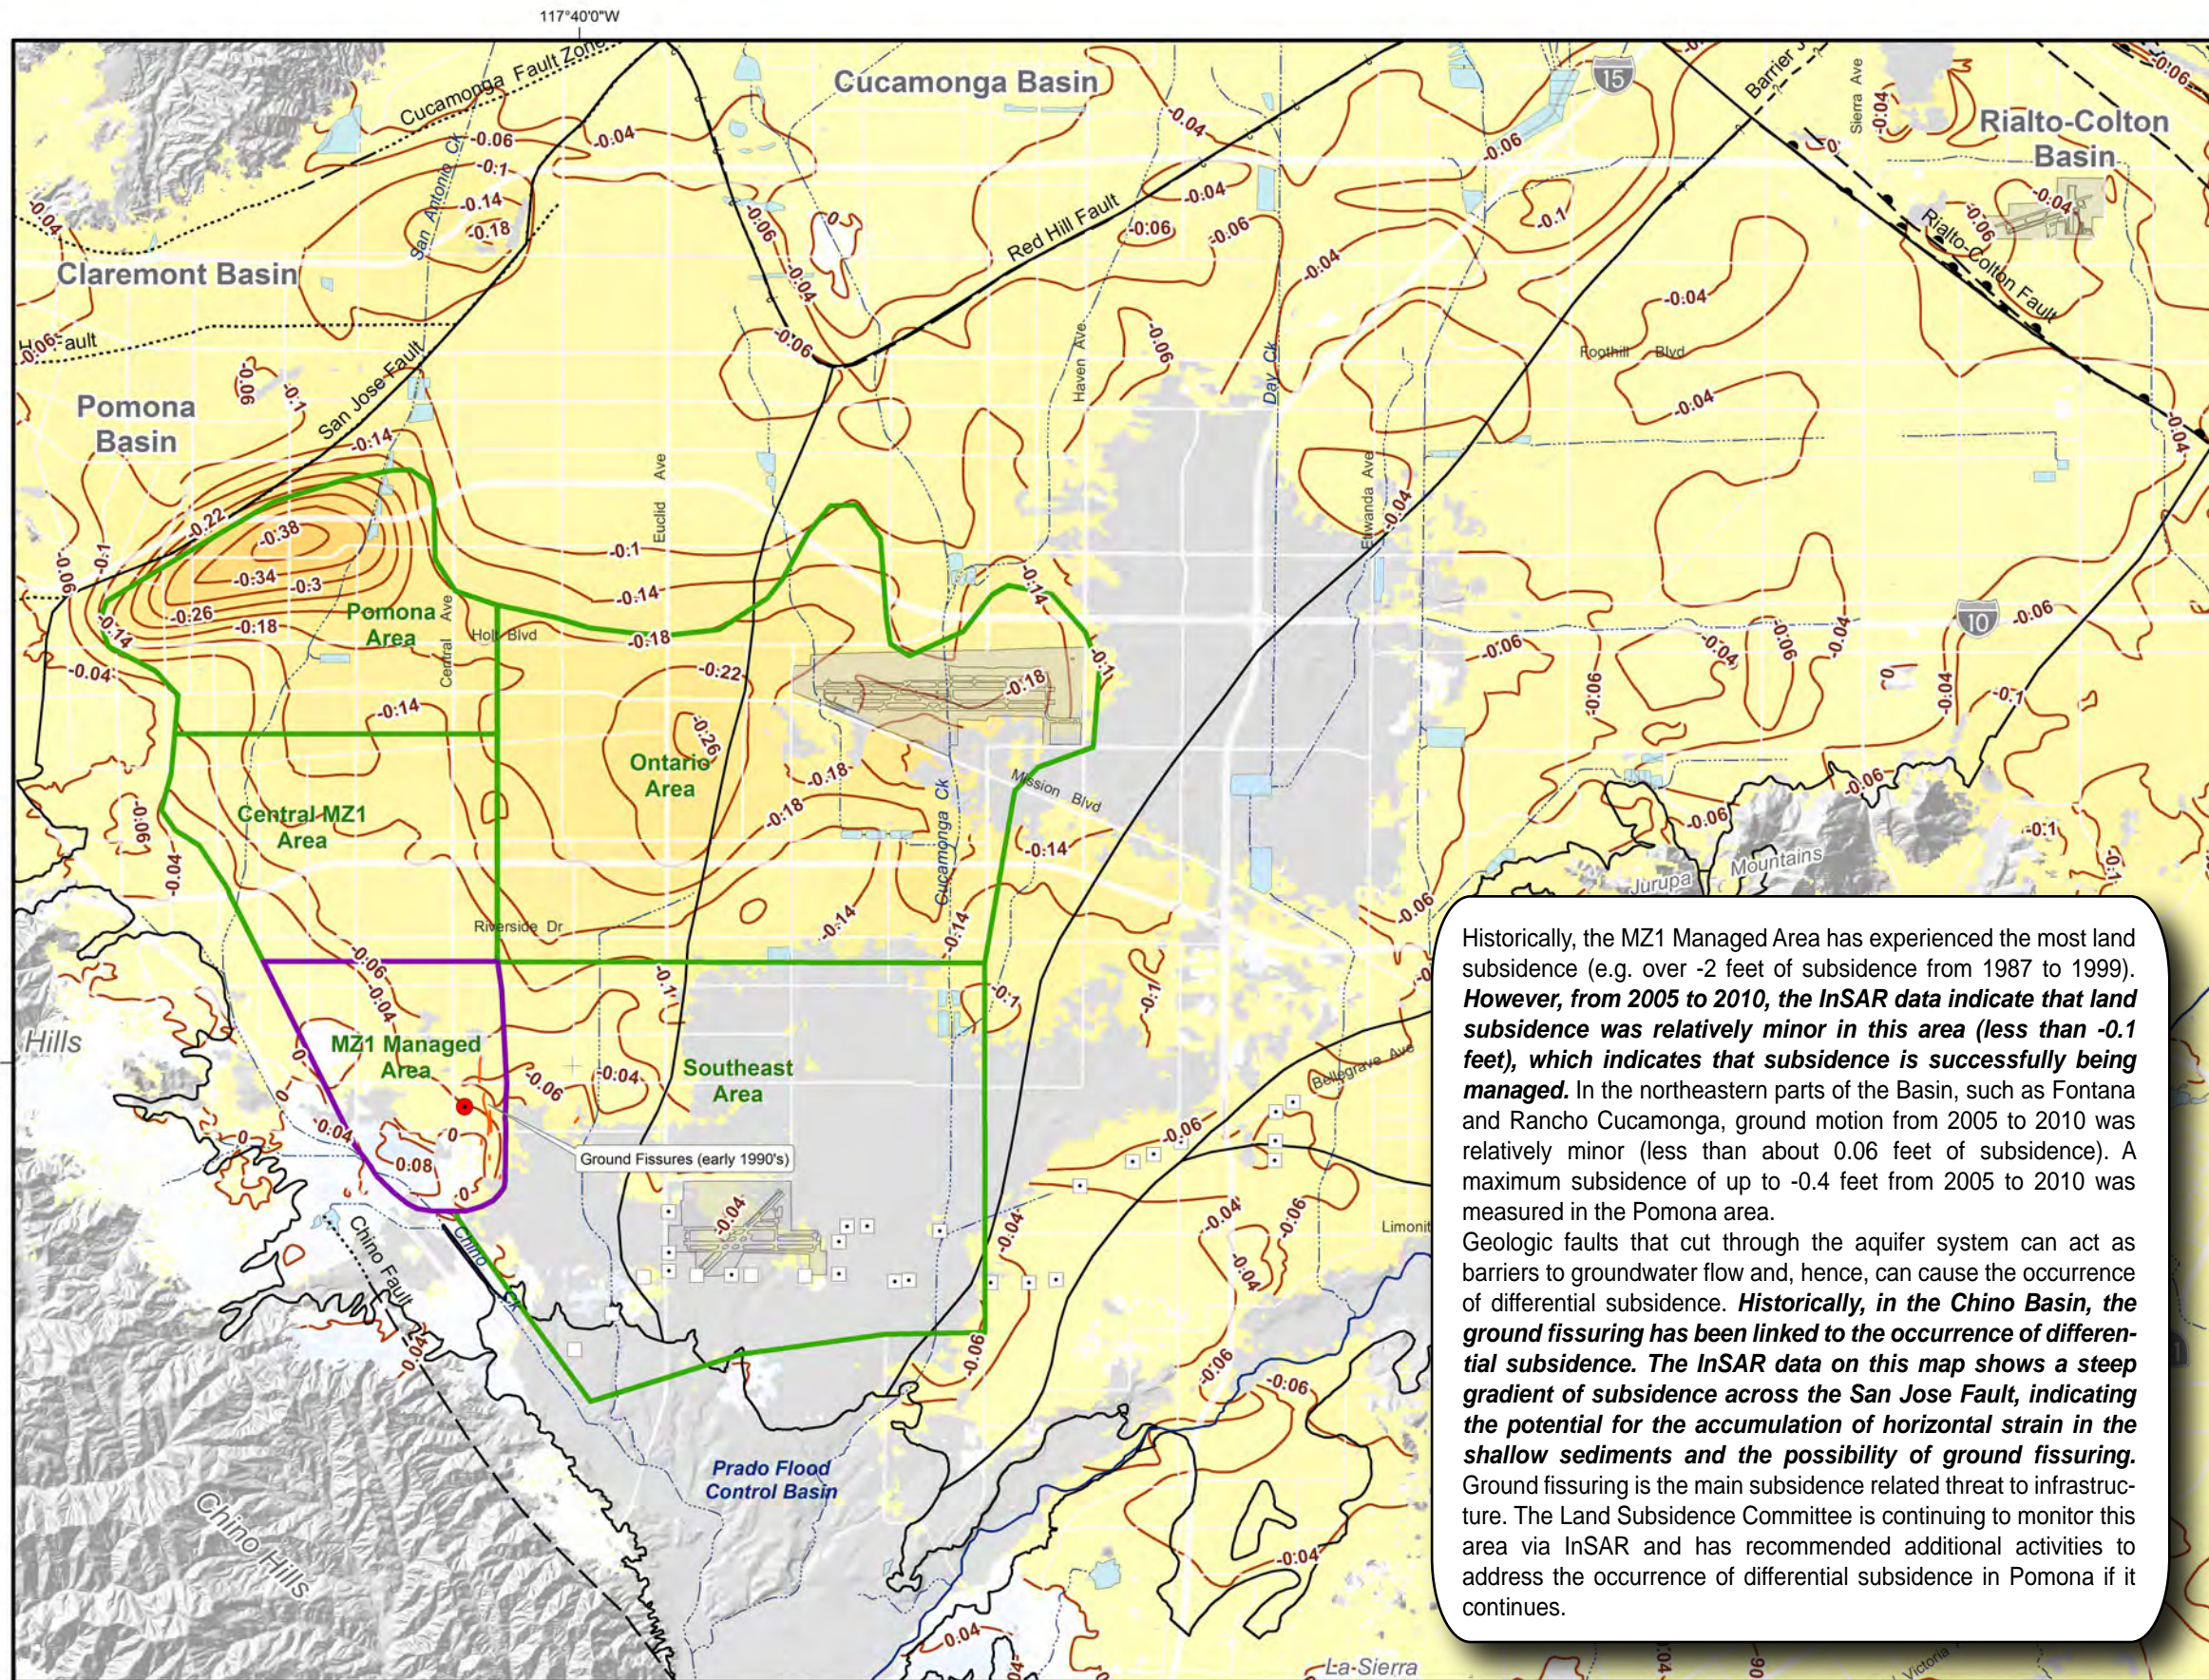
Vertical Ground Motion (2005 to 2010)
 as Measured by InSAR in the Chino Basin Area

Historically, the MZ1 Managed Area has experienced the most land subsidence (e.g. over -2 feet of subsidence from 1987 to 1999). **However, from 2005 to 2010, the InSAR data indicate that land subsidence was relatively minor in this area (less than -0.1 feet), which indicates that subsidence is successfully being managed.** In the northeastern parts of the Basin, such as Fontana and Rancho Cucamonga, ground motion from 2005 to 2010 was relatively minor (less than about 0.06 feet of subsidence). A maximum subsidence of up to -0.4 feet from 2005 to 2010 was measured in the Pomona area.

Geologic faults that cut through the aquifer system can act as barriers to groundwater flow and, hence, can cause the occurrence of differential subsidence. **Historically, in the Chino Basin, the ground fissuring has been linked to the occurrence of differential subsidence. The InSAR data on this map shows a steep gradient of subsidence across the San Jose Fault, indicating the potential for the accumulation of horizontal strain in the shallow sediments and the possibility of ground fissuring.** Ground fissuring is the main subsidence related threat to infrastructure. The Land Subsidence Committee is continuing to monitor this area via InSAR and has recommended additional activities to address the occurrence of differential subsidence in Pomona if it continues.

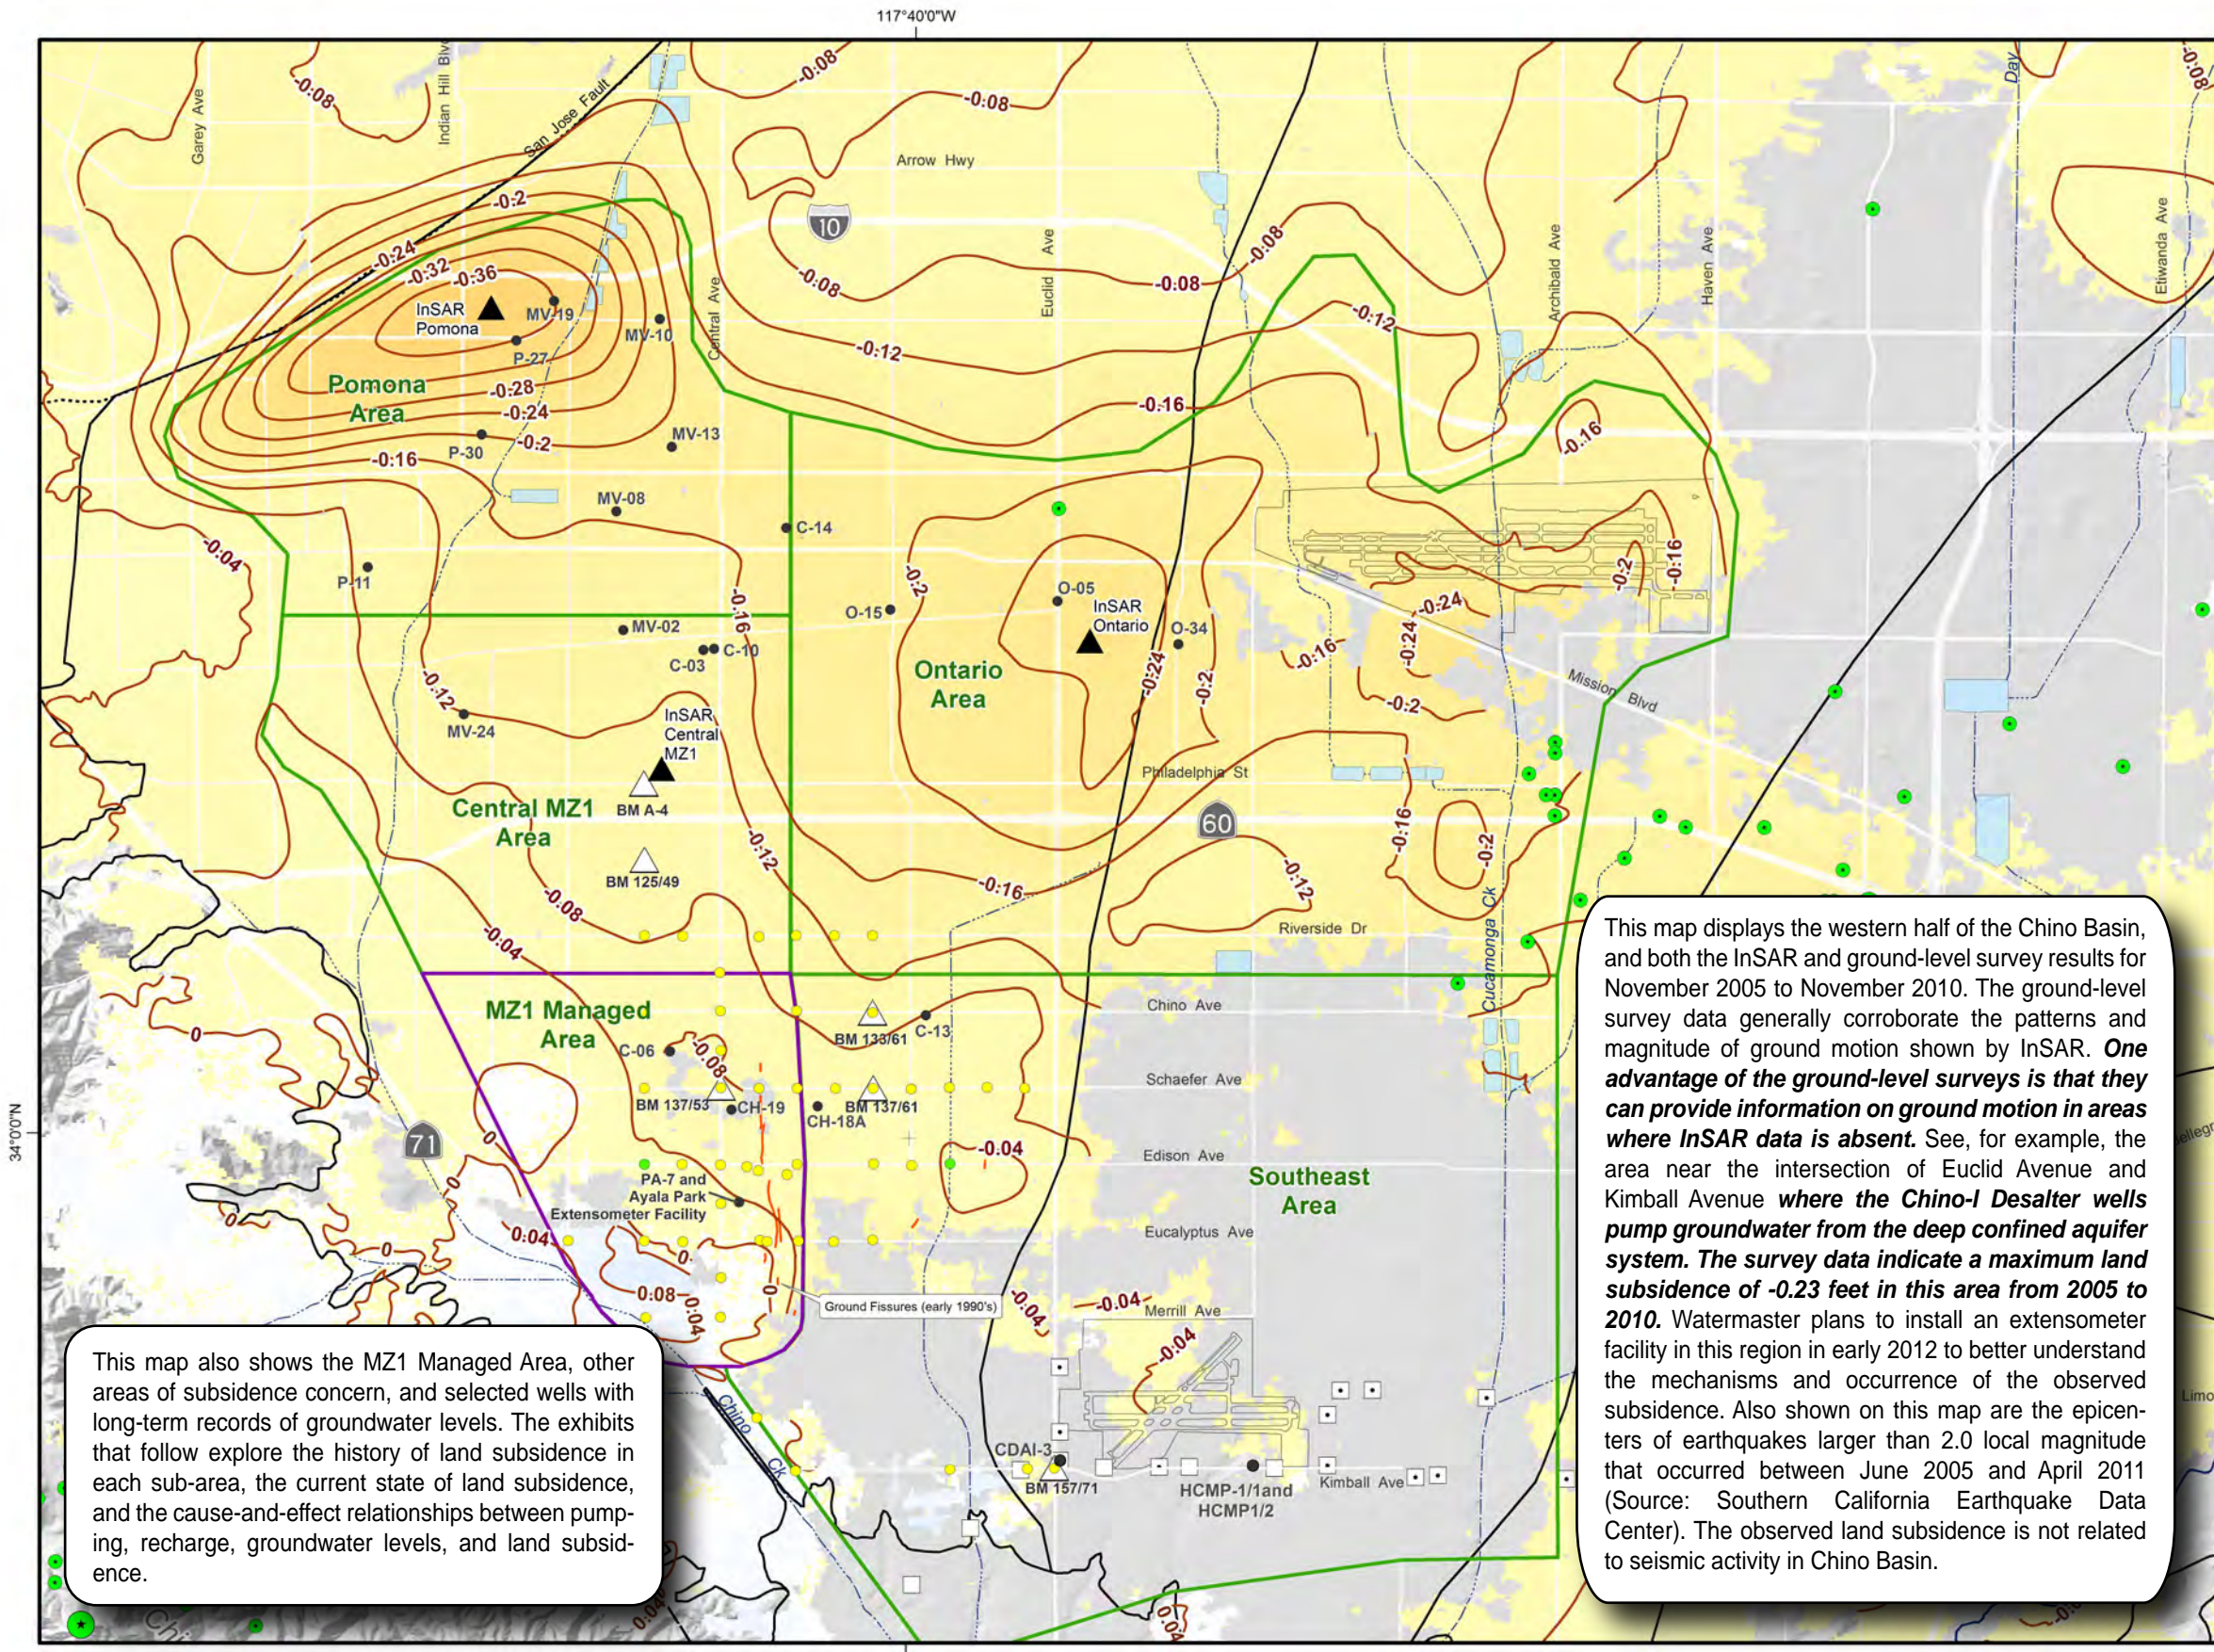
Vertical Ground Motion (2005 to 2010)
 Leveling Surveys and InSAR in Western Chino

This map displays the western half of the Chino Basin, and both the InSAR and ground-level survey results for November 2005 to November 2010. The ground-level survey data generally corroborate the patterns and magnitude of ground motion shown by InSAR. **One advantage of the ground-level surveys is that they can provide information on ground motion in areas where InSAR data is absent.** See, for example, the area near the intersection of Euclid Avenue and Kimball Avenue where the Chino-I Desalter wells pump groundwater from the deep confined aquifer system. The survey data indicate a maximum land subsidence of -0.23 feet in this area from 2005 to 2010. Watermaster plans to install an extensometer facility in this region in early 2012 to better understand the mechanisms and occurrence of the observed subsidence. Also shown on this map are the epicenters of earthquakes larger than 2.0 local magnitude that occurred between June 2005 and April 2011 (Source: Southern California Earthquake Data Center). The observed land subsidence is not related to seismic activity in Chino Basin.

This map also shows the MZ1 Managed Area, other areas of subsidence concern, and selected wells with long-term records of groundwater levels. The exhibits that follow explore the history of land subsidence in each sub-area, the current state of land subsidence, and the cause-and-effect relationships between pumping, recharge, groundwater levels, and land subsidence.

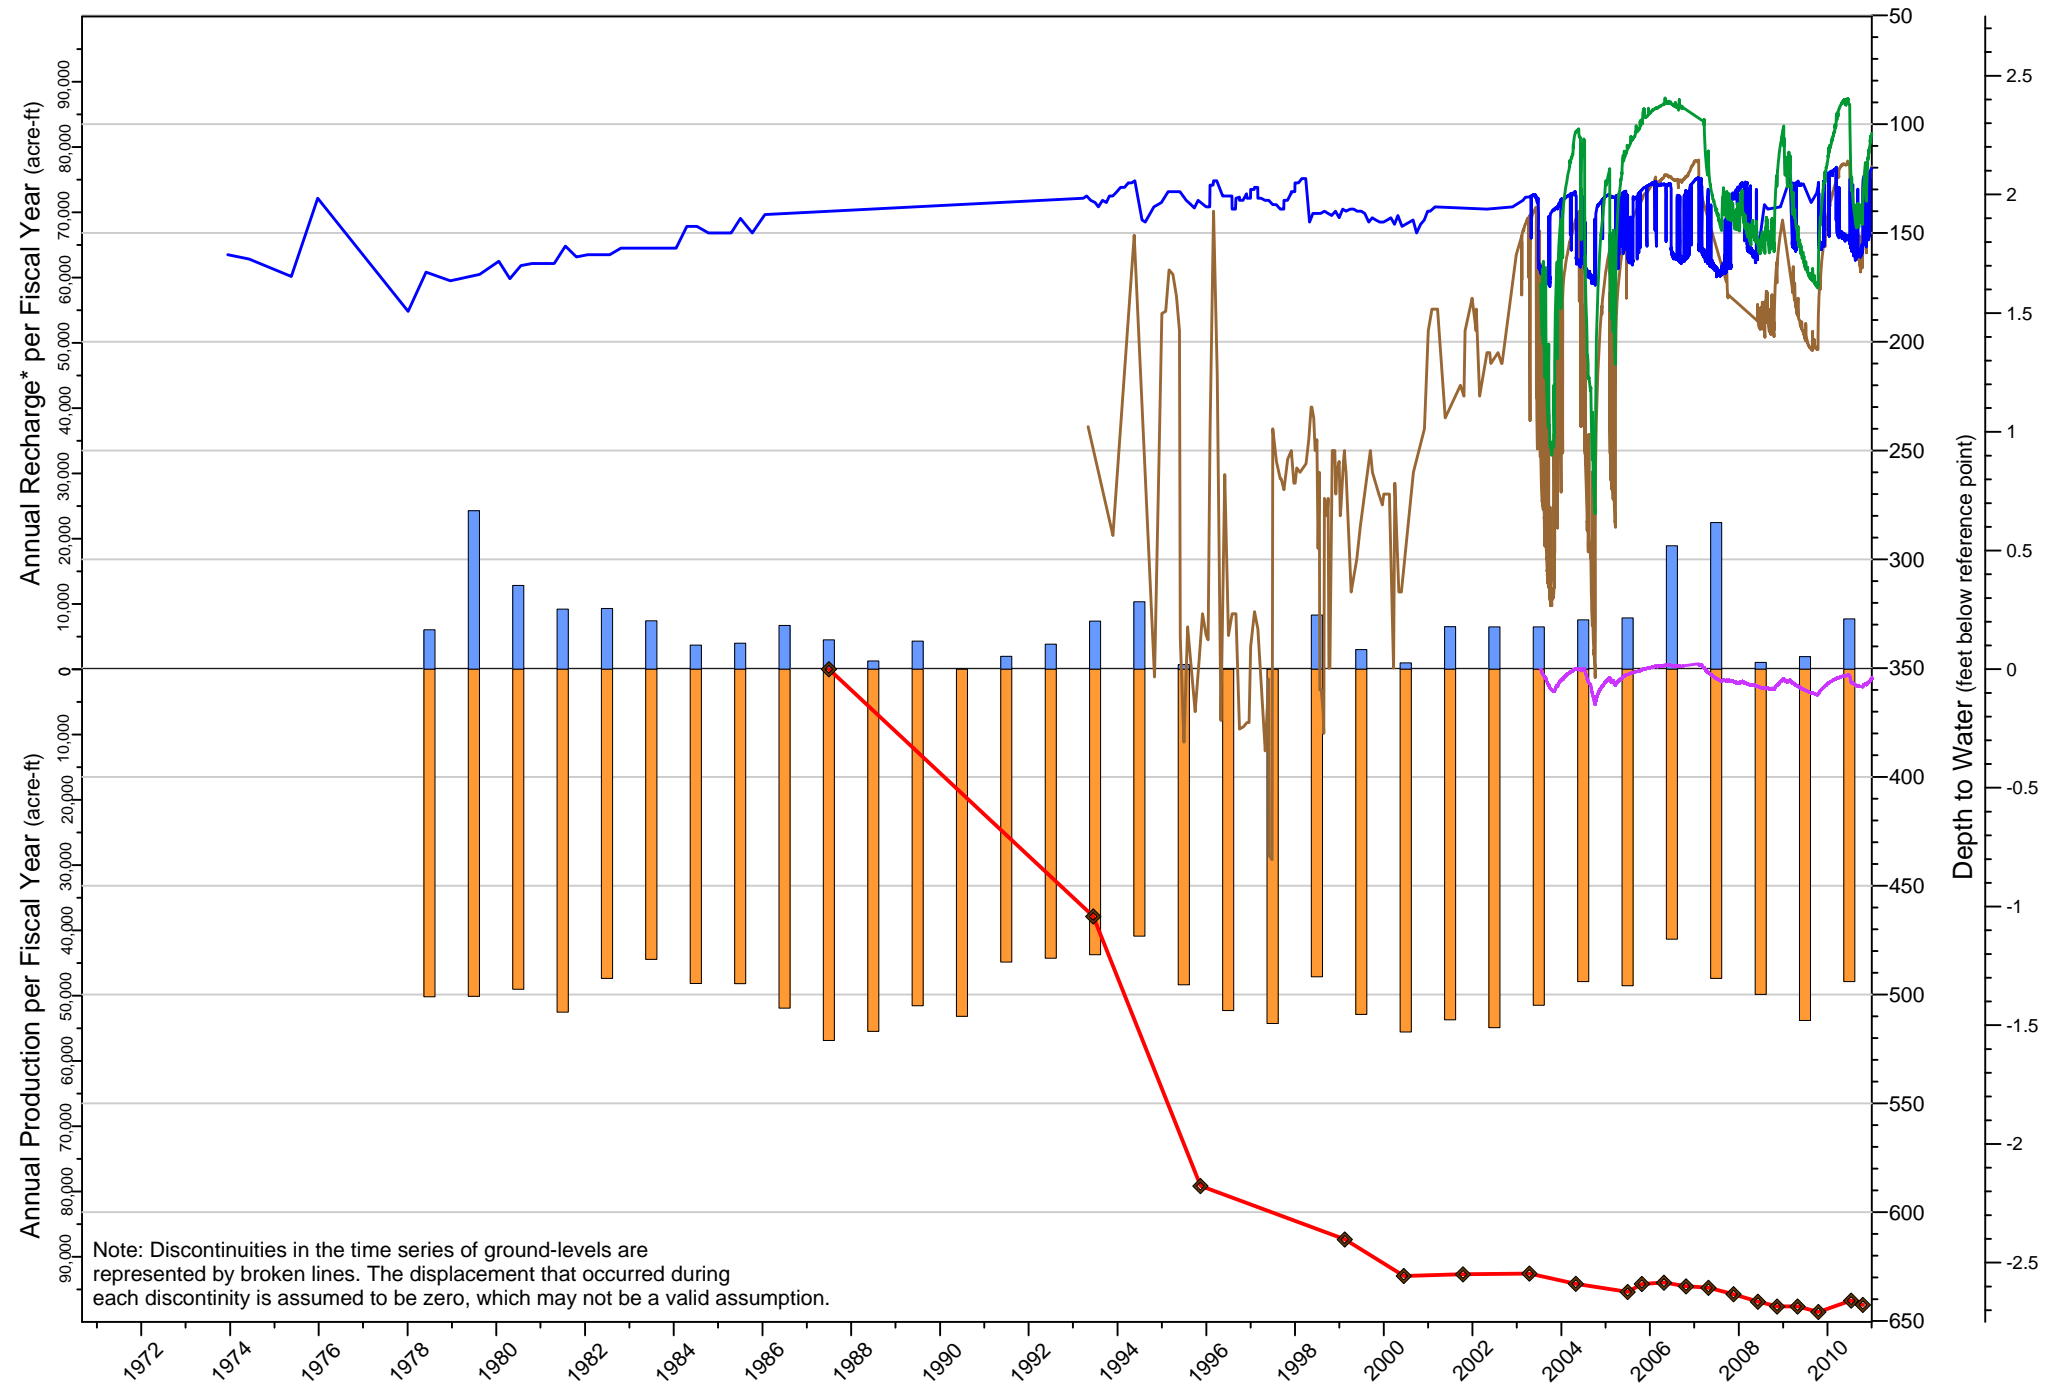
Exhibit 55 is a time series chart that displays annual pumping and recharge in MZ1, along with groundwater levels at wells and ground-level survey data at measurement stations within the MZ1 Managed Area (see Exhibit 54). The observations and conclusions described below were largely derived during the testing and monitoring that was performed by Watermaster during the development of the MZ1 Plan during 2000 to 2006.

Artificial recharge in the northern portions of MZ1 has no immediate impact on groundwater levels in the deep aquifer system. **Pumping of the deep aquifer system is the main cause of groundwater-level changes and ground motion in the MZ1 Managed Area.**

Wells CH-19 and PA-7 are perforated within the deep aquifer system. Well C-06 is perforated in the shallow aquifer system. Pumping of the deep confined aquifer system causes groundwater-level drawdowns that are much greater in magnitude and lateral extent than drawdowns caused by pumping of the shallow aquifer system. Groundwater-level drawdowns due to pumping of the deep aquifer system can cause inelastic (permanent) compaction of the aquifer-system sediments, which results in permanent land subsidence. During controlled pumping tests in 2004 and 2005, the initiation of inelastic compaction within the aquifer system began to happen when groundwater-levels were drawdown about 250 feet below reference point (ft-brp) in the PA-7 piezometer at Ayala Park. **In order to avoid inelastic compaction a guidance level of 245 feet in the PA-7 piezometer was established and is the primary criteria for the management of subsidence in the MZ1 Plan.**

This exhibit also shows the history of vertical ground motion measured at the Deep Extensometer at Ayala Park and at a benchmark monument (137/53) at the corner of Schaefer Avenue and Central Avenue. About -2.5 ft of subsidence occurred in portions of the **MZ1 Managed Area from 1987 to 2000, but very little inelastic subsidence has occurred since 2000, and no additional ground fissuring has been observed.** From 2006 to 2010, groundwater levels at PA-7 did not decline below 250 ft-brp, and very little, if any, inelastic compaction was recorded in the MZ1 Managed Area.

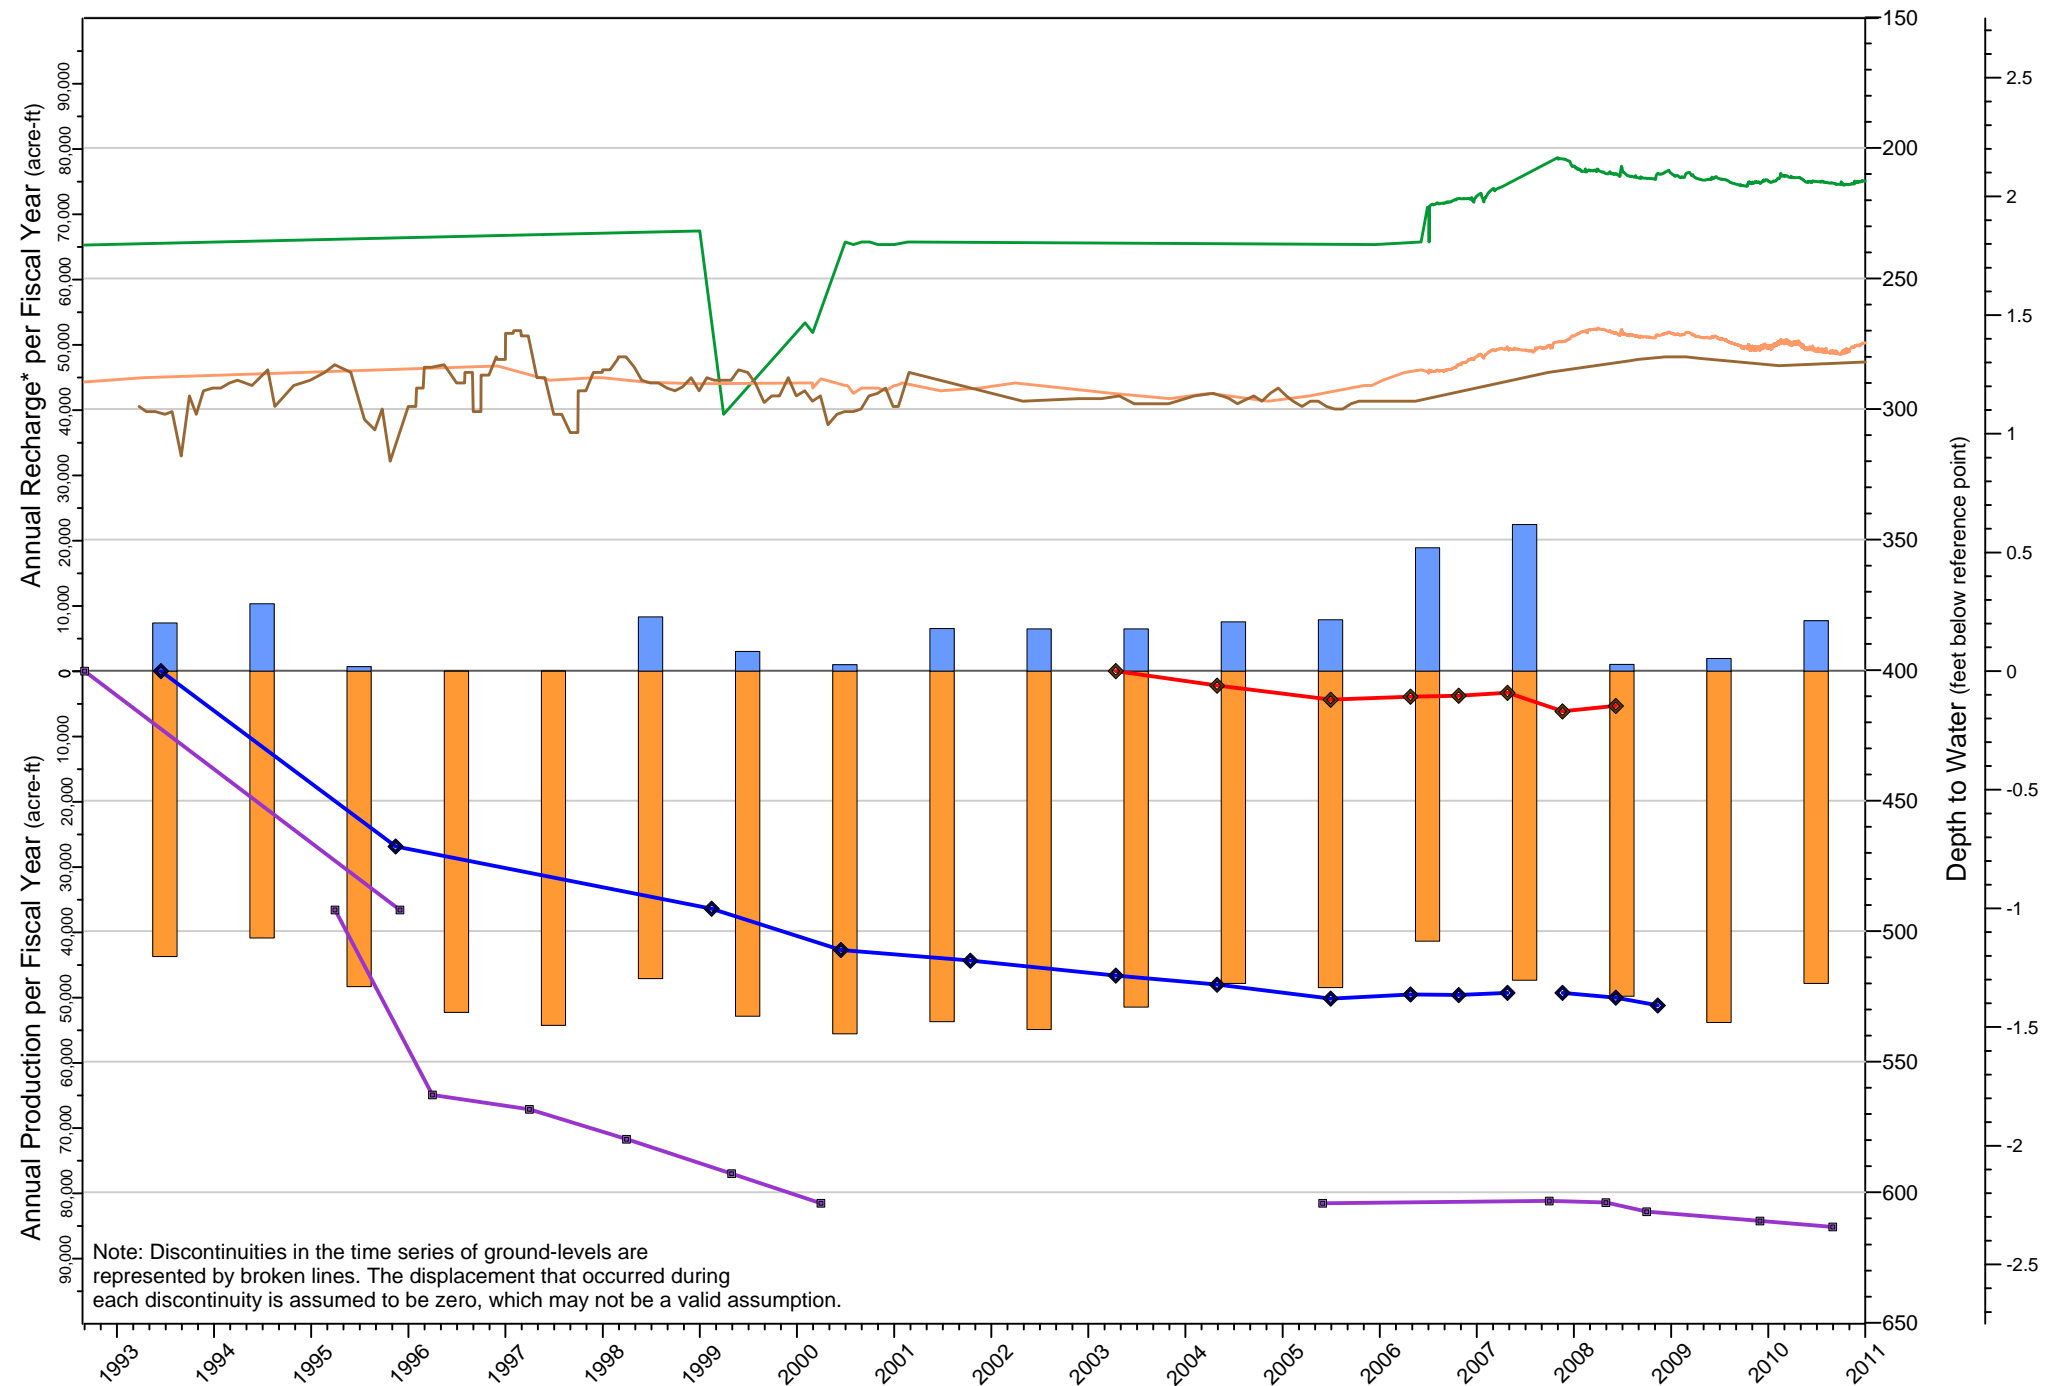
Exhibit 56

The Central MZ1 subsidence area is located directly north of the MZ1 Managed Area. Exhibits 56 and 57 are time series charts that display annual production and recharge in MZ1, along with groundwater levels at wells and ground-level survey data at measurement stations within the Central MZ1 Area (see Exhibit 54).

The vertical ground motion time histories for Central MZ1 subsidence area are similar to those of the MZ1 Managed Area: **as much as -2.2 feet of inelastic subsidence occurred at the corner of Philadelphia and Monte Vista Avenue from 1993-2000, but very little inelastic subsidence has occurred since 2000.** This similarity suggests a relationship to the causes of land subsidence in the MZ1 Managed Area; however, there is very little historical groundwater-level data in this area to confirm this relationship.

Most of the wells with historical groundwater level records are in the northern part of the Central MZ1 subsidence area (see Exhibit 54), where historical subsidence was not as pronounced. From about 1935 to 1978, groundwater levels in these wells declined by about 150 feet. Groundwater levels increase by about 50 feet during the 1980s and remained relatively stable until 2005. From 2005 to 2008, groundwater levels increased by about 25 feet, which was likely due to decreased pumping and increased recharge in MZ1. Since 2008, recharge in MZ1 has decreased, production has increased, and water levels have remained relatively stable.

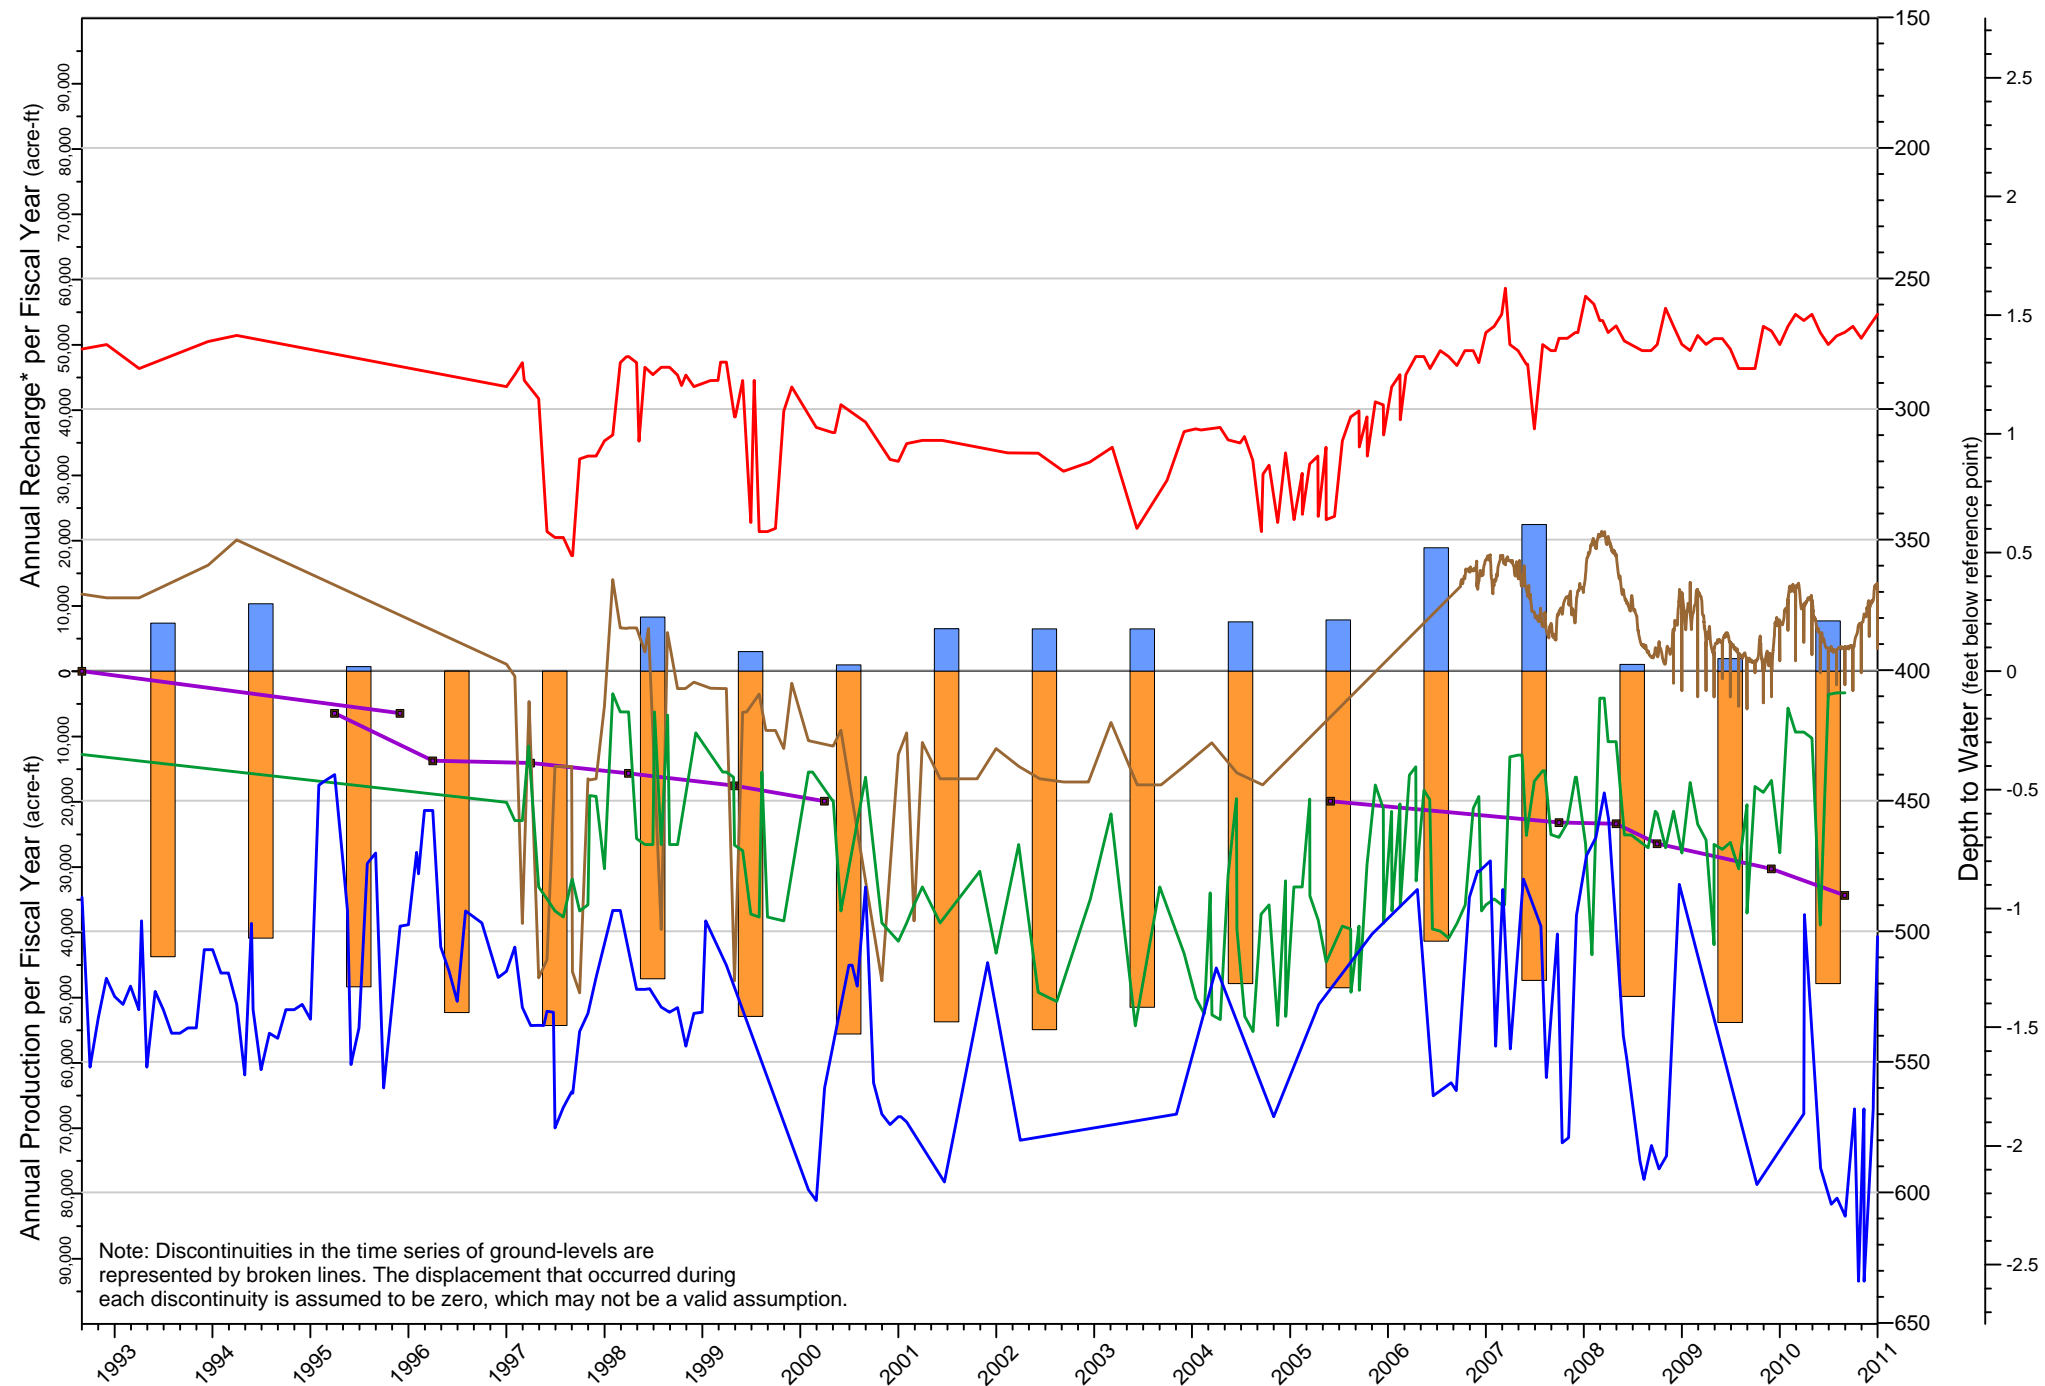
Exhibit 58

The Pomona subsidence area is located directly north of the Central MZ1 subsidence area. Exhibits 58 and 59 are time series charts that display annual production and recharge within MZ1, along with groundwater levels at wells and ground-level survey data at measurement stations within the Pomona Area (see Exhibit 54).

The history of vertical ground motion in the Pomona subsidence area is based solely on InSAR data from 1992 to 1995, 1995 to 2000, and 2005 to 2010. **These data indicate that land subsidence has occurred continuously in this area, generally at a rate of about 0.07 feet per year (ft/yr).**

From about 1935 to 1978, groundwater levels in the Pomona Area declined by about 175 feet or more. Groundwater levels increased by about 50 to 100 feet during the 1980s. From about 1990 to 2004, groundwater levels declined again by about 25 to 50 feet. From 2004 to 2008, groundwater levels increased by about 50 to over 100 feet. And, from 2008 to 2010, groundwater levels remained stable or declined slightly. **The groundwater level changes from 1990 to 2010 appear to be closely related to pumping and recharge in MZ1.**
