The exhibits in this section show the state of ground-level subsidence in the Chino Basin, using data from the Chino Basin ground-level monitoring program that was designed to minimize and/or abate land subsidence.

CHINO BASIN WATERMASTER
 Water in Basin Management
 2010 State of the Basin
 Ground-Level Monitoring

Historical Land Surface Deformation in Management Zone 1

2010 State of the Basin
 Ground-Level Monitoring

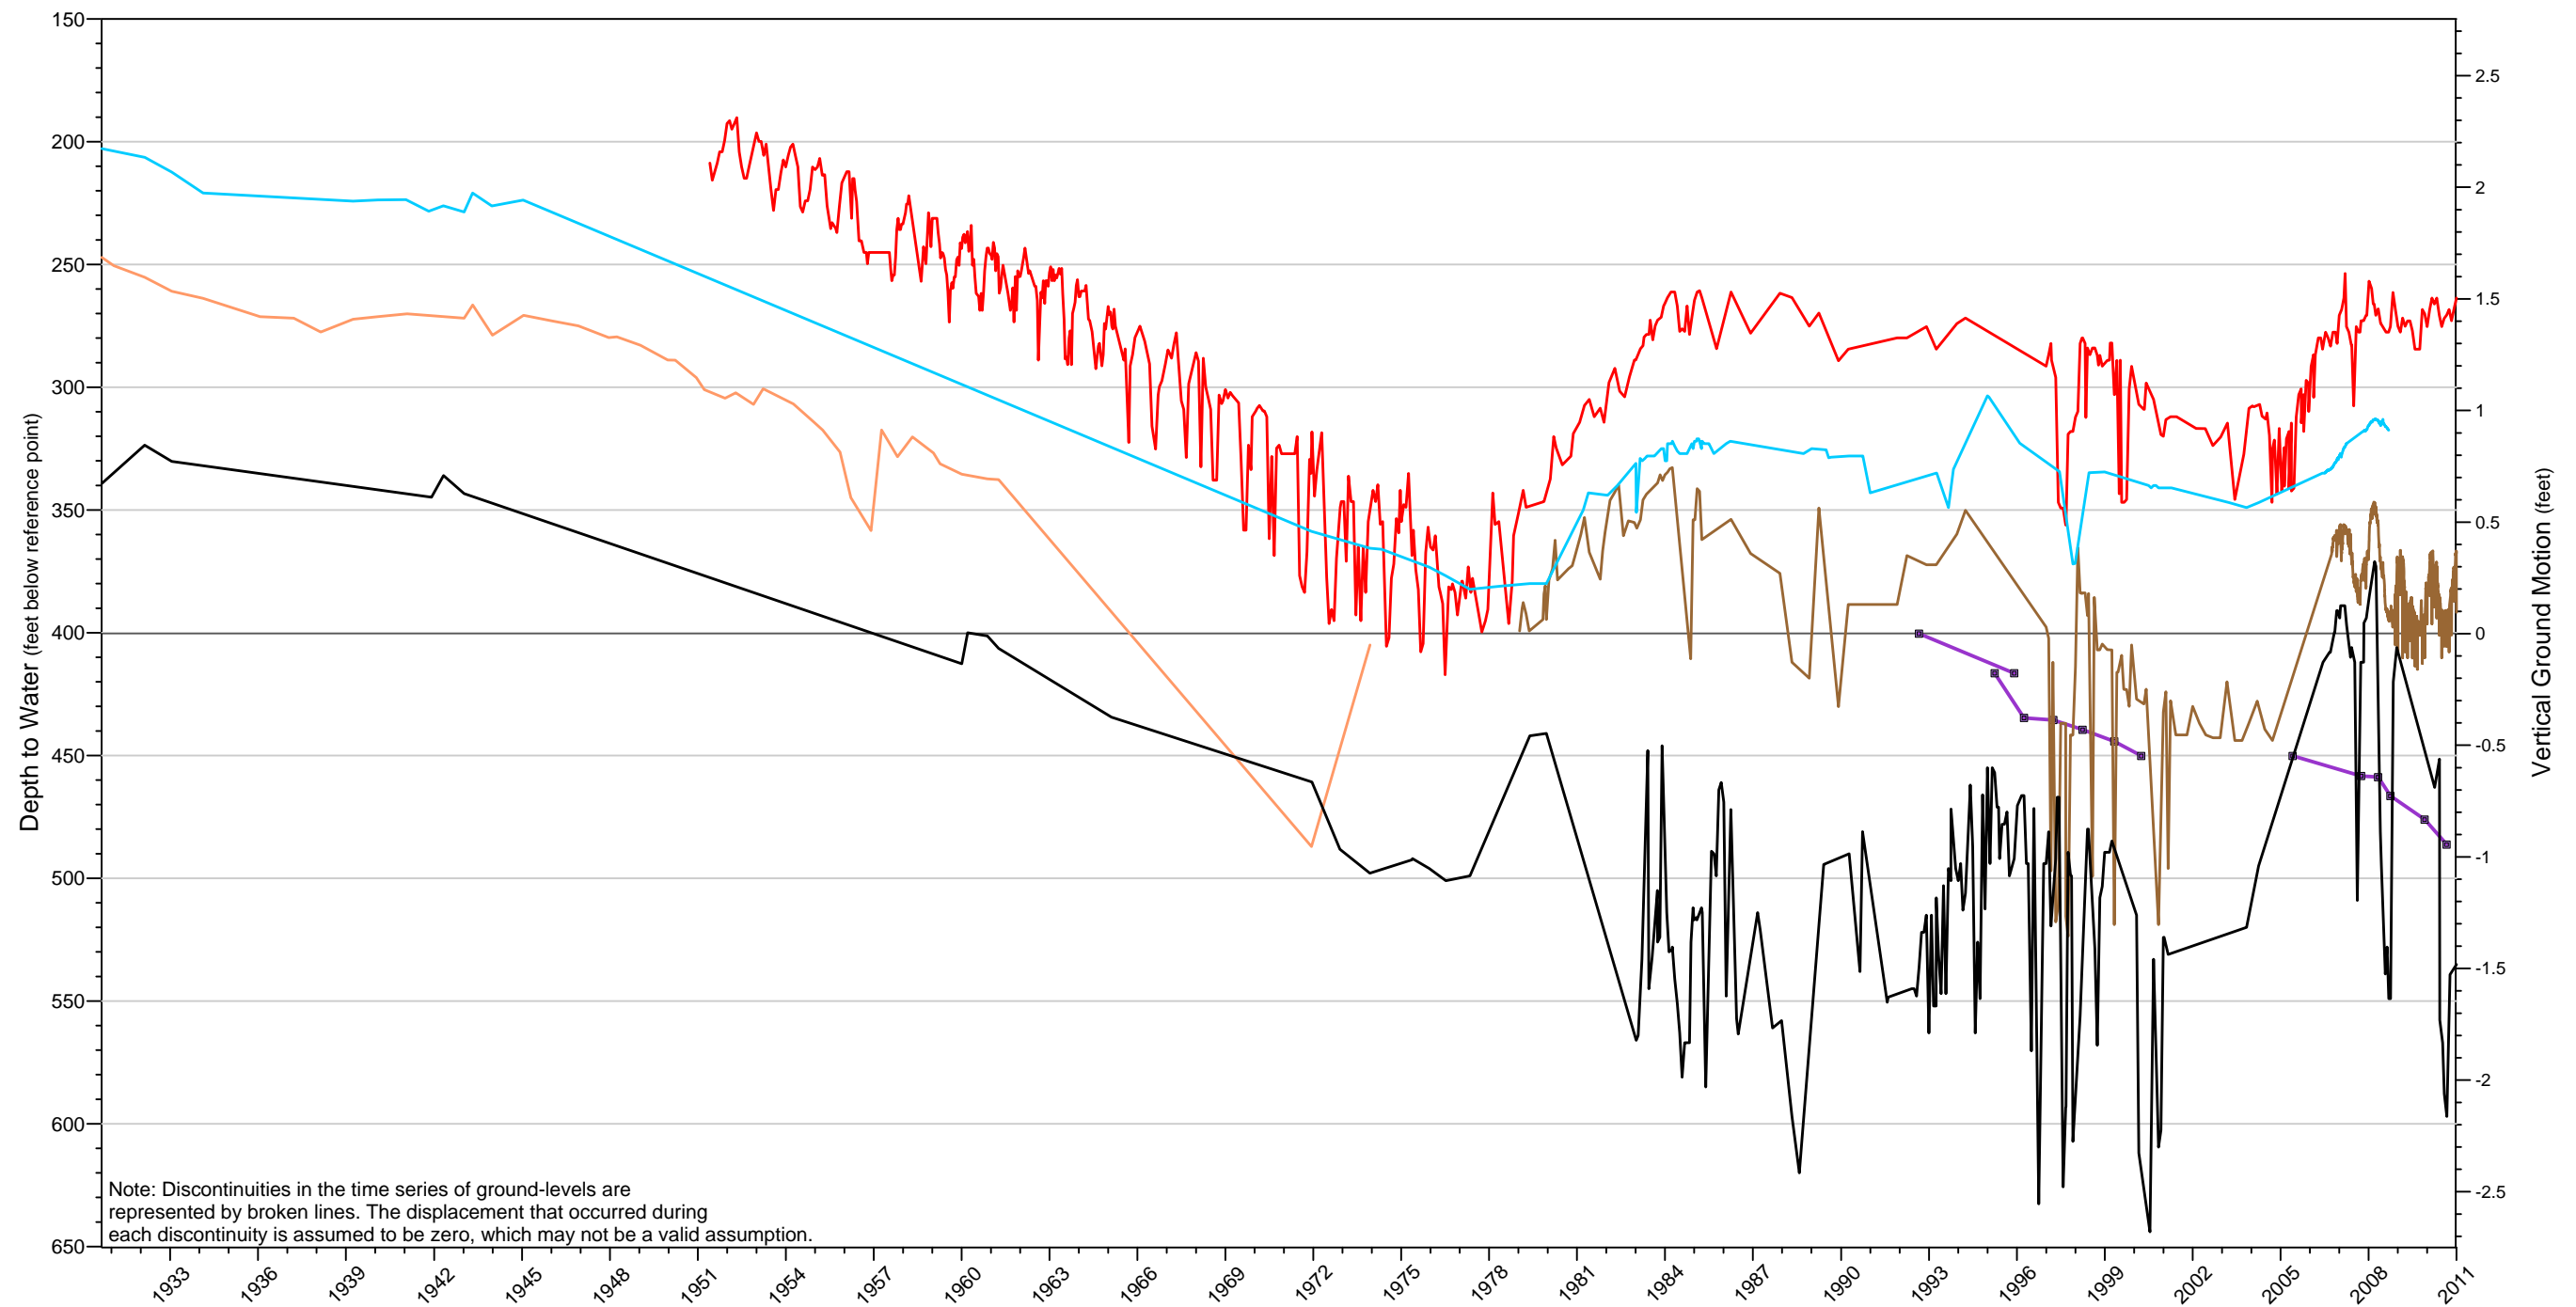
Exhibit 59

The observed, continuous land subsidence cannot be explained entirely by the corresponding changes in groundwater levels. A plausible explanation for the subsidence is that thick, slowly-draining aquitards are compacting in response to the historical drawdowns that occurred from 1935 to 1978 (see Exhibit 59).

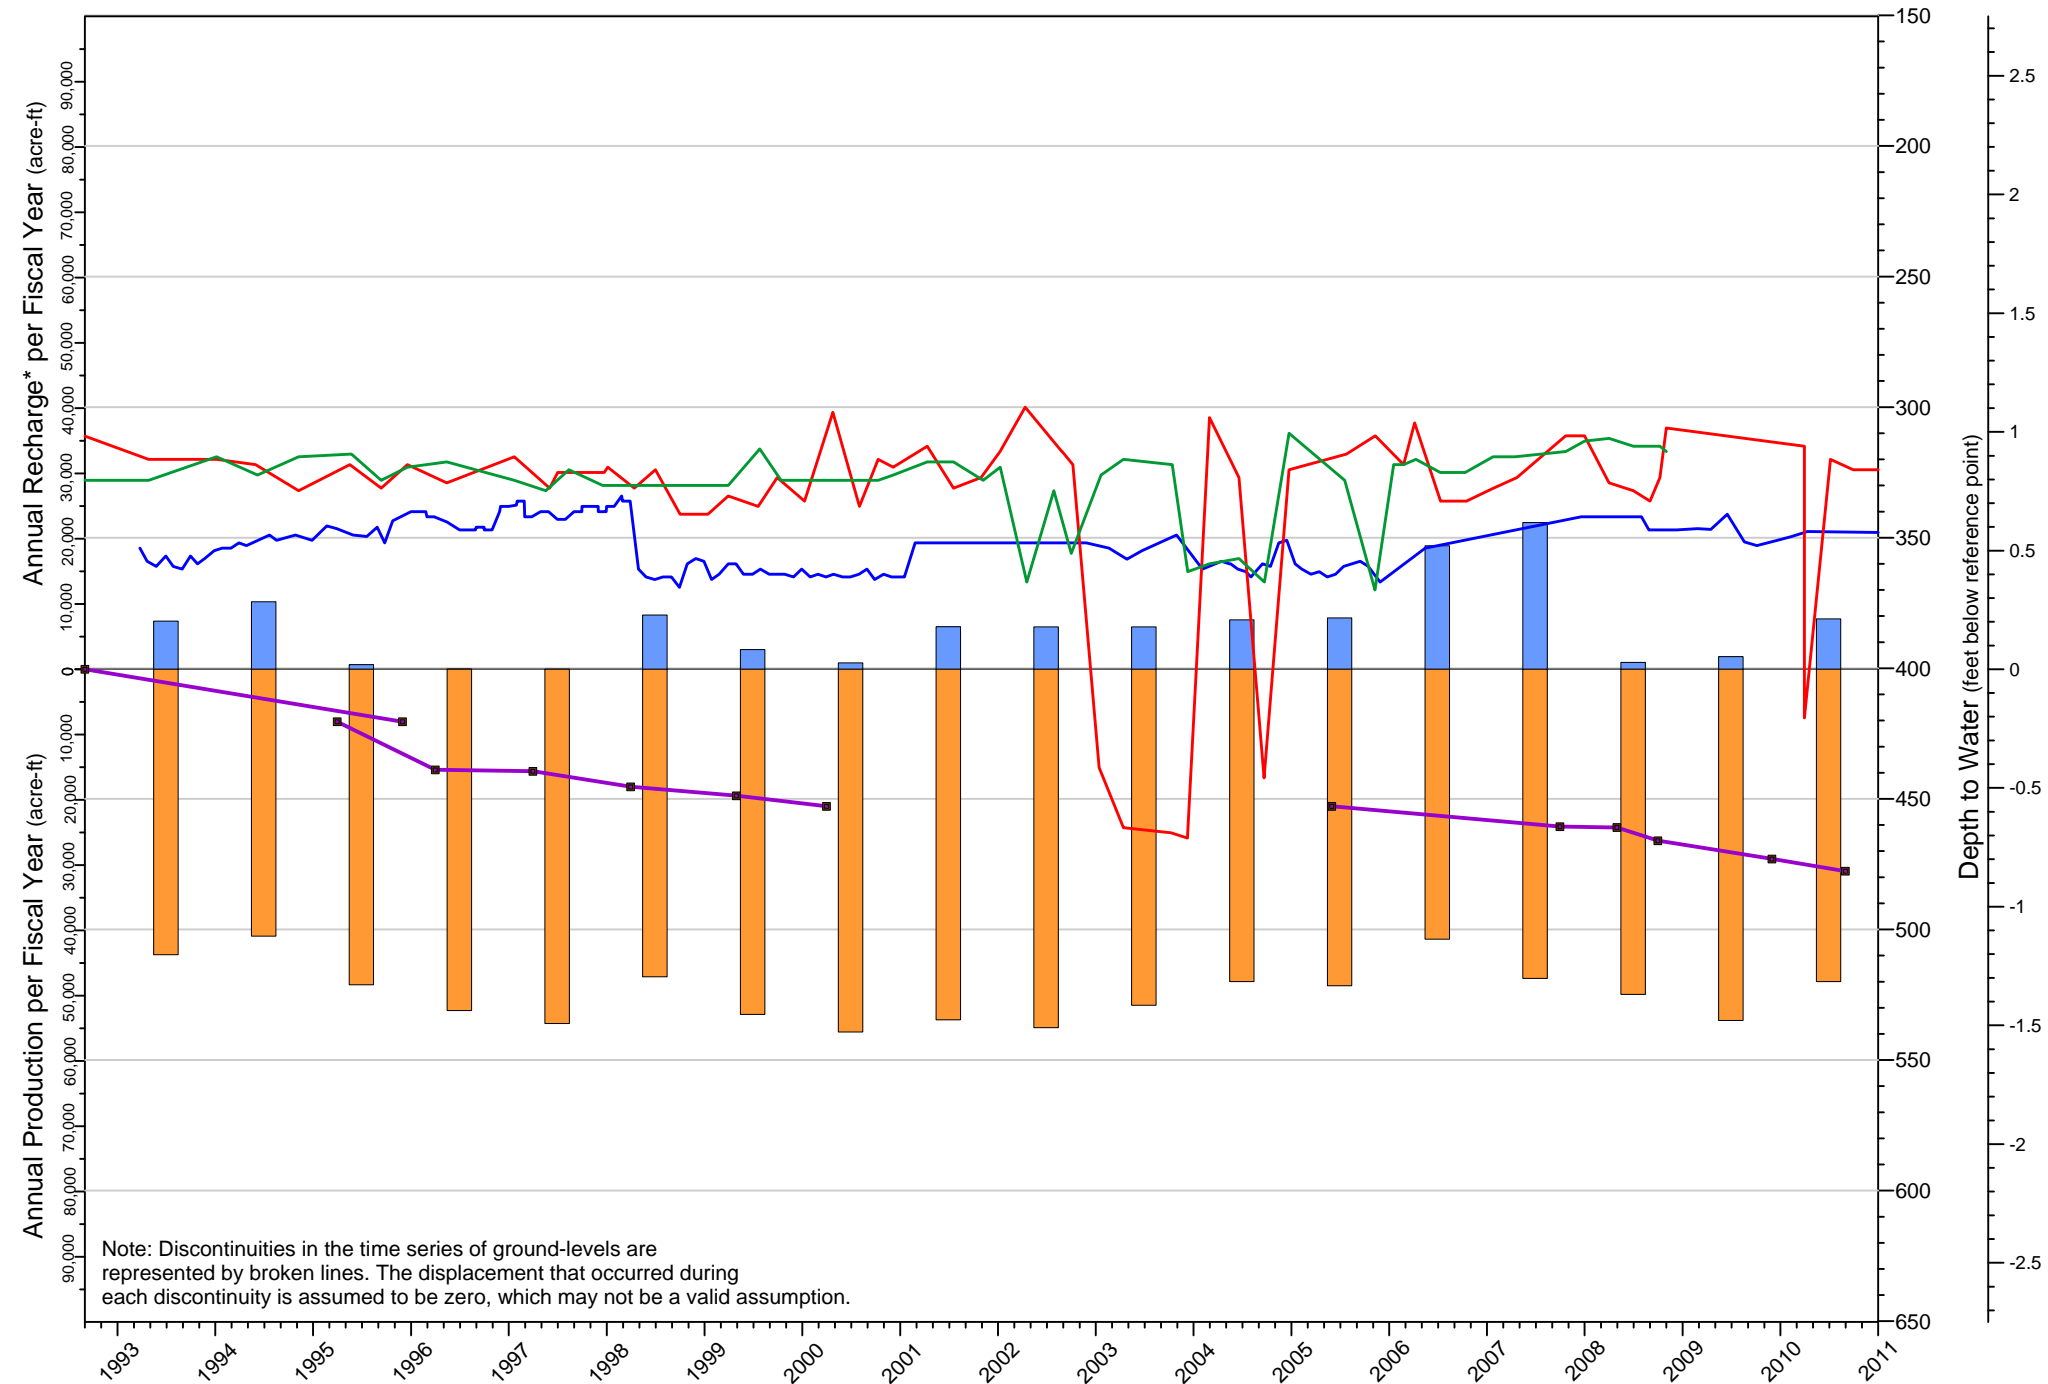
Exhibit 60

The Ontario subsidence area is located east of the Central MZ1 and the Pomona subsidence areas. Exhibits 60 and 61 are time series charts that display MZ1 annual production and recharge, along with groundwater levels at wells and ground-level survey data at measurement stations within the Ontario Area (see Exhibit 54).

The history of vertical ground motion in the Ontario Area is based solely on InSAR data from 1992 to 1995, 1995 to 2000, and 2005 to 2010. **These data indicate that land subsidence has occurred continuously in this area, generally at a rate of about 0.07 ft/yr.**

From about 1935 to 1978, groundwater levels in the Ontario Area declined by about 125 feet. Groundwater levels increased by about 10 to 20 feet during the early 1980s and have remained relatively stable since then.

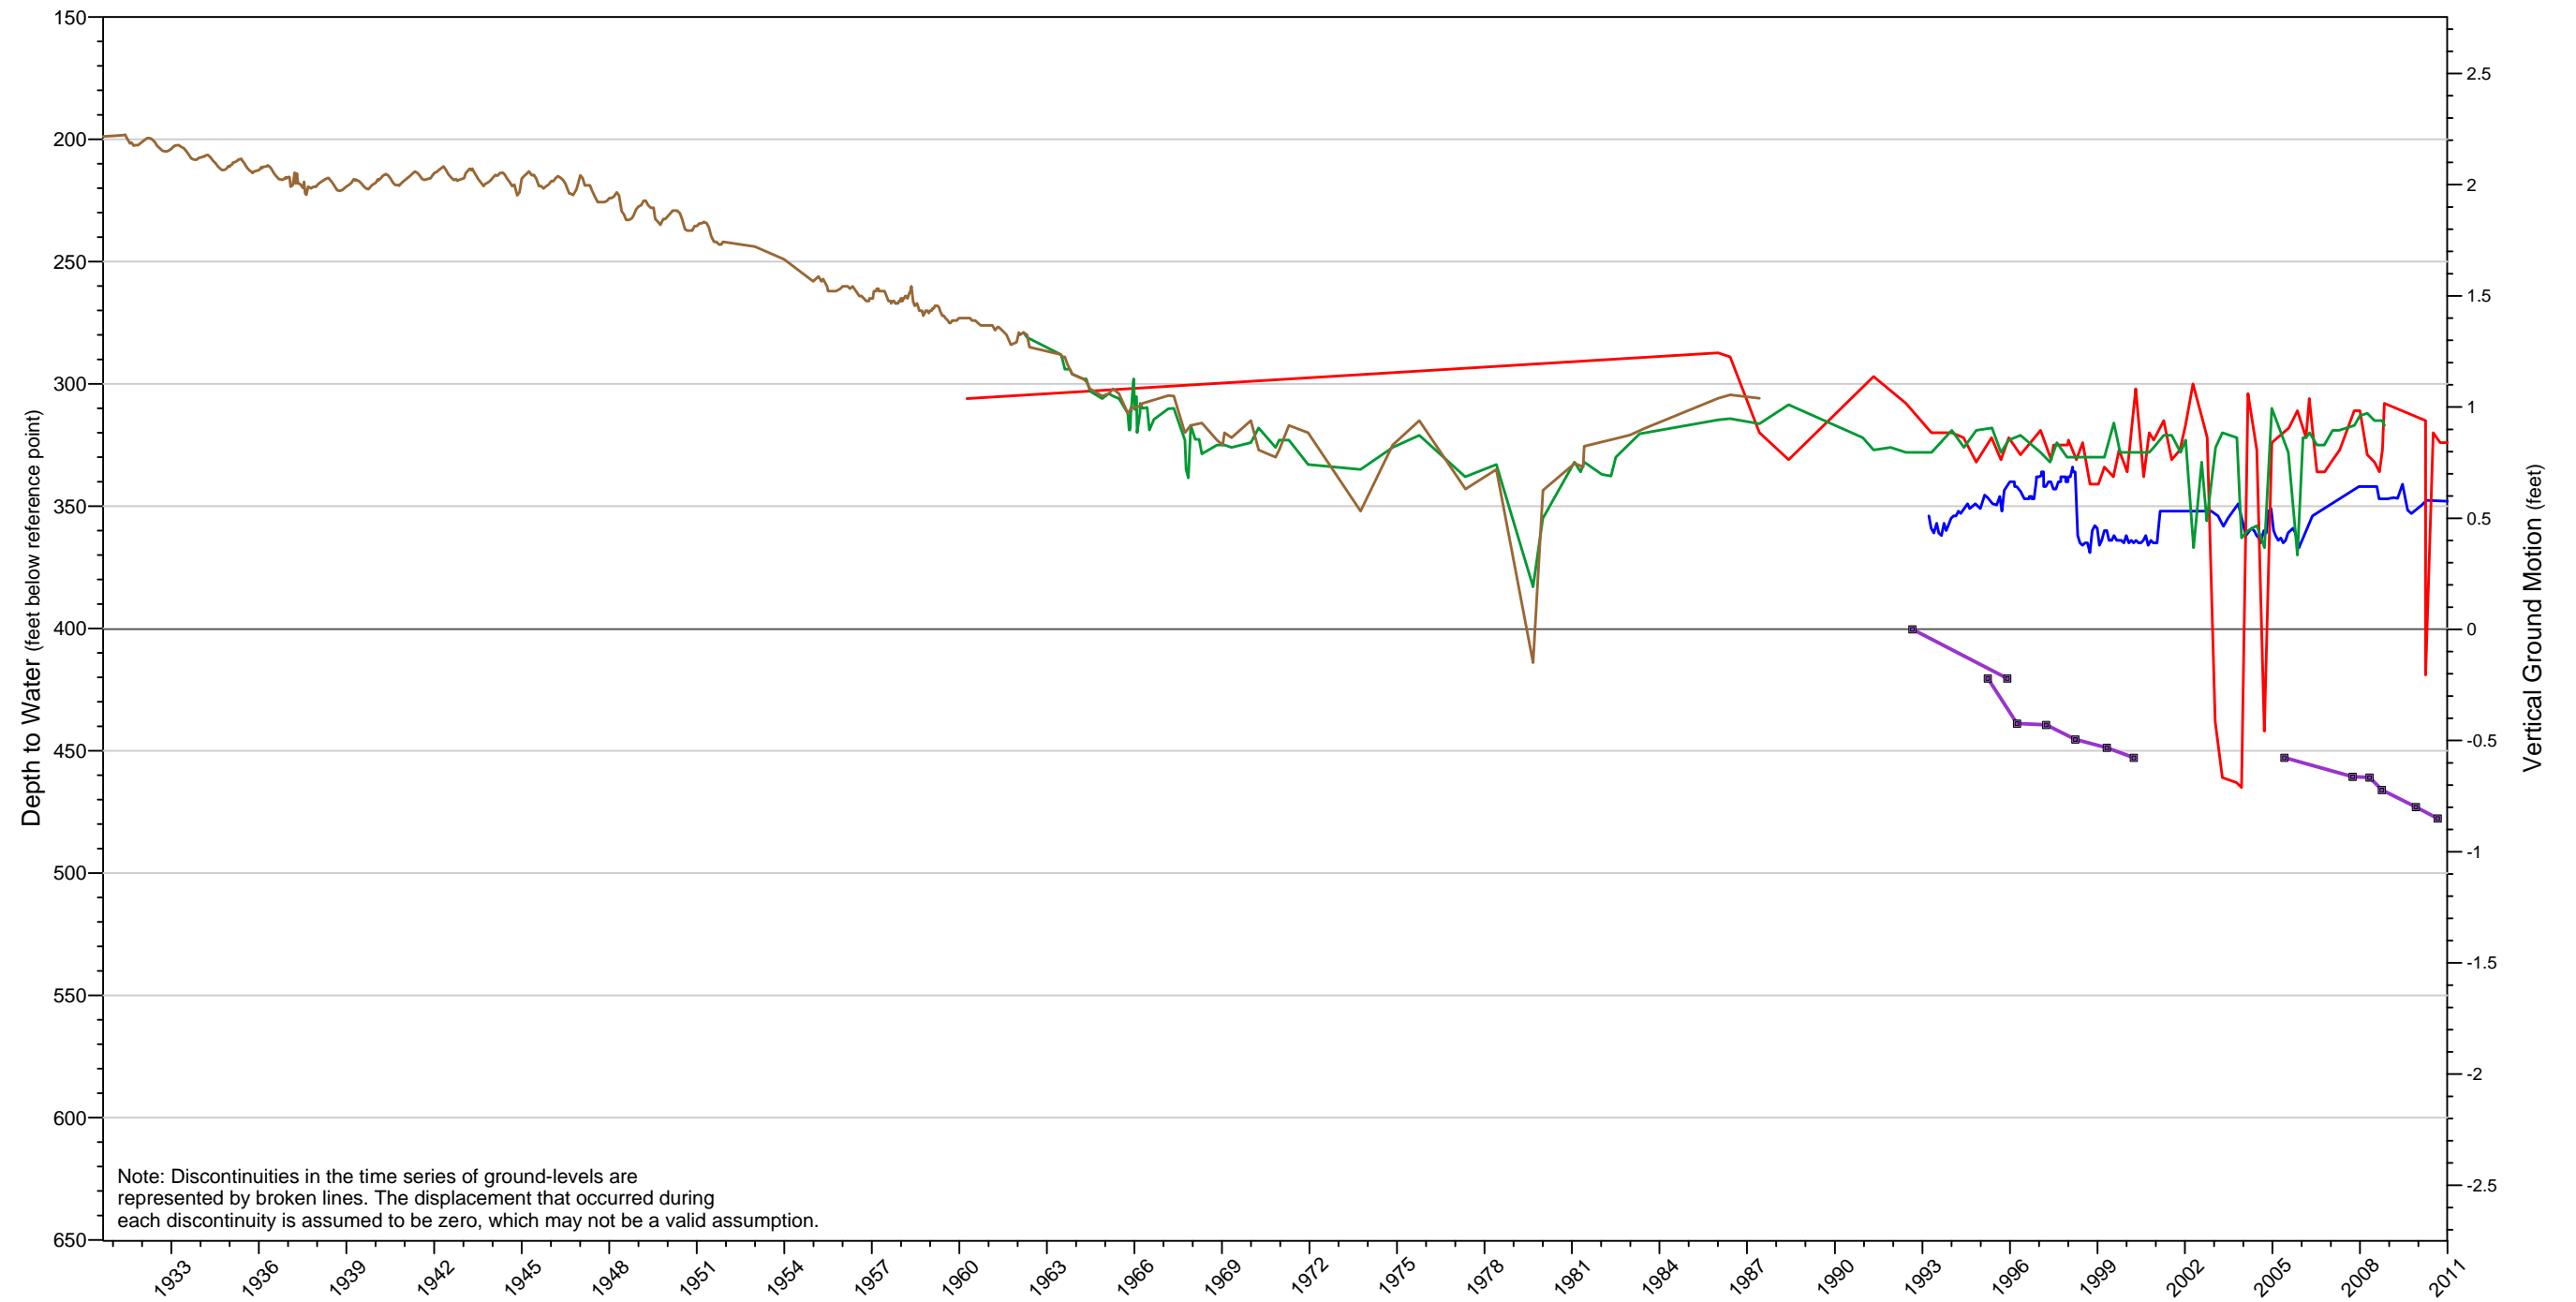
Exhibit 61

The observed, continuous land subsidence from 1992 to 2010 is not explained by the relatively stable groundwater levels. A plausible explanation for the subsidence is that thick, slowly draining aquitards are compacting in response to the historical draw-downs that occurred from 1935 to 1978 (see Exhibit 61).

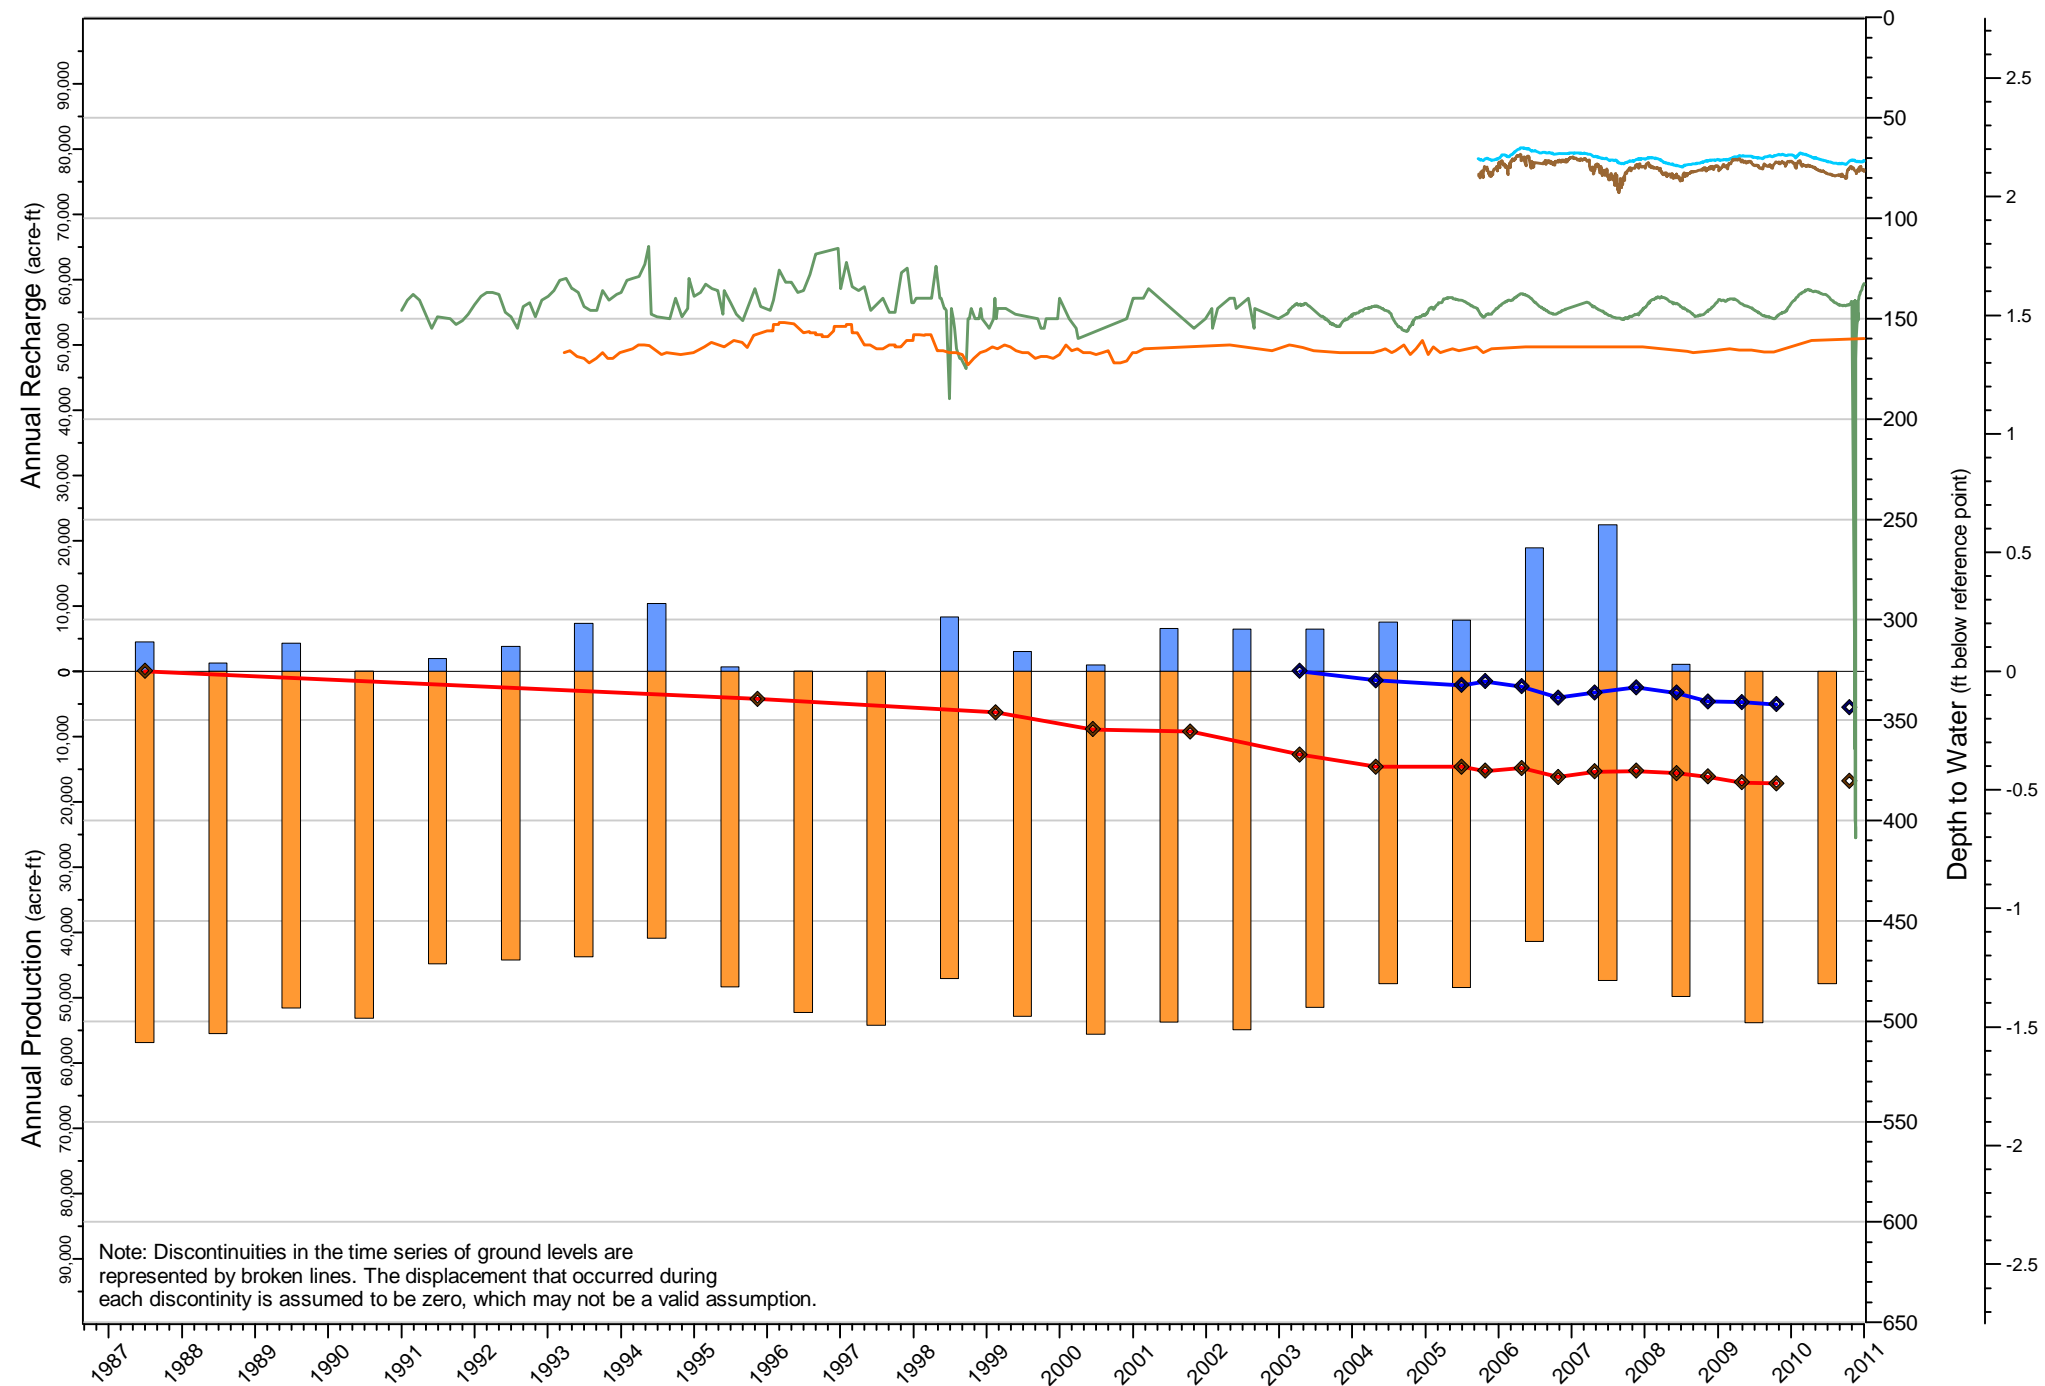
Figure 62

The Southeast subsidence area is located east of the MZ1 Managed Area. This exhibit is a time series chart that displays annual production and recharge within MZ1, along with groundwater levels at wells and ground-level survey data at measurement stations within the Southeast Area. The history of vertical ground motion in the Southeast Area is based solely on ground-level surveys performed from 1987 to 2010.

In the northern portion of the Southeast Area, the ground-level survey data indicate that land subsidence has occurred continuously and slowly in this area, generally at a rate of about 0.02 ft/yr. There is very little historical groundwater-level data for this area prior to about 1990. **The data since 1990 indicate relatively stable groundwater levels. The observed slow but continuous land subsidence from 1987 to 2010 is not explained by the relatively stable groundwater levels. A plausible explanation for the subsidence in this area is that thick, slowly-draining aquitards are compacting in response to the historical drawdowns that occurred prior to 1990.**

In the area near the intersection of Euclid Avenue and Kimball Avenue, where the Chino-I Desalter wells pump groundwater from the deep confined aquifer system, the ground-level survey data indicate land subsidence of about -0.23 feet in this area from 2005 to 2010. **The desalter wells have been pumping since 2000, and have been causing drawdown within the deep aquifer system that is likely the cause of the observed land subsidence.** Watermaster plans to install an extensometer facility in this region in early 2012 to better understand the mechanisms and occurrence of the subsidence in the vicinity of the Chino I-Desalter well field.

The first ground fissures documented in the Chino Basin occurred in the Southeast Area in the early 1970s, but ground fissuring has not been observed in the area since.
