Wineville Basin Proof of Concept Project Final Report

Inland Empire Utilities Agency
A MUNICIPAL WATER DISTRICT

**CHINO BASIN
WATERMASTER**

April 2, 2014

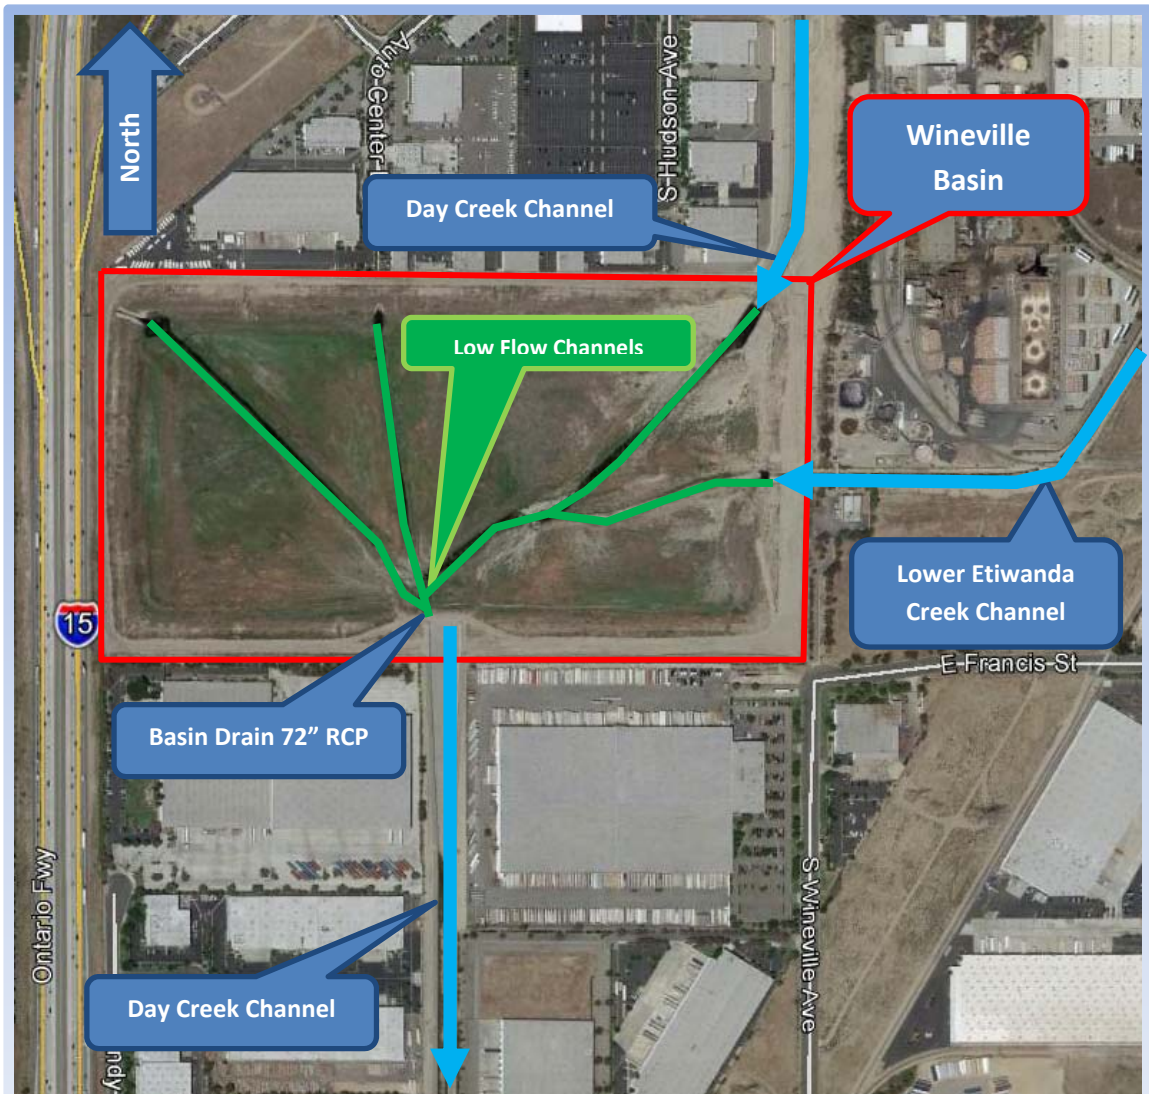
Figure 2: Basin Map

Wineville Basin is approximately 60 acres in size and has an average depth of approximately 25 feet. The overall volume of the Basin is approximately 1,200 acre-feet. A gravel maintenance road, with an average width of 60 feet, provides access to the perimeter of the Basin. The Basin side slopes average 3 feet horizontal to 1 foot of vertical distance (3:1). The bottom of the Basin generally slopes from north to south, with four excavated low-flow drainages channels maintained by SBCFCD to allow the Basin to drain, manage vector control issues and control nuisance flows through the Basin (Figure 2).

The north-east quarter of Basin bottom is 1 to 3 feet higher than the rest of the Basin, this is due to sediment deposition from Day Creek Channel and Lower Etiwanda Creek

Channel. Sediments deposited in this area generally consist of fine to coarse grained sands, intermixed with smaller amounts of silts and clays. Regular nuisance flow into the Basin promotes a variety of riparian and wetland vegetation along the low flow channels. Higher elevations in the Basin have variety of native and non-native vegetation. SBCFCD regularly cuts/sprays invasive vegetation and excavates/re-grades the low flow channels in the Basin.

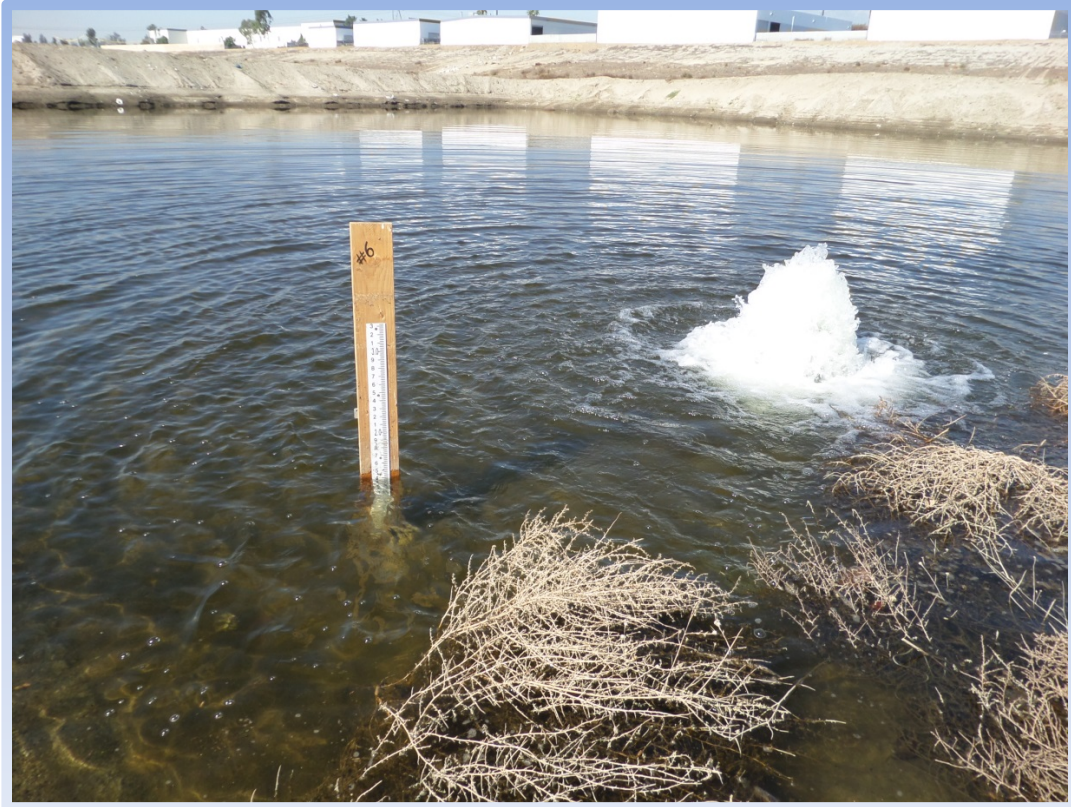
Figure 8: PTC #6 Filling

Once construction was complete and the pipes and valves were tested and inspected for leaks, the system was put into operation. Two to three PTCs were filled simultaneously. Once the water elevation reached from 1.5 to 3 feet in the PTC (as determined by visual observation of the staff gauges), the valve to the PTC was closed and a starting depth and time was manually recorded, the cell was then monitored until the depth was below 0.5 feet, the time and depth was recorded, infiltration rate calculated and then flow was delivered to the test cell once again and the process repeated. Level logger data was periodically downloaded from each PTC and compared to the staff gauge data to assure consistency in the test data.

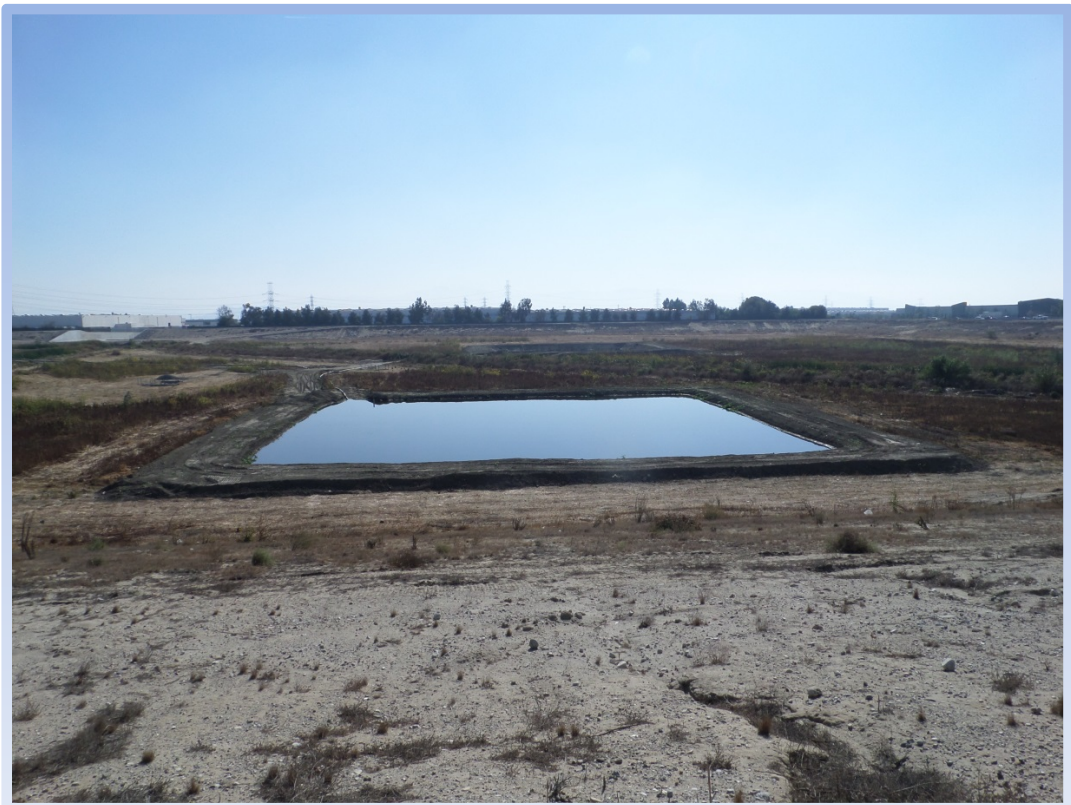
Figure 9: PTC #5 In Operation

The PTCs were put into operation on October 1, 2013 and testing was terminated on November 26, 2013. During the test period, water was supplied by the City of Ontario - Well 30. Well 30 delivered flow to Day Creek Channel, the Channel would then deliver flow to the 12-inch pipeline, and then onto the PTCs.

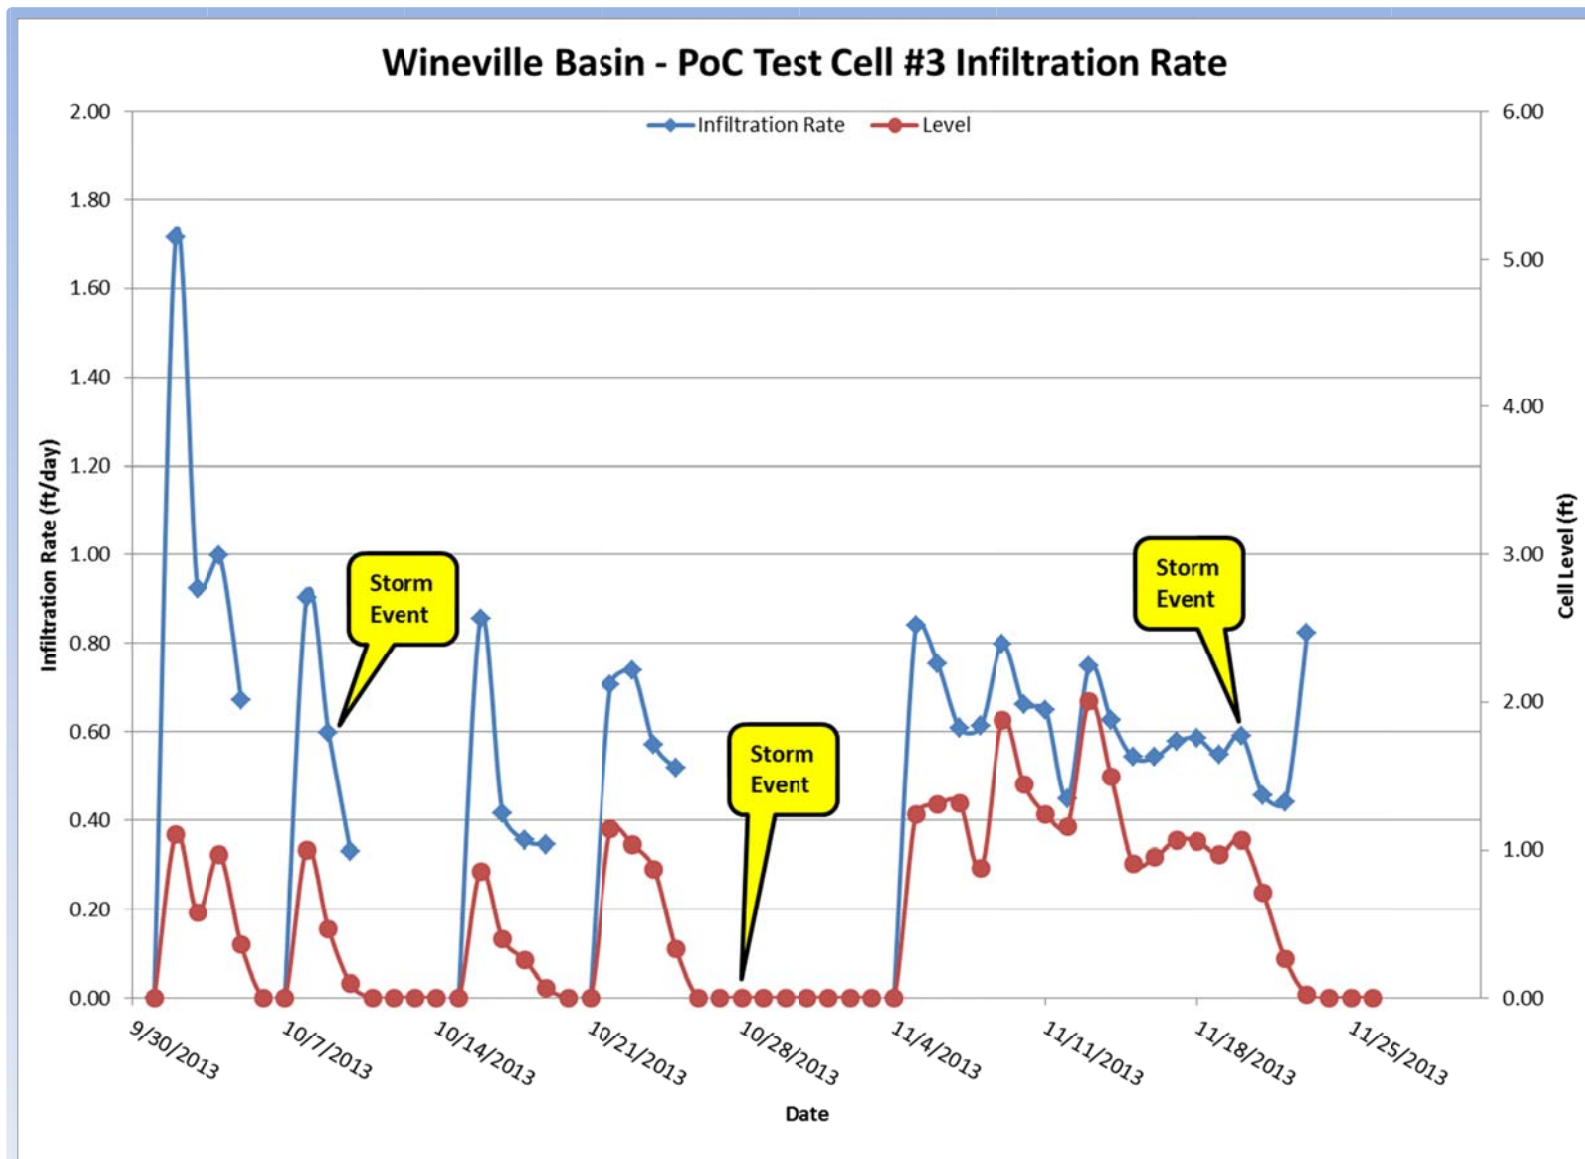
Figure 13: PTC #3 Graph

Test Cell #3 was located in the eastern 1/3rd of the Basin and slightly to the north of the Basin centerline (north to south). The bottom of the PTC was positioned at elevation 866.8, approximately 3 feet below the existing ground surface, just below a zone of semi-impervious sediments. The bottom of PTC #3 was more than 4 feet higher than any other PTC bottom.

Figure 13 below shows the PoC infiltration rates, along with the corresponding water level. The three previously discussed storm events have been annotated on the figure for reference. Data gaps in the infiltration rate indicate a period of time when the PTC water level was zero due to operational constraints.

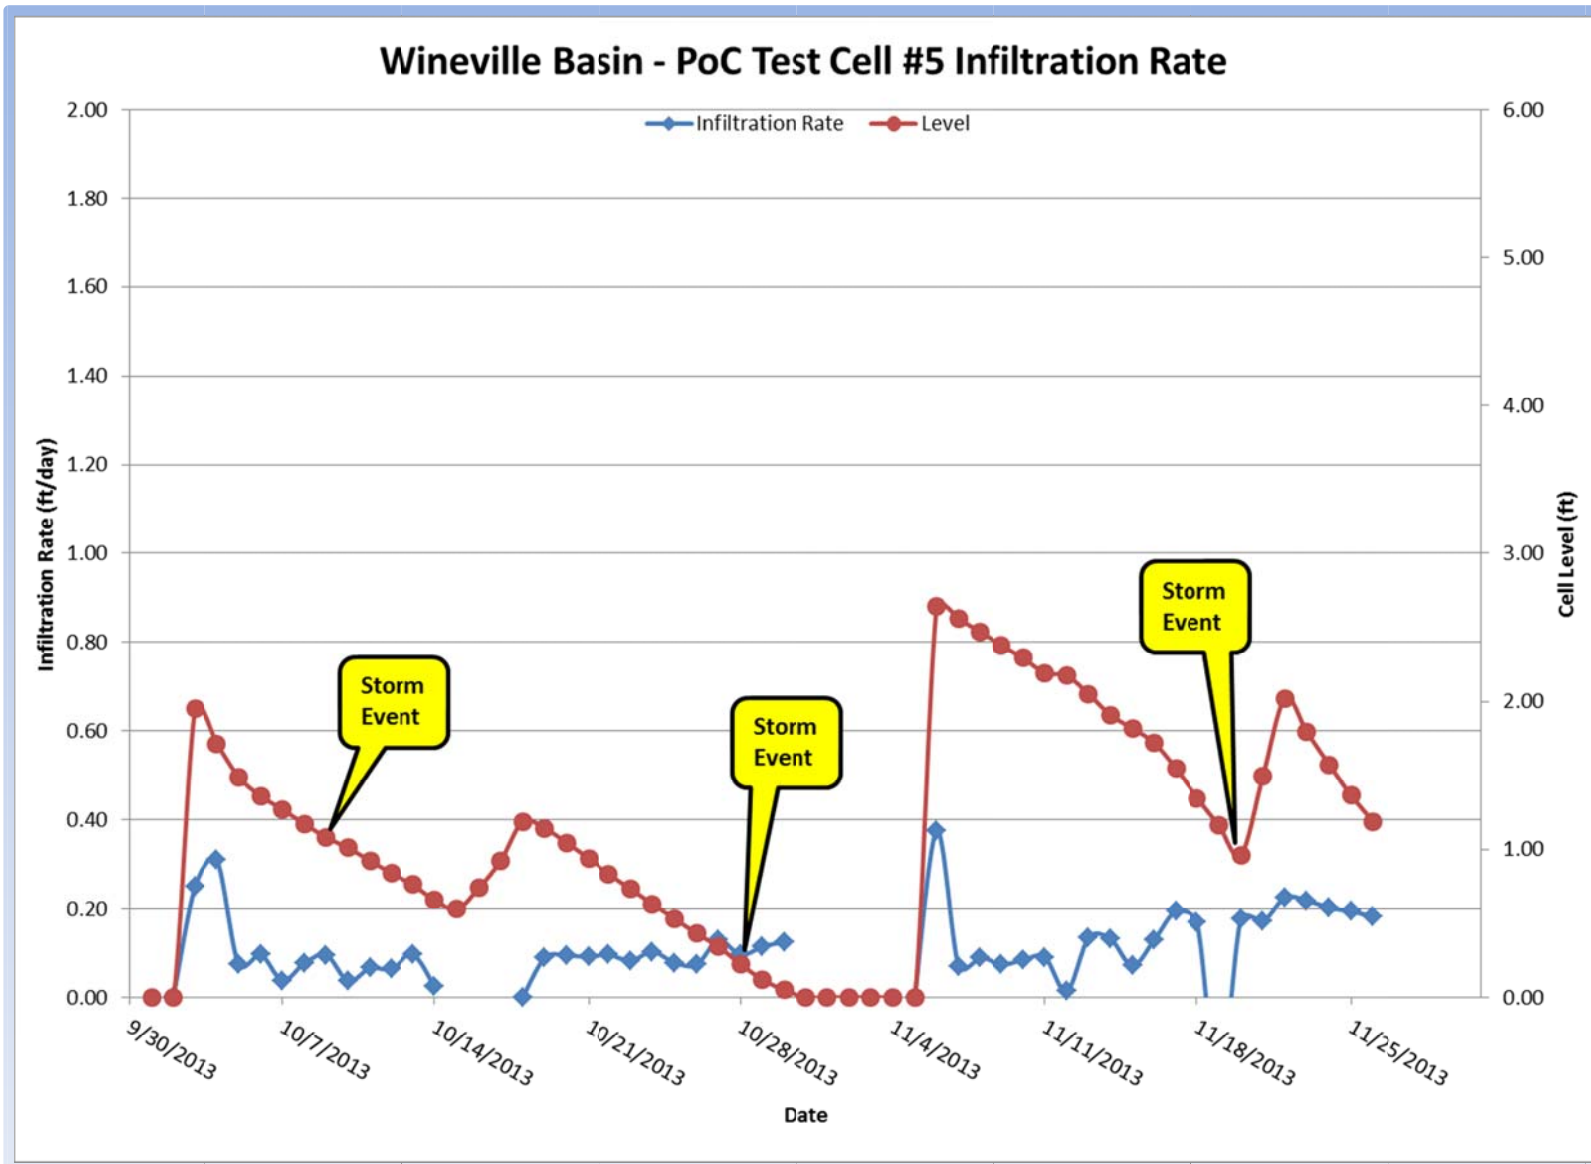
Figure 15: PTC #5 Graph

Test Cell #5 was located in the western 1/3rd of the Basin and in the northern 1/2 of the Basin (north to south). The bottom of the PTC was positioned at elevation 861.3, approximately 2 feet below the existing ground surface, within a zone of semi-impervious sediments as discovered during construction of the PTC.

Figure 15 below shows the PoC infiltration rate, along with the corresponding water level. The three previously discussed storm events have been annotated on the figure for reference. Data gaps in the infiltration rate indicate a period of time when the PTC water level was zero due to operational constraints.
