# 2018 Annual Report of the Prado Basin Habitat Sustainability Committee

Prado Basin Habitat Sustainability Committee Meeting  
May 14, 2019

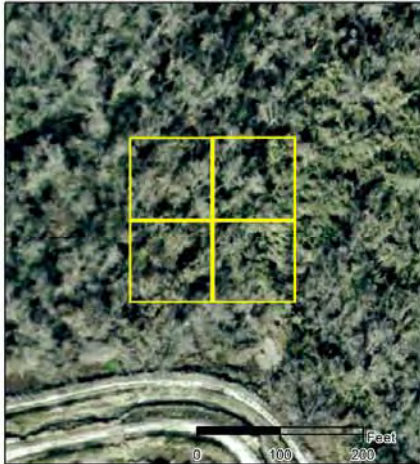
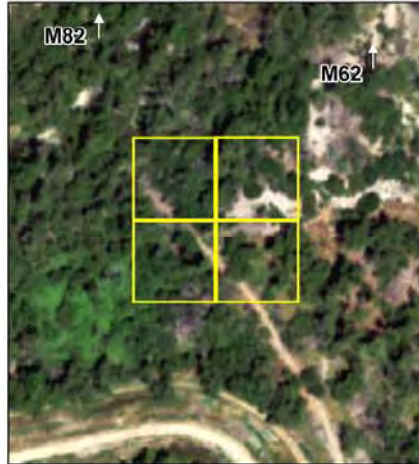
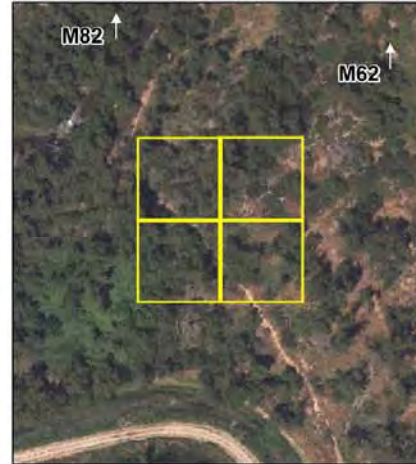
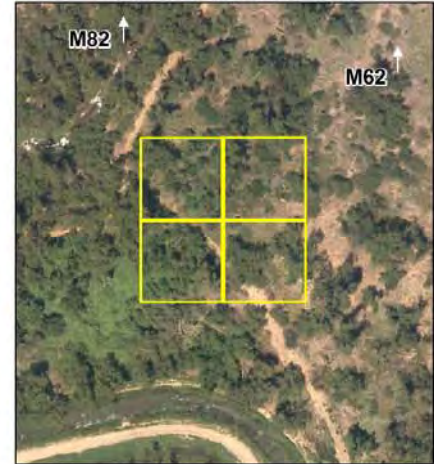
# NDVI Analysis – MC-4

2006 Air Photo (Date Unknown)

2016 Air Photo (May 3 to June 14, 2016)

2017 Air Photo (July 3, 2017)

2018 Air Photo (July 2, 2018)

NDVI 30 x 30 Meter Pixel

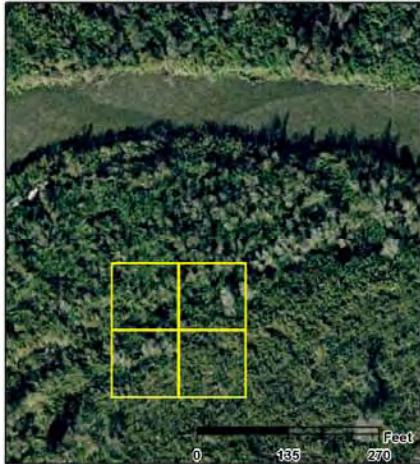
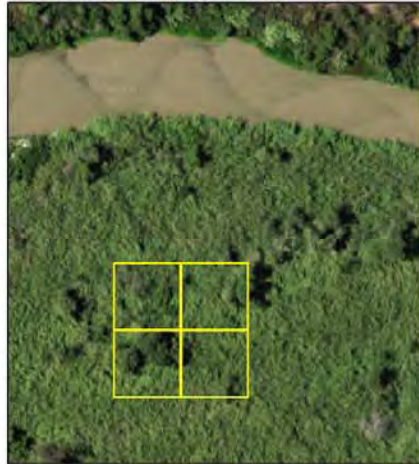
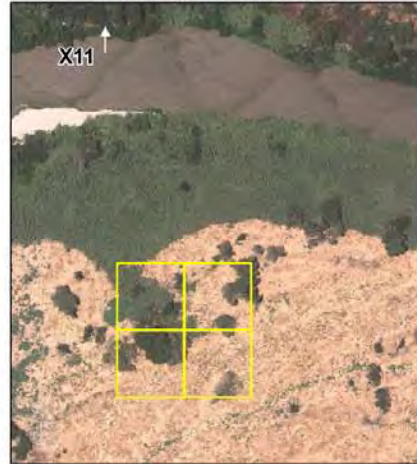
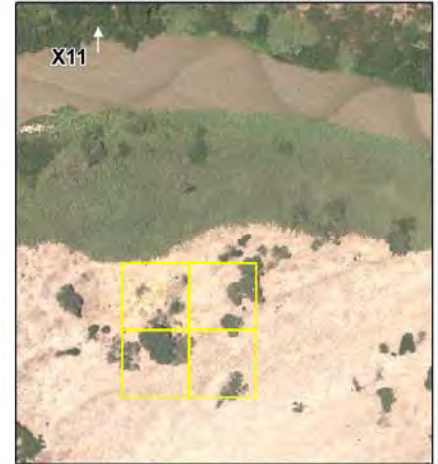
# NDVI Analysis – SAR-1

2006 Air Photo (Date Unknown)

2016 Air Photo (May 3 to June 14, 2016)

2017 Air Photo (July 3, 2017)

2018 Air Photo (July 2, 2018)

NDVI 30 x 30 Meter Pixel

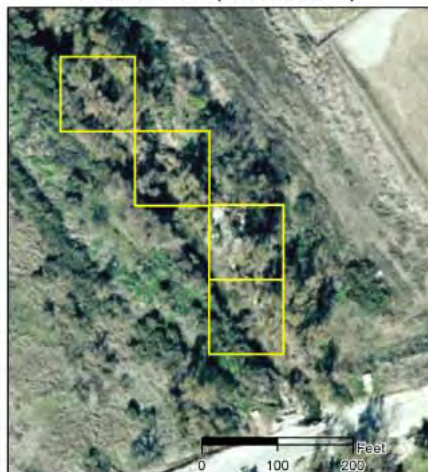
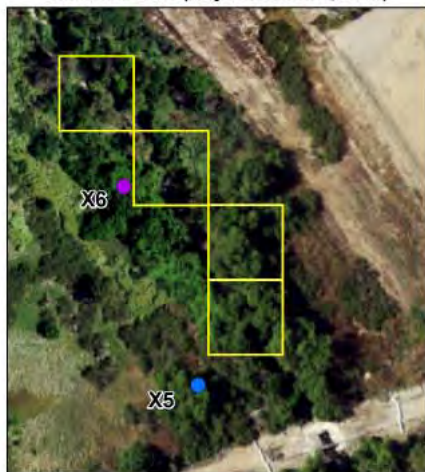
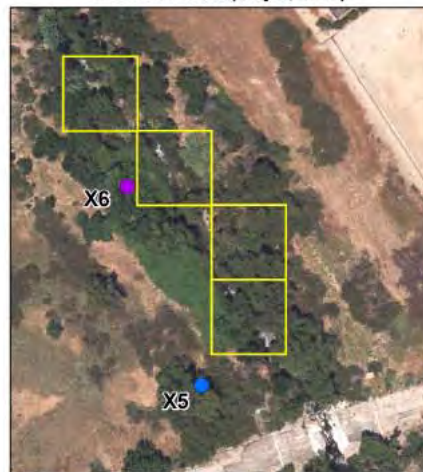
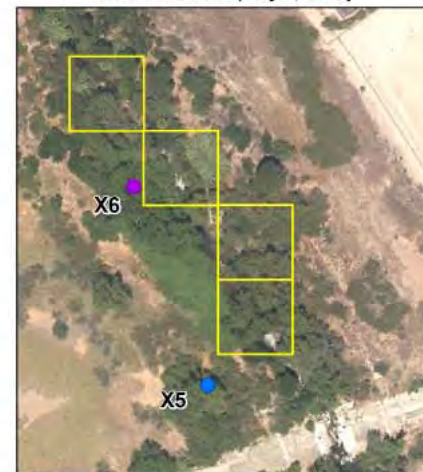
# NDVI Analysis – CC-2

2006 Air Photo (Date Unknown)

2016 Air Photo (May 3 to June 14, 2016)

2017 Air Photo (July 3, 2017)

2018 Air Photo (July 2, 2018)

NDVI 30 x 30 Meter Pixel

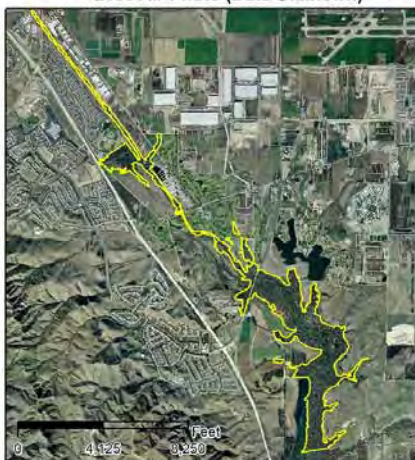
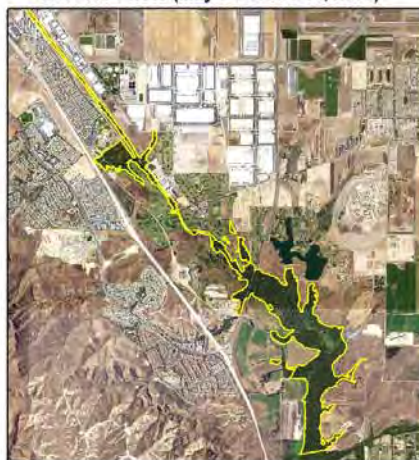
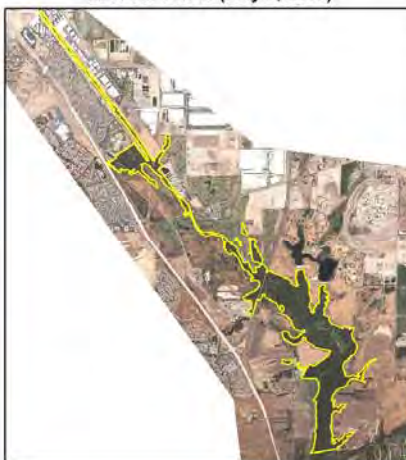
# NDVI Analysis – Along Chino Creek

2006 Air Photo (Date Unknown)

2016 Air Photo (May 3 to June 14, 2016)

2017 Air Photo (July 3, 2017)

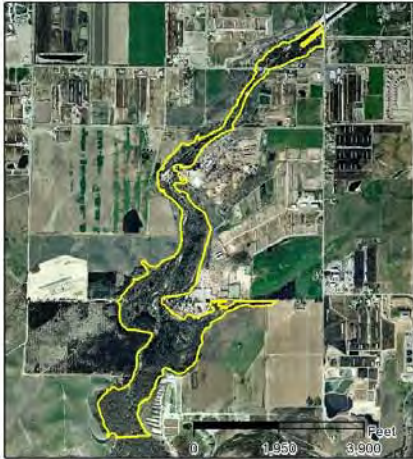
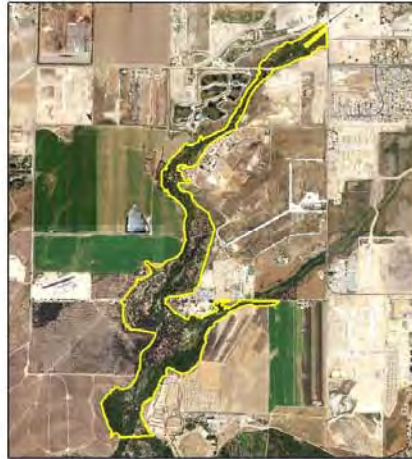
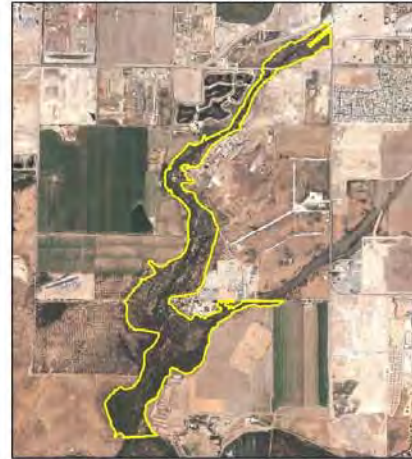
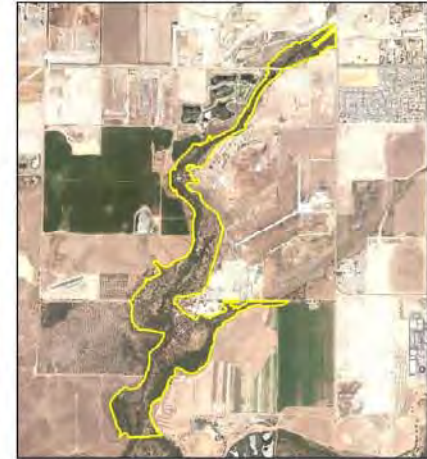
# NDVI Analysis – Along Mill Creek

2006 Air Photo (Date Unknown)

2016 Air Photo (May 3 to June 14, 2016)

2017 Air Photo (July 3, 2017)

2018 Air Photo (July 2, 2018)

0.26 Square Mile Area  
(759 30 x 30-meter pixels)

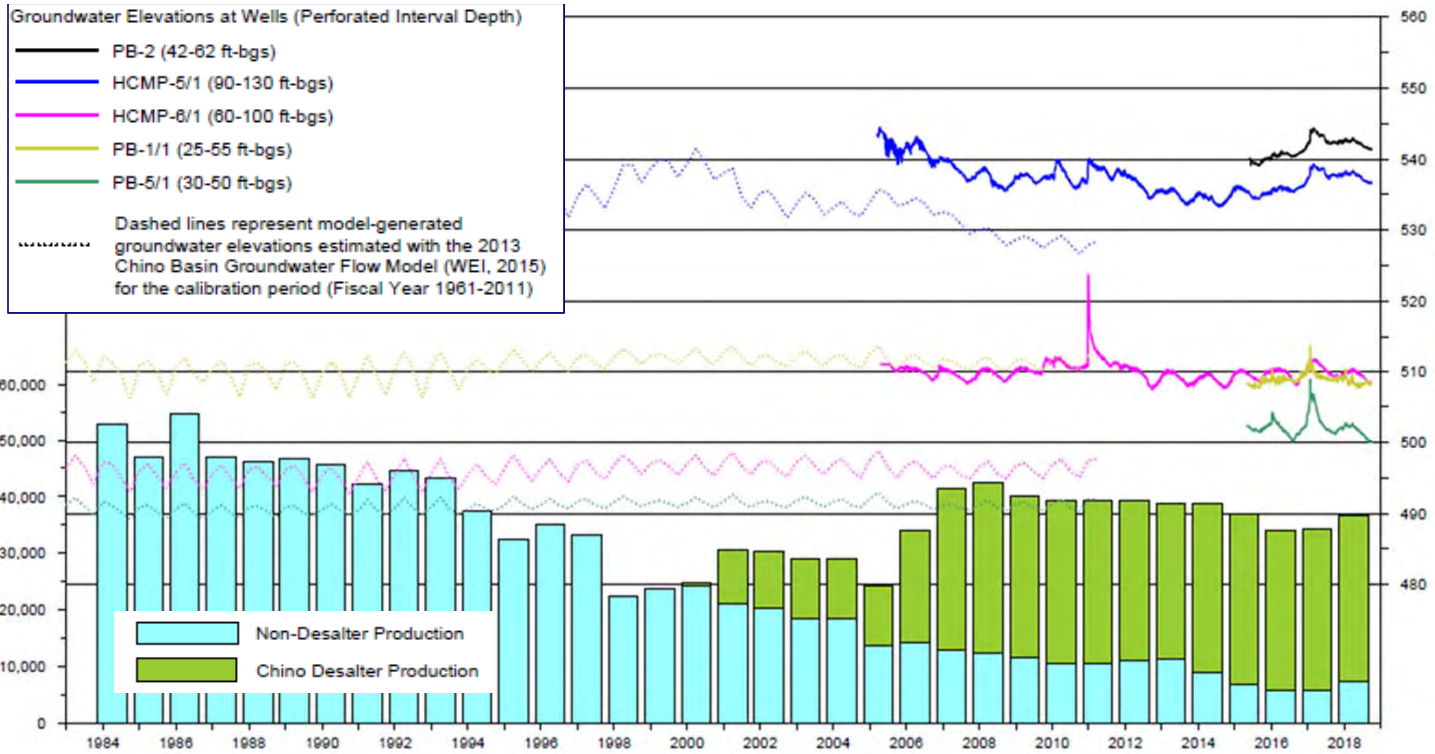
## Production, Groundwater Levels, NDVI – Mill Creek

Average Growing Season NDVI for Areas Along Mill Creek - (Mann-Kendall Result for 1984-2018; 1984-2006; 2007-2018)

- MC-1 (Increasing Trend; No Trend; No Trend)
- MC-2 (No Trend; Decreasing Trend; No Trend)
- MC-3 (No Trend; No Trend; No Trend)
- MC-4 (Increasing Trend; Increasing Trend; Decreasing Trend)
- Mill Creek Area (No Trend; Decreasing Trend; No Trend)

- Declining groundwater levels are not likely the cause of the recent declines in the greenness of the riparian vegetation, because groundwater levels across the study area were relatively stable during 2015-2018.

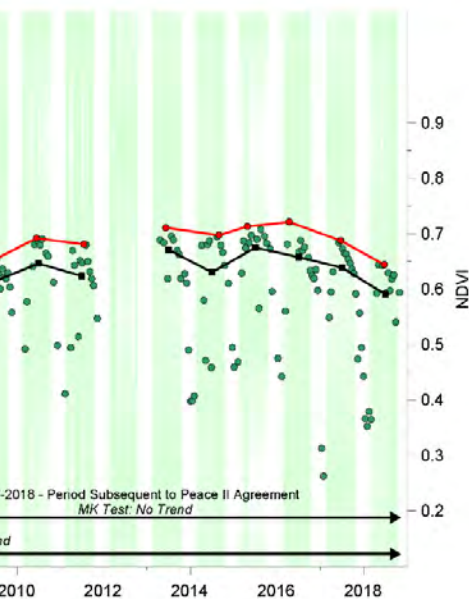
## Other Factors – Wildfires

- June 12, 2018 wildfire burned the southern portion of Chino Creek. The Chino Creek area, which includes the northern portion of the 2018 wildfire, shows a decrease in the Average Growing-Season NDVI of about 0.05
- In the area of the 2015 wildfire there are still notable low NDVI values within the perimeter of the fire.

- ▶ **Wildfires** in the Prado Basin burned areas of riparian habitat southeast of the OCWD Wetlands in 2015 and along Chino Creek in 2018, which contributed to recent declines in the greenness of the riparian vegetation during 2015-2018.
