The exhibits in this section show the state of ground-level subsidence in the Chino Basin, using data from the Chino Basin ground-level monitoring program that was designed to minimize and/or abate land subsidence.

CHINO BASIN WATERMASTER
 Water in Basin Management
 2010 State of the Basin
 Ground-Level Monitoring

Historical Land Surface Deformation in Management Zone 1

2010 State of the Basin
 Ground-Level Monitoring

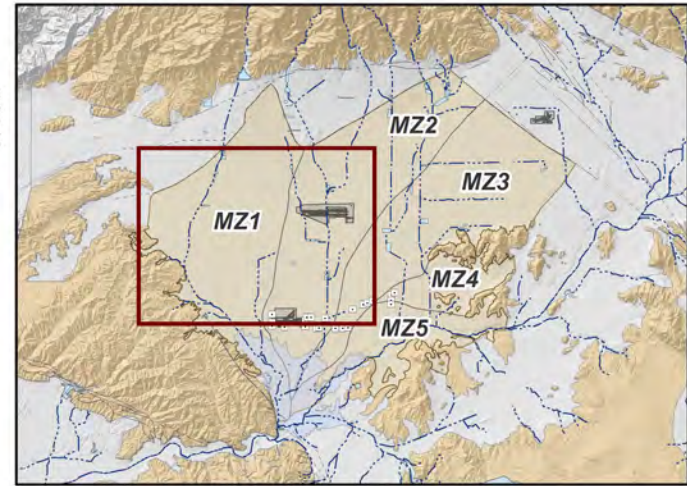
This map displays the historical deformation of the land surface in the western Chino Basin—specifically, land subsidence and ground fissuring. One of the earliest indications of land subsidence in the Chino Basin was the appearance of ground fissures in the City of Chino. These fissures appeared as early as 1973, but an accelerated occurrence of ground fissuring ensued after 1991 and resulted in damage to existing infrastructure. **The monitoring programs and scientific studies that followed attributed the fissuring phenomenon to differential land subsidence caused by pumping of the underlying aquifer system and the consequent drainage and compaction of aquitard sediments.**

The OBMP included a strategy to develop the MZ1 Subsidence Management Plan (MZ1 Plan, WEI, 2007b) to minimize or abate the future occurrence of land subsidence and ground fissuring in MZ1. Watermaster constructed a sophisticated monitoring facility—the Ayala Park Extensometer—that provided the critical information to develop the MZ1 Plan. The Court approved the MZ1 Plan in 2007. **In short, the MZ1 Plan (1) delineates the area where local pumpers are to voluntarily manage pumping such that groundwater levels do not decline below a defined level at an index well located at the Ayala Park Extensometer Facility and (2) calls for continued monitoring, data assessment, and updates to the plan as necessary.**

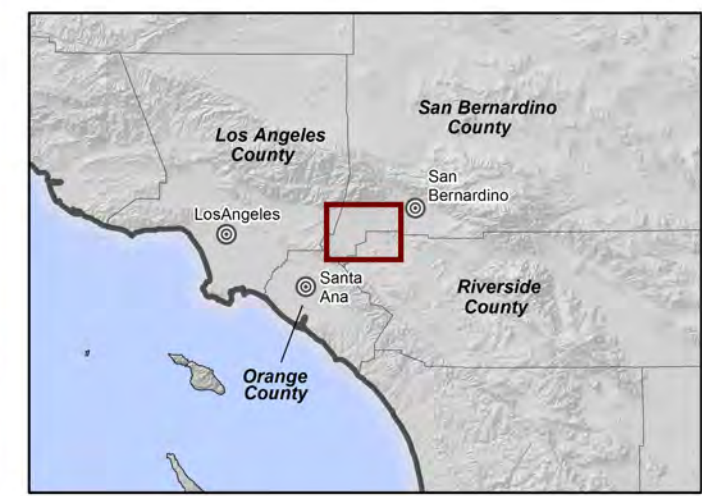
Vertical Ground Motion (2005 to 2010)
 as Measured by InSAR in the Chino Basin Area

Historically, the MZ1 Managed Area has experienced the most land subsidence (e.g. over -2 feet of subsidence from 1987 to 1999). **However, from 2005 to 2010, the InSAR data indicate that land subsidence was relatively minor in this area (less than -0.1 feet), which indicates that subsidence is successfully being managed.** In the northeastern parts of the Basin, such as Fontana and Rancho Cucamonga, ground motion from 2005 to 2010 was relatively minor (less than about 0.06 feet of subsidence). A maximum subsidence of up to -0.4 feet from 2005 to 2010 was measured in the Pomona area.

Geologic faults that cut through the aquifer system can act as barriers to groundwater flow and, hence, can cause the occurrence of differential subsidence. **Historically, in the Chino Basin, the ground fissuring has been linked to the occurrence of differential subsidence. The InSAR data on this map shows a steep gradient of subsidence across the San Jose Fault, indicating the potential for the accumulation of horizontal strain in the shallow sediments and the possibility of ground fissuring.** Ground fissuring is the main subsidence related threat to infrastructure. The Land Subsidence Committee is continuing to monitor this area via InSAR and has recommended additional activities to address the occurrence of differential subsidence in Pomona if it continues.

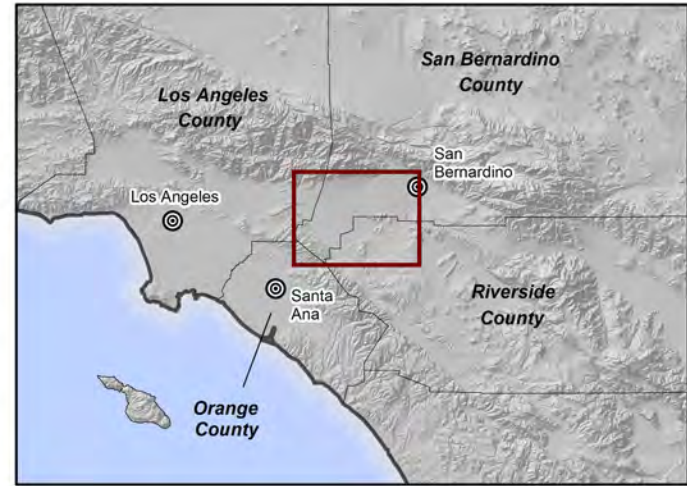
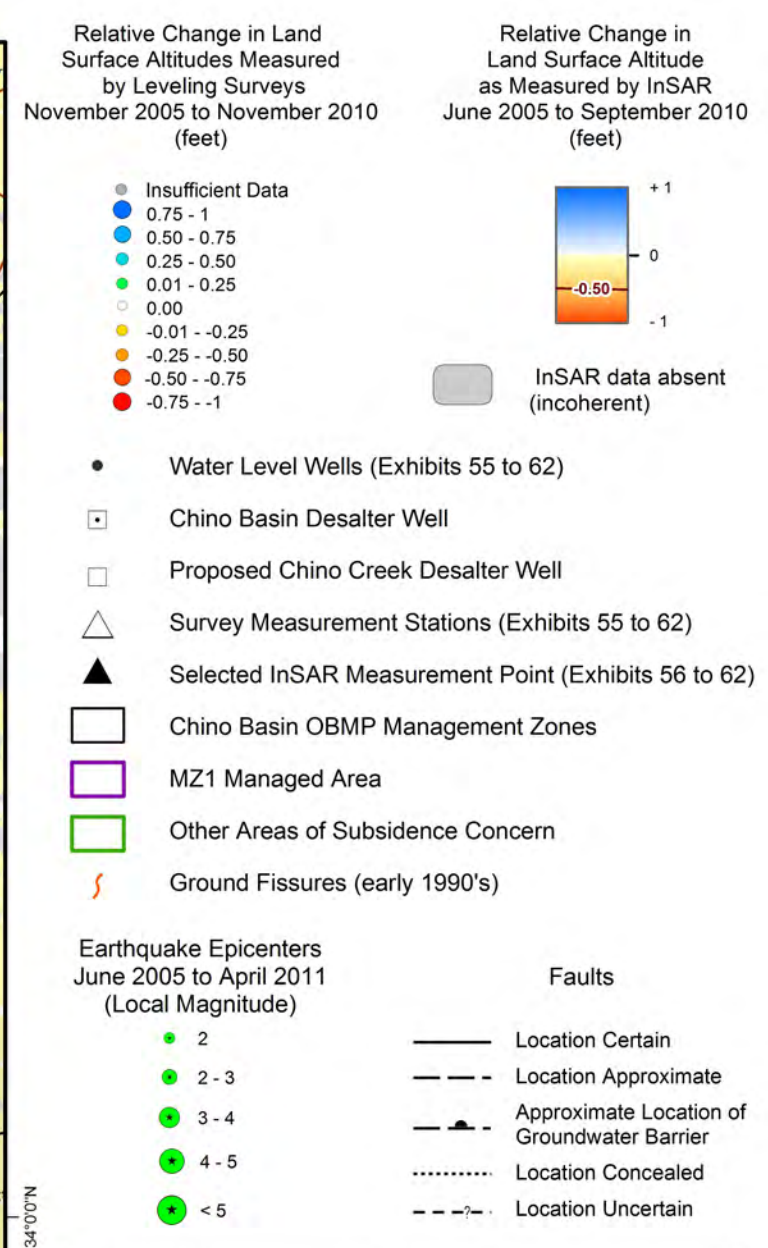
Vertical Ground Motion (2005 to 2010)
 Leveling Surveys and InSAR in Western Chino

This map displays the western half of the Chino Basin, and both the InSAR and ground-level survey results for November 2005 to November 2010. The ground-level survey data generally corroborate the patterns and magnitude of ground motion shown by InSAR. **One advantage of the ground-level surveys is that they can provide information on ground motion in areas where InSAR data is absent.** See, for example, the area near the intersection of Euclid Avenue and Kimball Avenue where the Chino-I Desalter wells pump groundwater from the deep confined aquifer system. The survey data indicate a maximum land subsidence of -0.23 feet in this area from 2005 to 2010. Watermaster plans to install an extensometer facility in this region in early 2012 to better understand the mechanisms and occurrence of the observed subsidence. Also shown on this map are the epicenters of earthquakes larger than 2.0 local magnitude that occurred between June 2005 and April 2011 (Source: Southern California Earthquake Data Center). The observed land subsidence is not related to seismic activity in Chino Basin.

This map also shows the MZ1 Managed Area, other areas of subsidence concern, and selected wells with long-term records of groundwater levels. The exhibits that follow explore the history of land subsidence in each sub-area, the current state of land subsidence, and the cause-and-effect relationships between pumping, recharge, groundwater levels, and land subsidence.
