2017/18 Annual Report of the Ground-Level Monitoring Committee

*FINAL REPORT
NOVEMBER 2018*

Prepared for:
Ground-Level Monitoring Committee

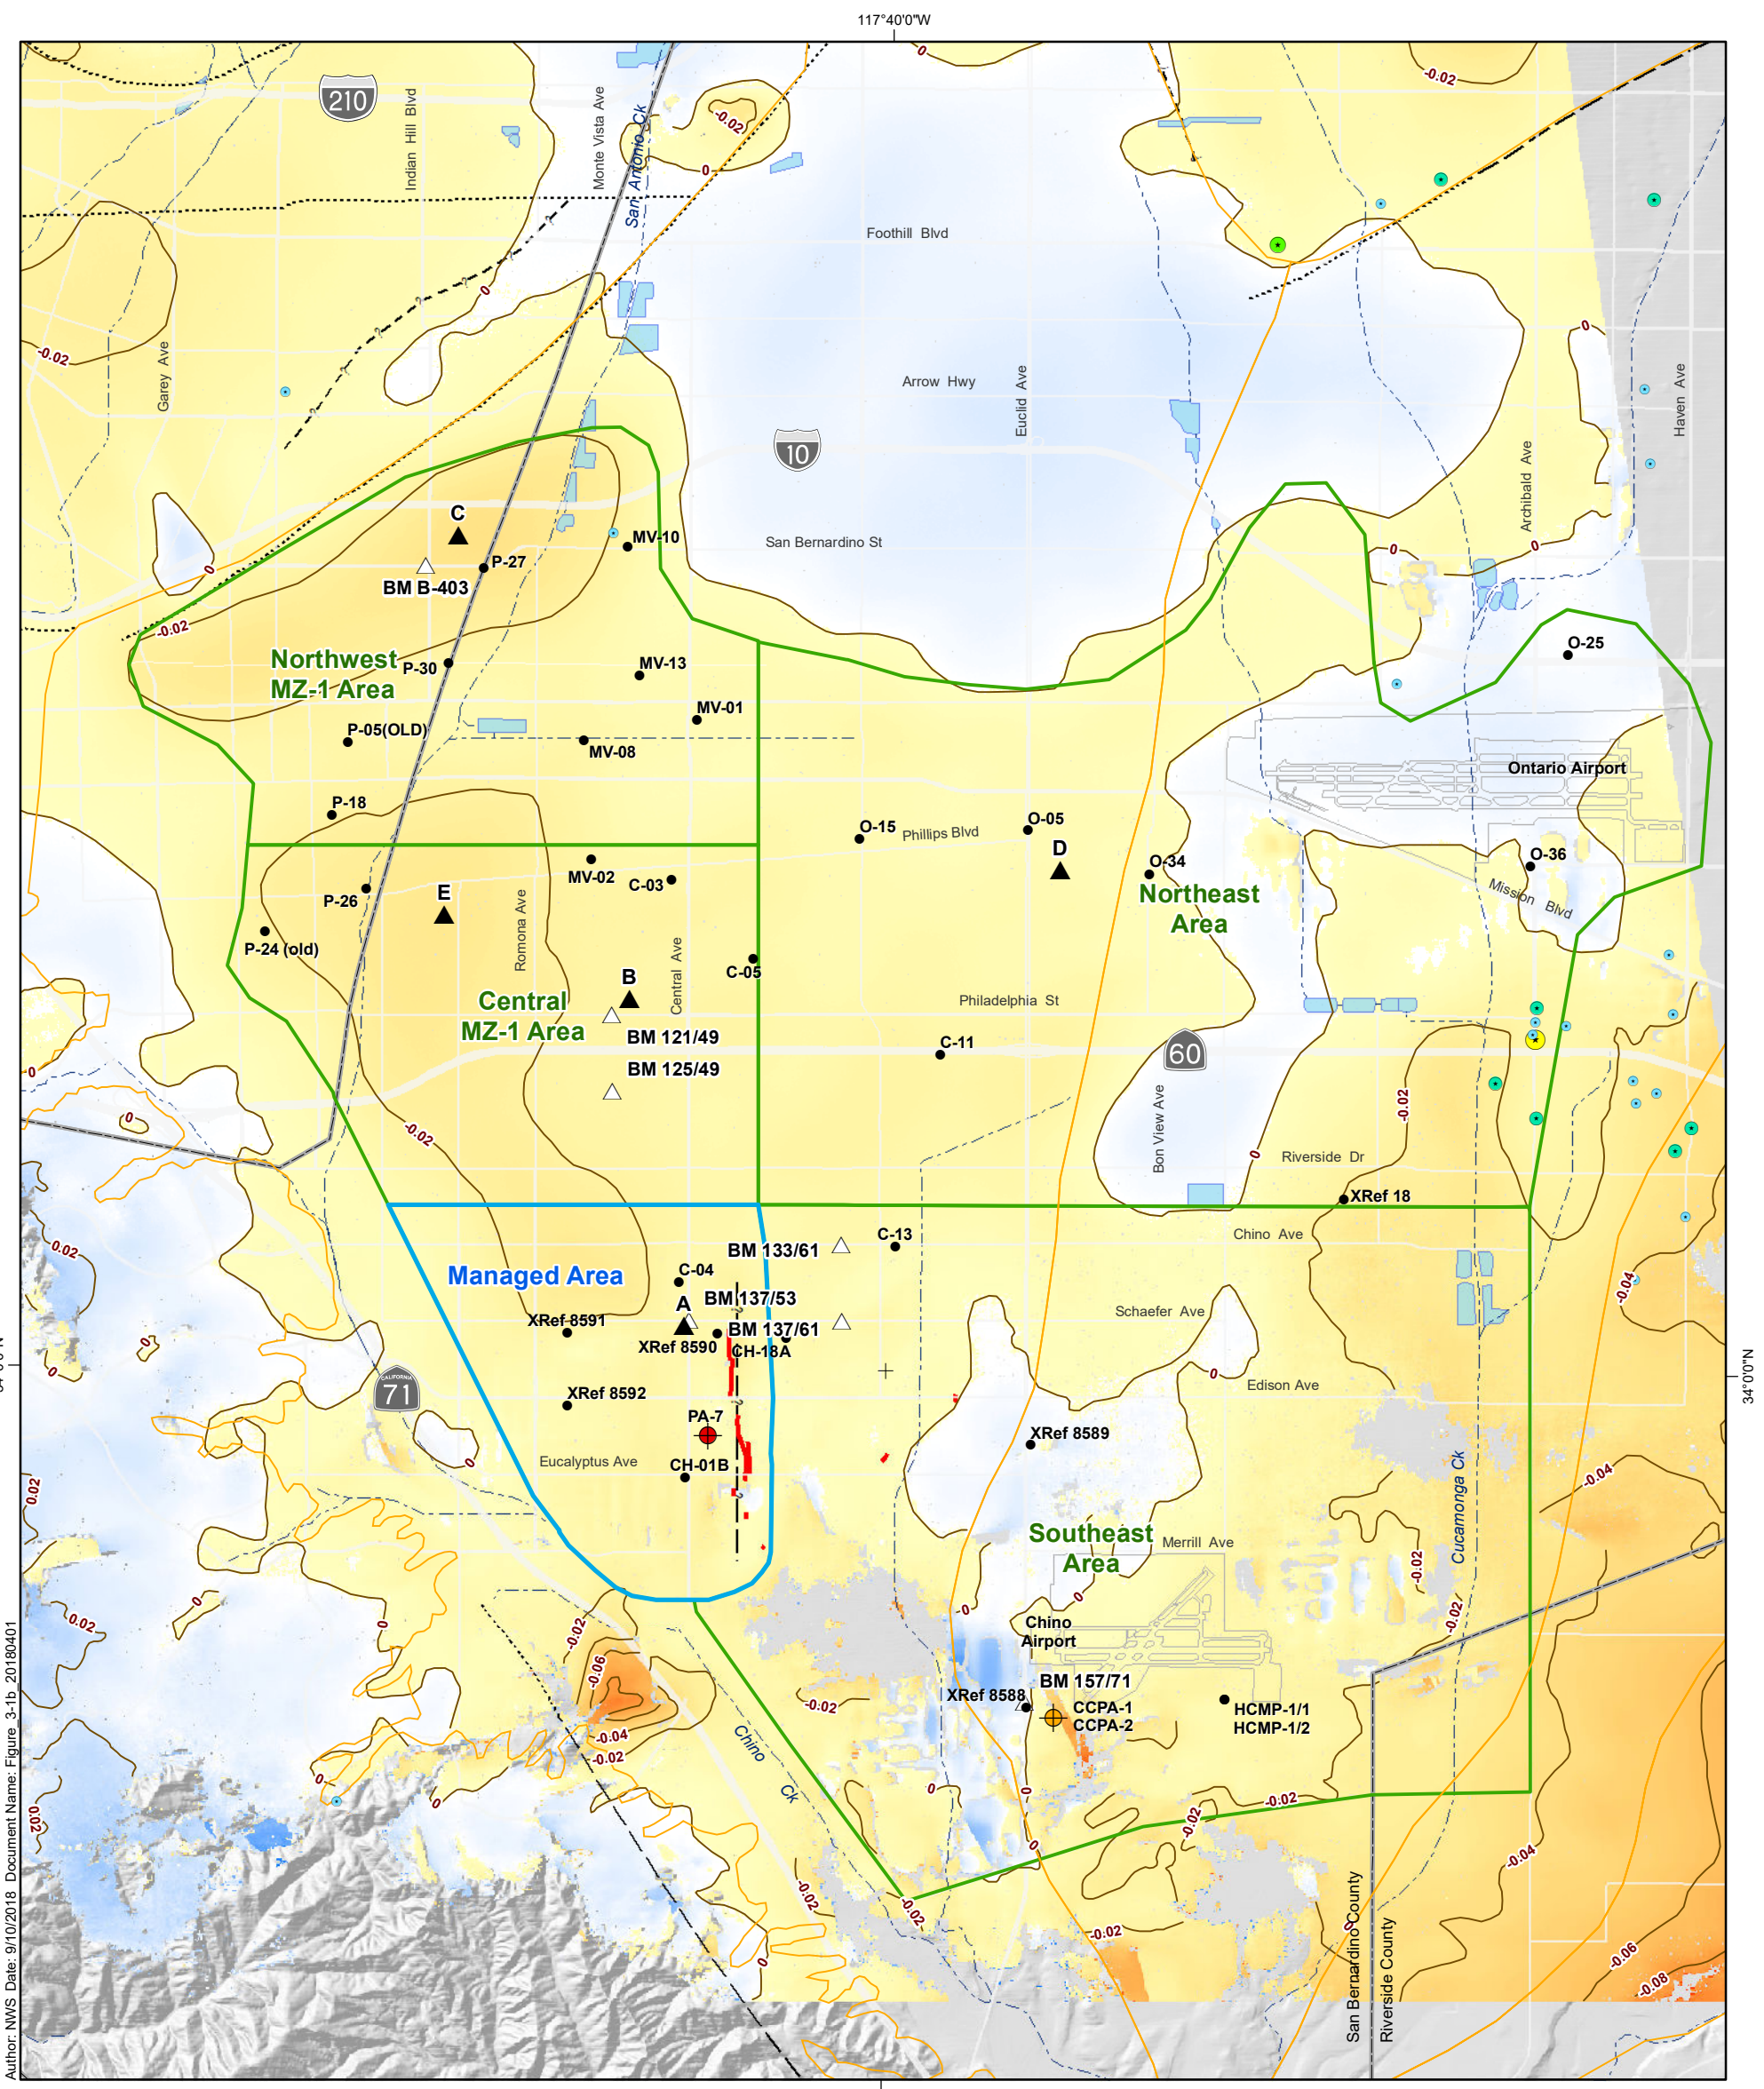
Figure 3-1b

Relative Change in Land Surface Altitude as Estimated by InSAR (March 2017 to March 2018)

Vertical Ground Motion across the Western Chino Basin 2017/18

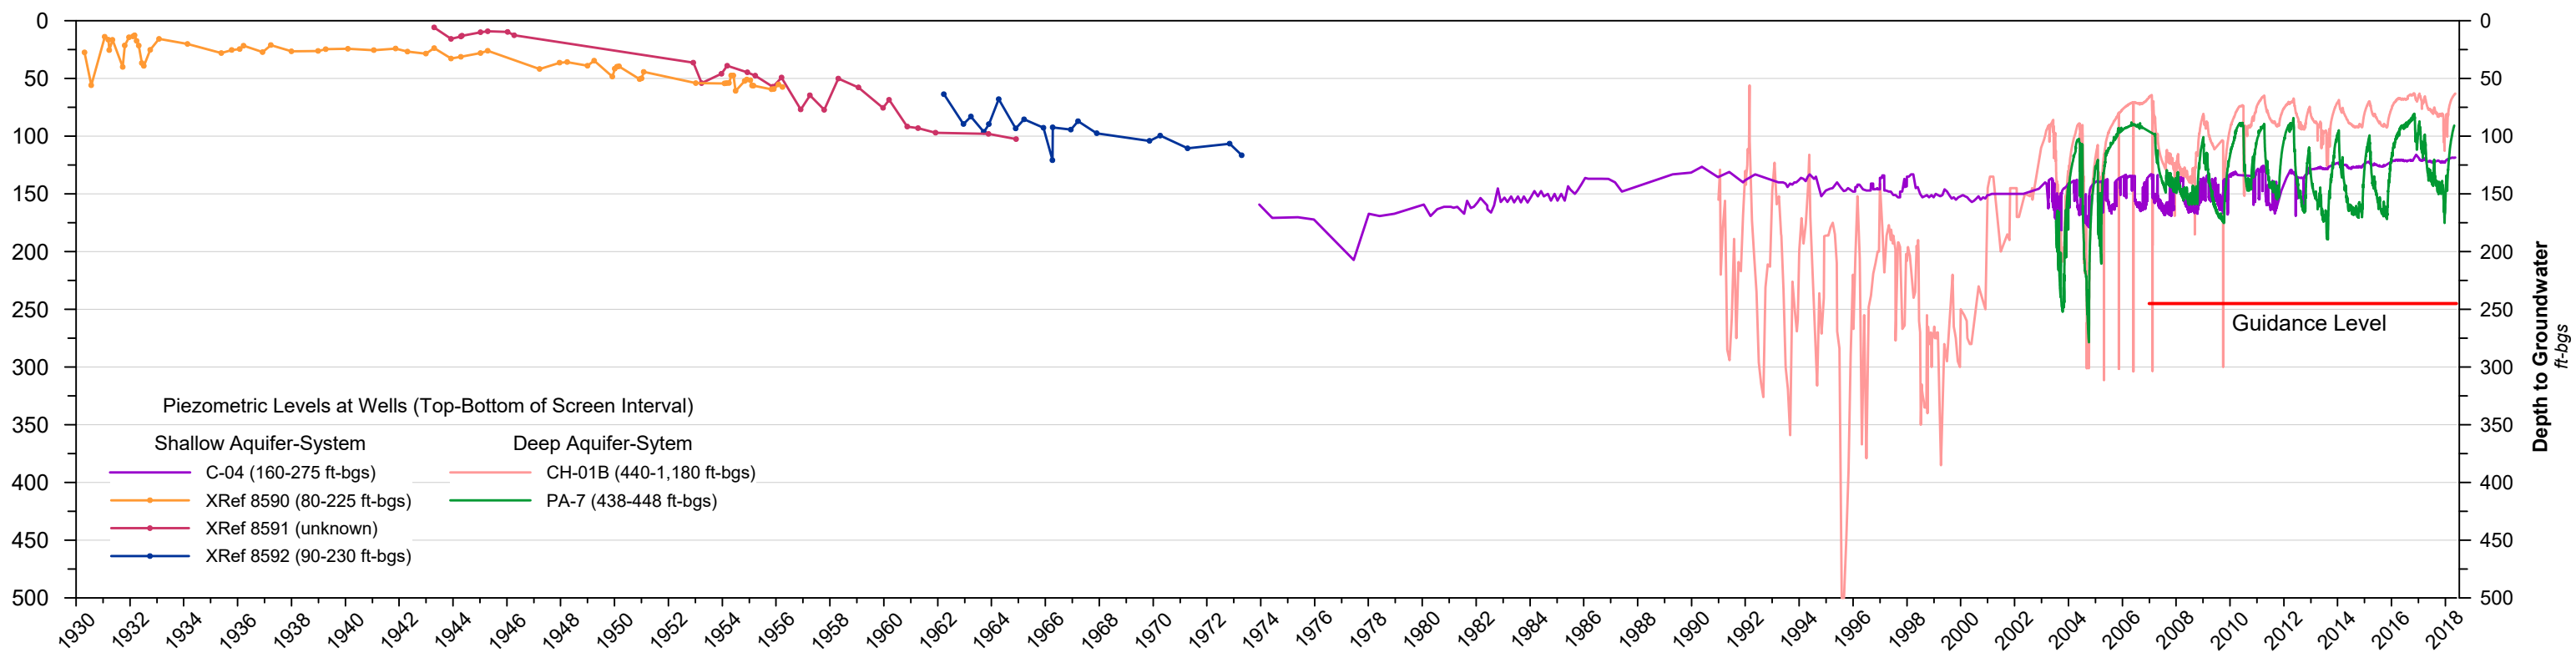
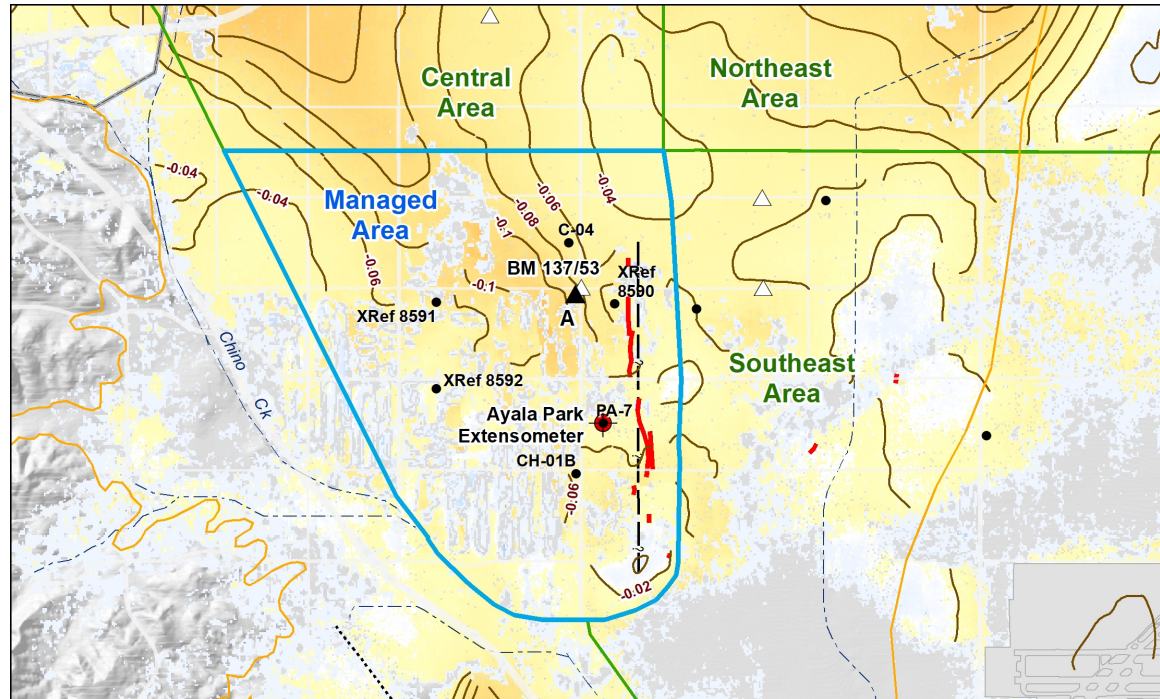
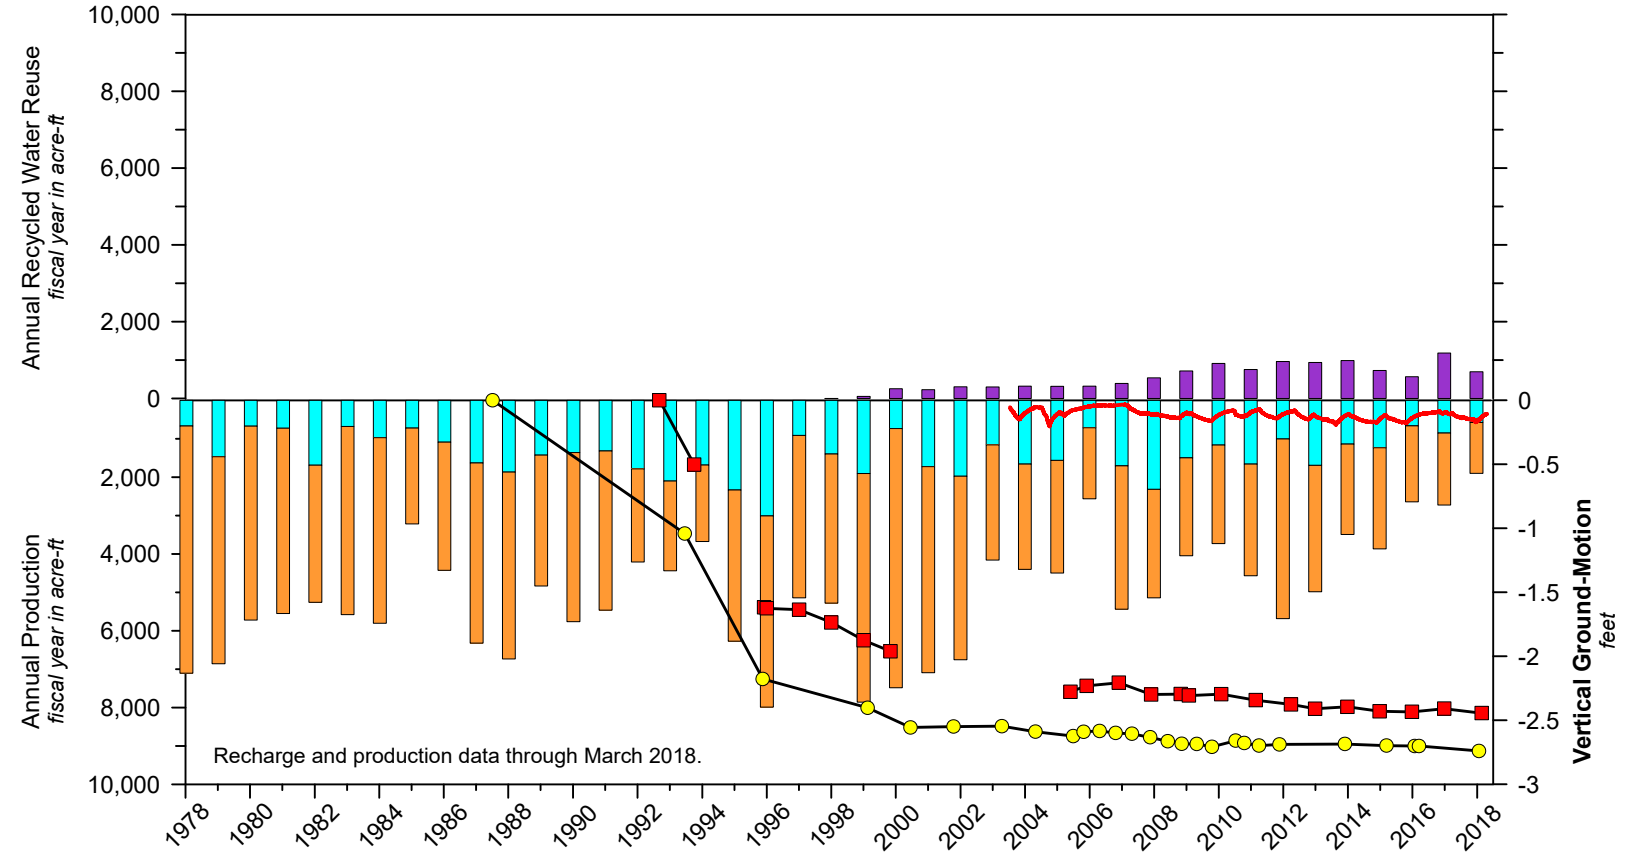
| <p>Vertical Ground-Motion (Cumulative Displacement)</p> <ul style="list-style-type: none"> ■ InSAR Point A (see inset) ● BM 137/53 — Ayala Park Deep Extensometer Measures between: 30 and 1,440 ft-bgs | <p>Recycled Water Reuse and Production</p> <ul style="list-style-type: none"> ■ Recycled Water Direct Reuse ■ Groundwater Production ■ Shallow Aquifer or Unknown Aquifer ■ Deep Aquifer or Both Aquifers |

Figure 3-2 is a chart that illustrates the long-term history of groundwater production, piezometric levels, and vertical ground motion in the Managed Area. Also shown is the volume of the direct use of recycled water in the Managed Area, which is an alternative water supply that can result in decreased groundwater production from the area. Recycled water is often used for irrigation purposes and can contribute to groundwater recharge as well. The main observations and interpretations from this chart are:

- Pumping from the shallow aquifer-system between the 1930s and about 1977 caused the water table to decline by about 150 ft. From 1978 to 1990, the water table recovered by about 50 ft.

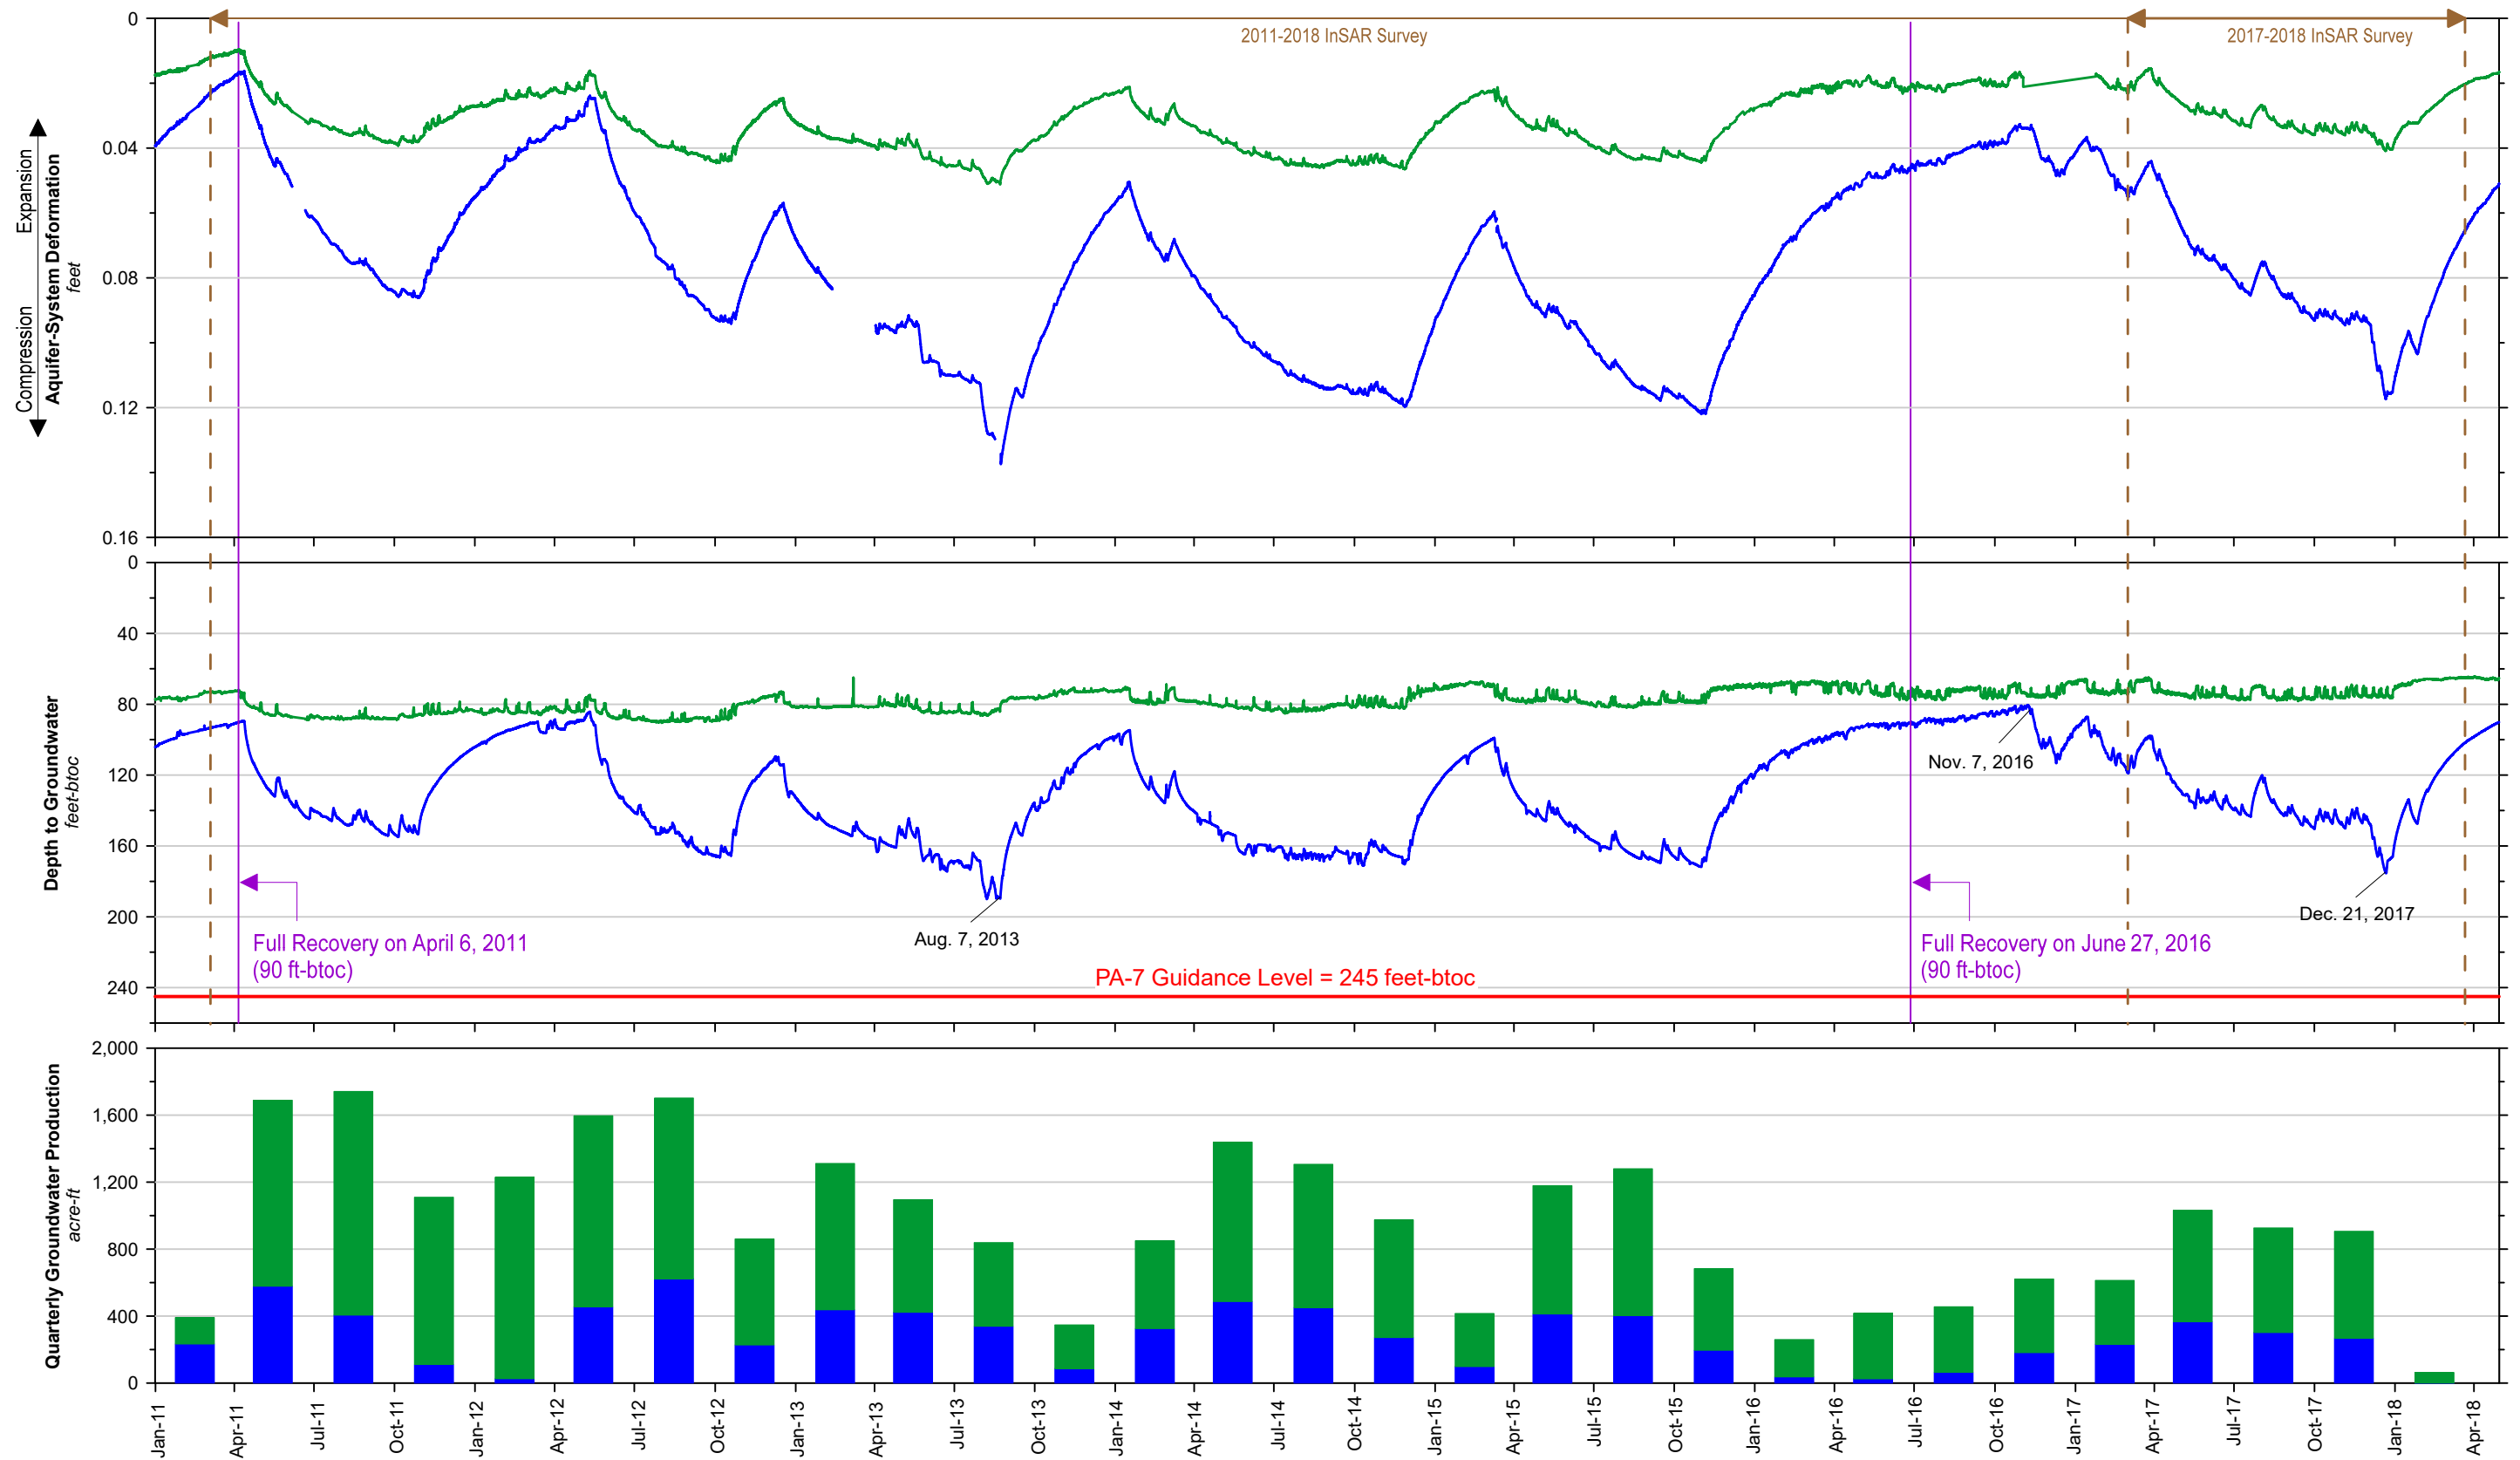
Aquifer-System Deformation at Ayala Park
(Extensometer Depth Interval)

- Shallow Extensometer (30-550 ft-bgs)
- Deep Extensometer (30-1,400 ft-bgs)

Stress and Strain within the Managed Area

Figure 3-3 is a time-series chart that displays stress and strain in the shallow and deep aquifer-systems in the Managed Area. The chart includes: quarterly groundwater production, the resultant piezometric change (stress), and aquifer-system deformation (strain) for the period January 2011 through March 2018. The chart illustrates a seasonal pattern of production in the Managed Area—increased production during the spring and summer and decreased production during the fall and winter.

Figure 3-3 displays the time-series of piezometric levels at two piezometers at Ayala Park, PA-7 (deep aquifer-system) and PA-10 (shallow aquifer-system), illustrating the deep and shallow piezometric level responses to seasonal groundwater production. These data are consistent with the conclusions of the IMP and show that pumping from the deep confined aquifer-system causes a piezometric level decline that is much greater in magnitude than the piezometric level decline caused by pumping from the shallow aquifer-system—even though more groundwater production occurs from the shallow aquifer-system. The chart shows that piezometric levels at PA-7 have fluctuated from a low of approximately 190 ft-btoc in August 2013 to a high of about 80 ft-btoc in November 2016 and have not declined below the Guidance Level of 245 ft-btoc. The recovery of piezometric levels at PA-7 to above 90 ft-btoc in 2016 represented a “full recovery” of piezometric levels at PA-7 as defined in the SMP. This is the first instance of full recovery since 2012, which complies with the recommendation in the SMP for full piezometric recovery within the deep aquifer-system at least once every five years.⁹

Figure 3-3 illustrates that the length of the period of piezometric decline in the deep aquifer-system was about 13 months, which, since 2011, is about three to seven months longer than prior periods of seasonal piezometric decline.

Figure 3-3 includes a time-series chart of vertical deformation of the aquifer-system as measured at the Ayala Park Extensometers for the period January 2011 through March 2018. These data show that the seasonal vertical compression and expansion of the aquifer-system is responding to the seasonal decline and recovery of piezometric levels and indicate that the vertical deformation of the aquifer-system was mainly elastic during this period. However, between April 6, 2011 and June 27, 2016 (dates of full recovery of piezometric levels at PA-7 to 90 ft-btoc), the Deep Extensometer recorded about 0.029 ft of compression within the aquifer-system, which indicates that this compression is permanent compaction that occurred within the depth interval of 30-1,400 ft-bgs.¹⁰

From November 2016 to March 2018, Figure 3-3 displays the compression and expansion of the aquifer-system at the Deep Extensometer in response to the decline and recovery of piezometric levels at PA-7 (described in the prior section). By the end of March 2018, the Deep Extensometer recorded about 0.02 ft of compression since November 2016. That piezometric levels at PA-7 are about 20 ft lower in March 2018 compared to November 2016 indicates that the 0.02 ft of compression is mostly elastic deformation of the aquifer-system.

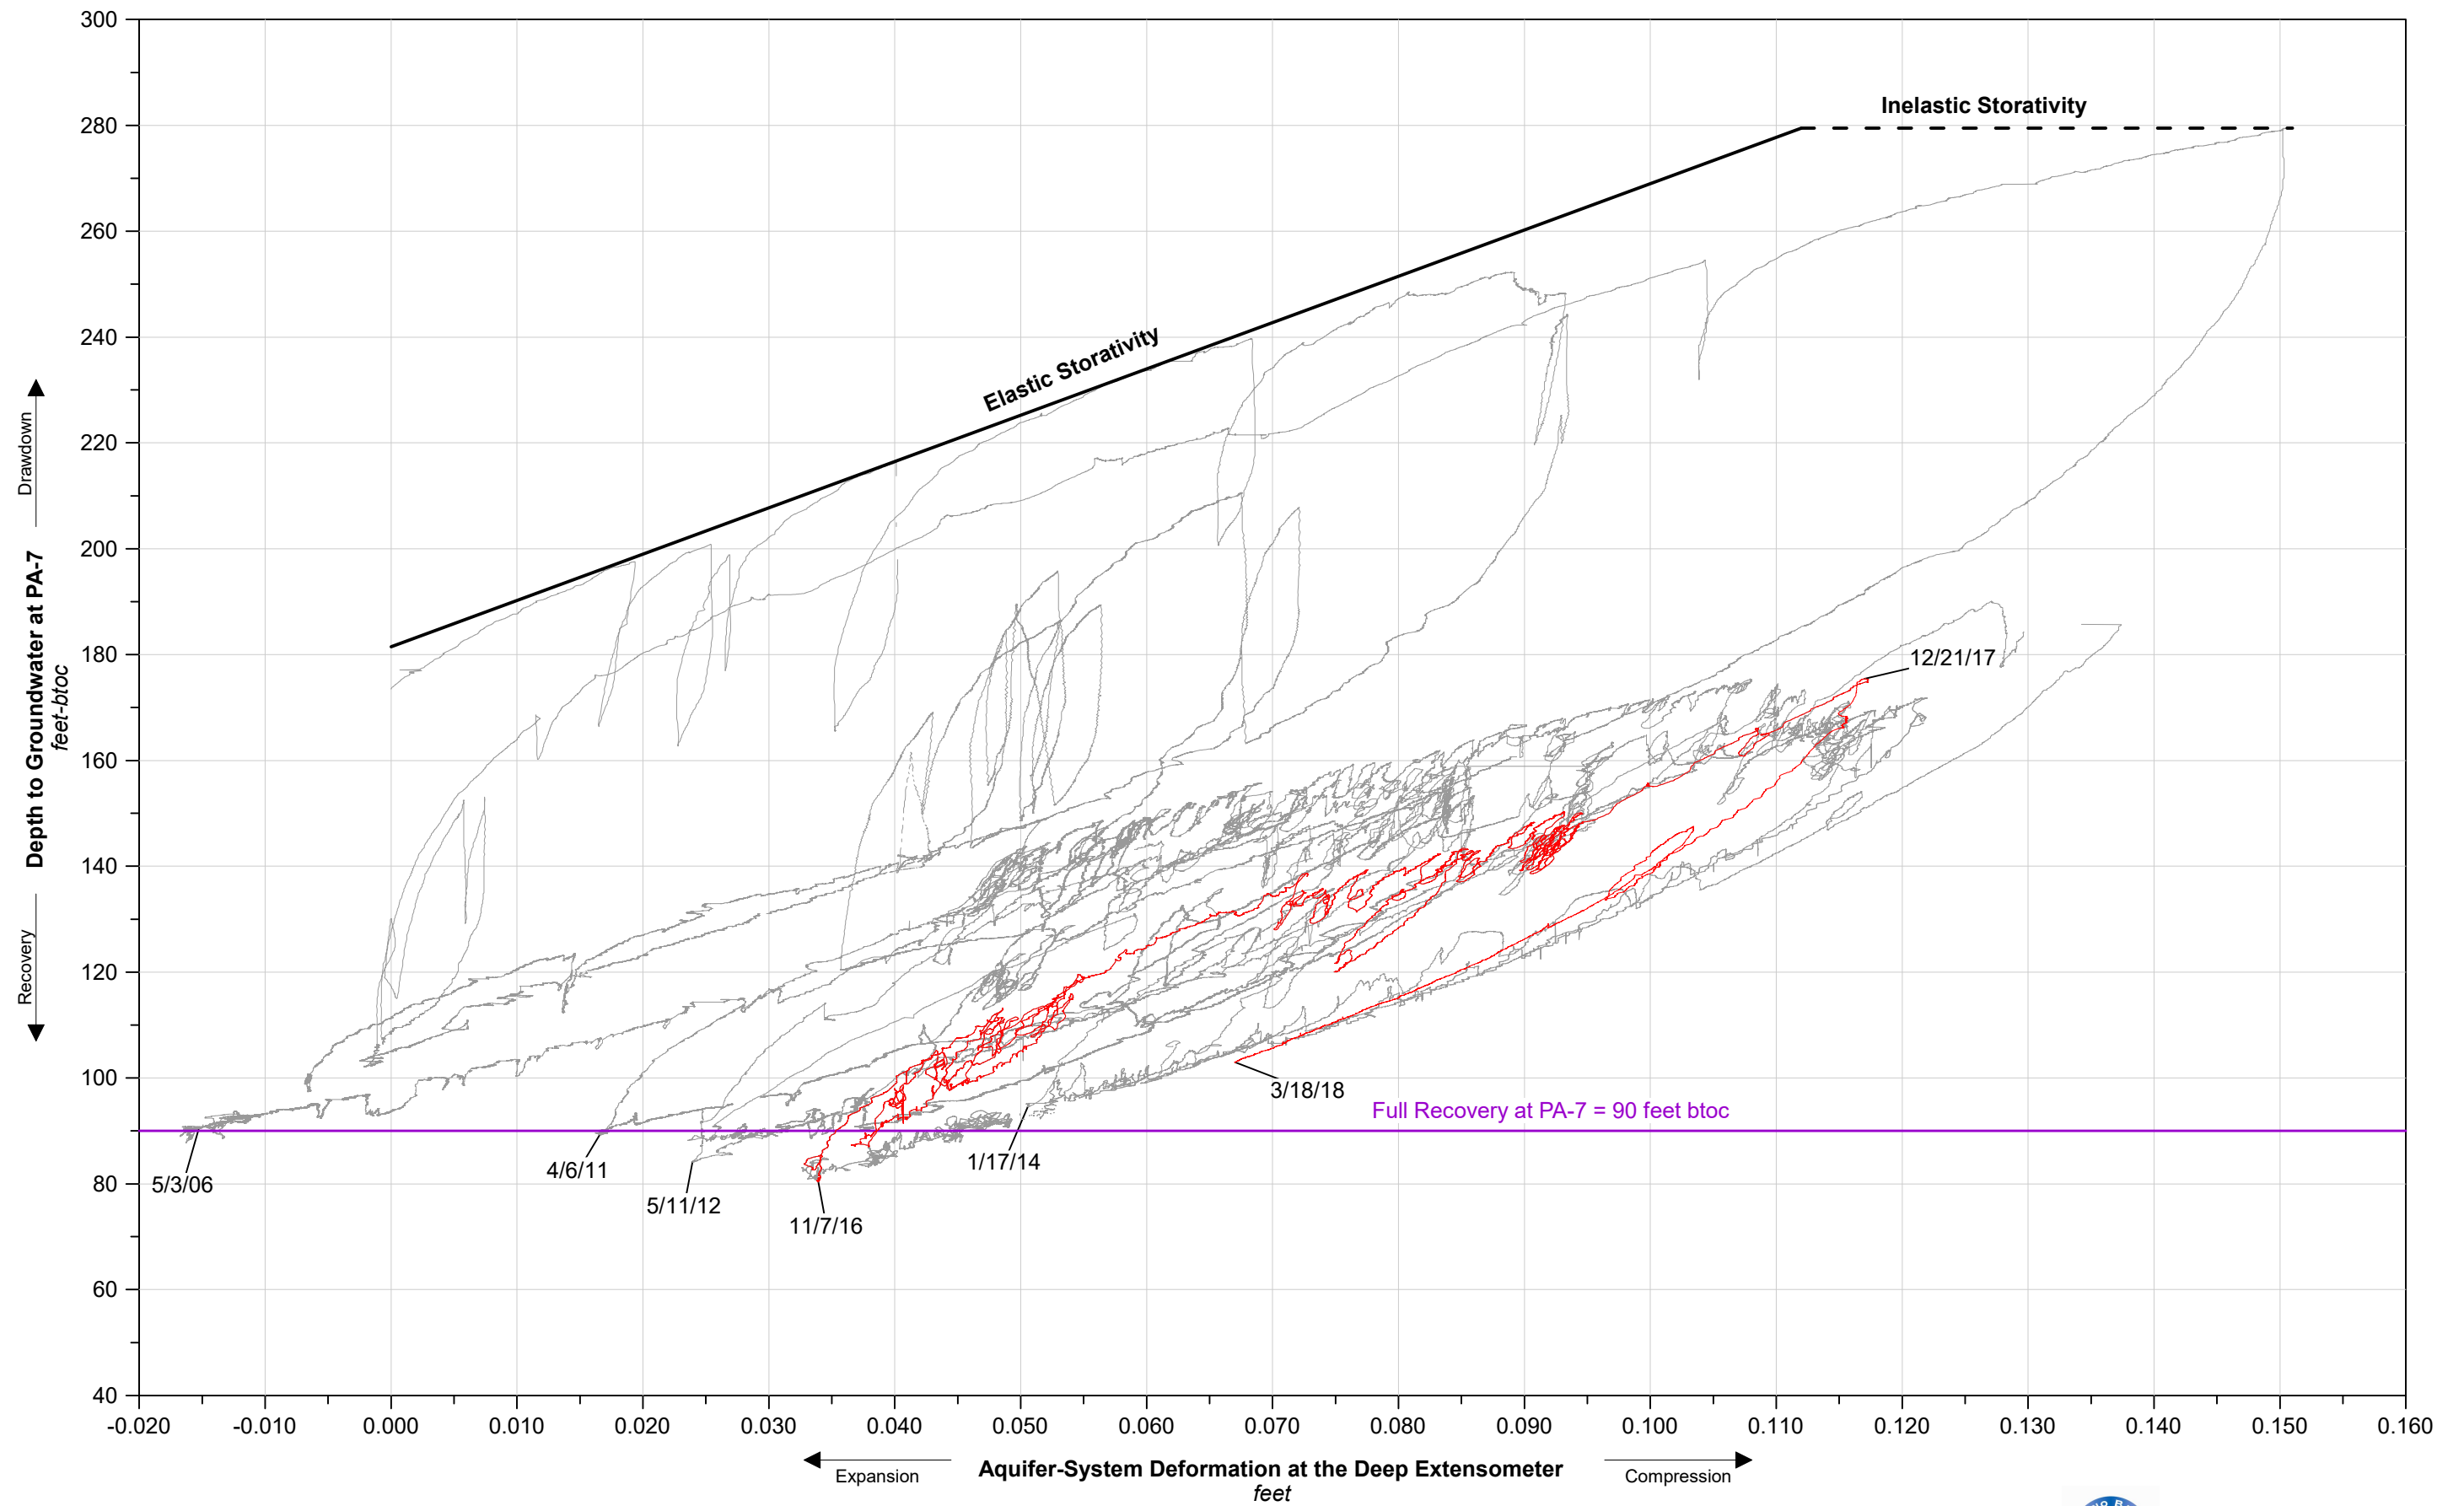
Stress - Strain Hysteresis Loops of Drawdown and Recovery Cycles

- Drawdown and Recovery Between July 2003 and November 2016
- Drawdown and Recovery Between November 2016 and March 2018

Stress-Strain Diagram
 Ayala Park Extensometer

Figure 3-4 is a stress-strain diagram of piezometric levels measured at PA-7 (stress) versus vertical deformation of the aquifer-system sediments as measured at the Deep Extensometer (strain). This diagram provides additional information on the nature of the aquifer-system deformation that occurred during the November 2016 to March 2018 period (i.e. elastic versus inelastic deformation). The hysteresis loops on this figure represent piezometric level decline-recovery cycles and the resultant compression-expansion of the aquifer-system sediments. The diagram can be interpreted to understand the timing and magnitude of the occurrence of compaction within the depth interval of the aquifer-system that is penetrated by the Deep Extensometer. Piezometric level decline is shown as increasing from bottom to top on the y-axis, and aquifer-system compression is shown as increasing from left to right on the x-axis. From April 2011 to January 2014, the hysteresis loops progressively shift to the right on this chart, indicating that about 0.029 ft of inelastic compaction occurred during this time-period. Beginning in 2014 through March 2018, the hysteresis loops start to overlap one another, indicating that the seasonal vertical deformation observed in the deep aquifer-system sediments have deformed almost entirely elastically. Figure 3-4 shows the most recent decline-recovery cycle from the November 2016 to March 2018 in red. By the end of the record in March 2018, the hysteresis loop shows a slight shift to the right compared to the prior hysteresis loop of about 0.004 ft of compression. There are two potential interpretations of this shift:

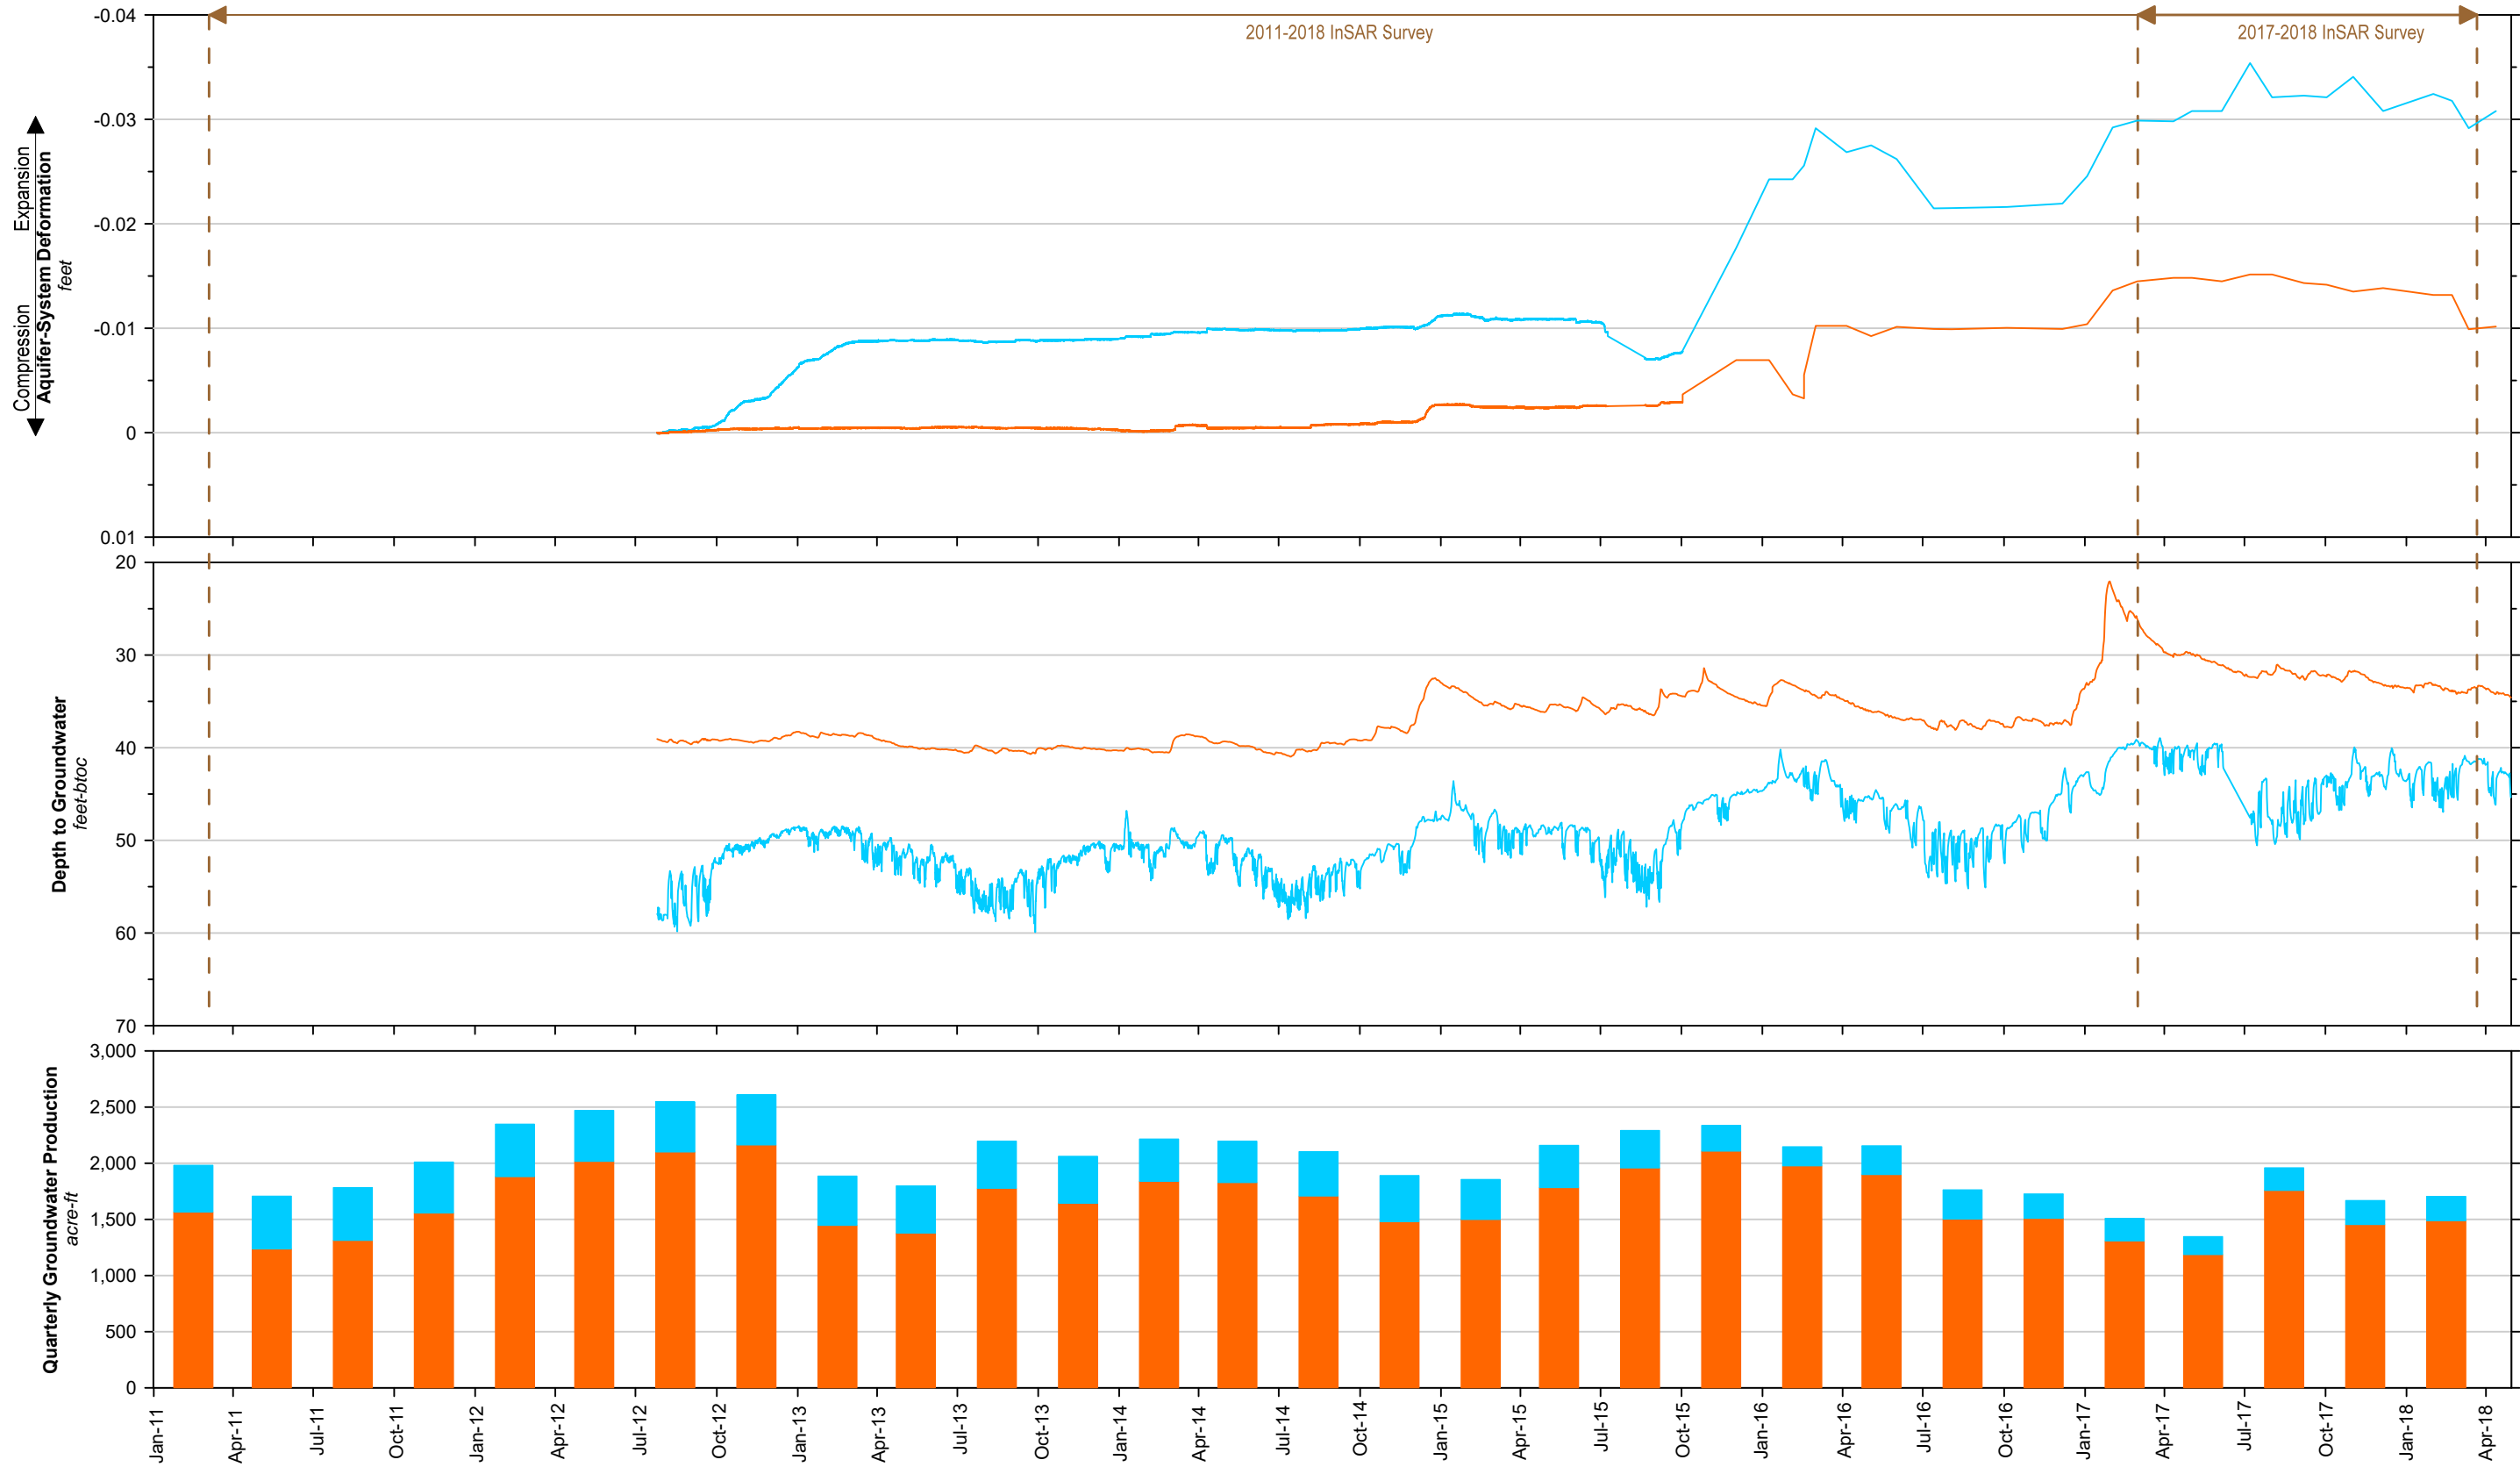
Aquifer-System Deformation
(Extensometer Depth Interval)

- Shallow Extensometer
CCX-1 (50-140 ft-bgs)
- Deep Extensometer
CCX-2 (50-610 ft-bgs)

**Stress and Strain
within the Southeast Area**

Figure 3-8 displays the time series of piezometric levels and vertical aquifer-system deformation recorded at the CCX, which began collecting data in July 2012. Groundwater production began at the Chino Creek Well Field in 2014, but appears to have had little, if any, effect on piezometric levels or aquifer-system deformation at the CCX through March 2018. In general, piezometric

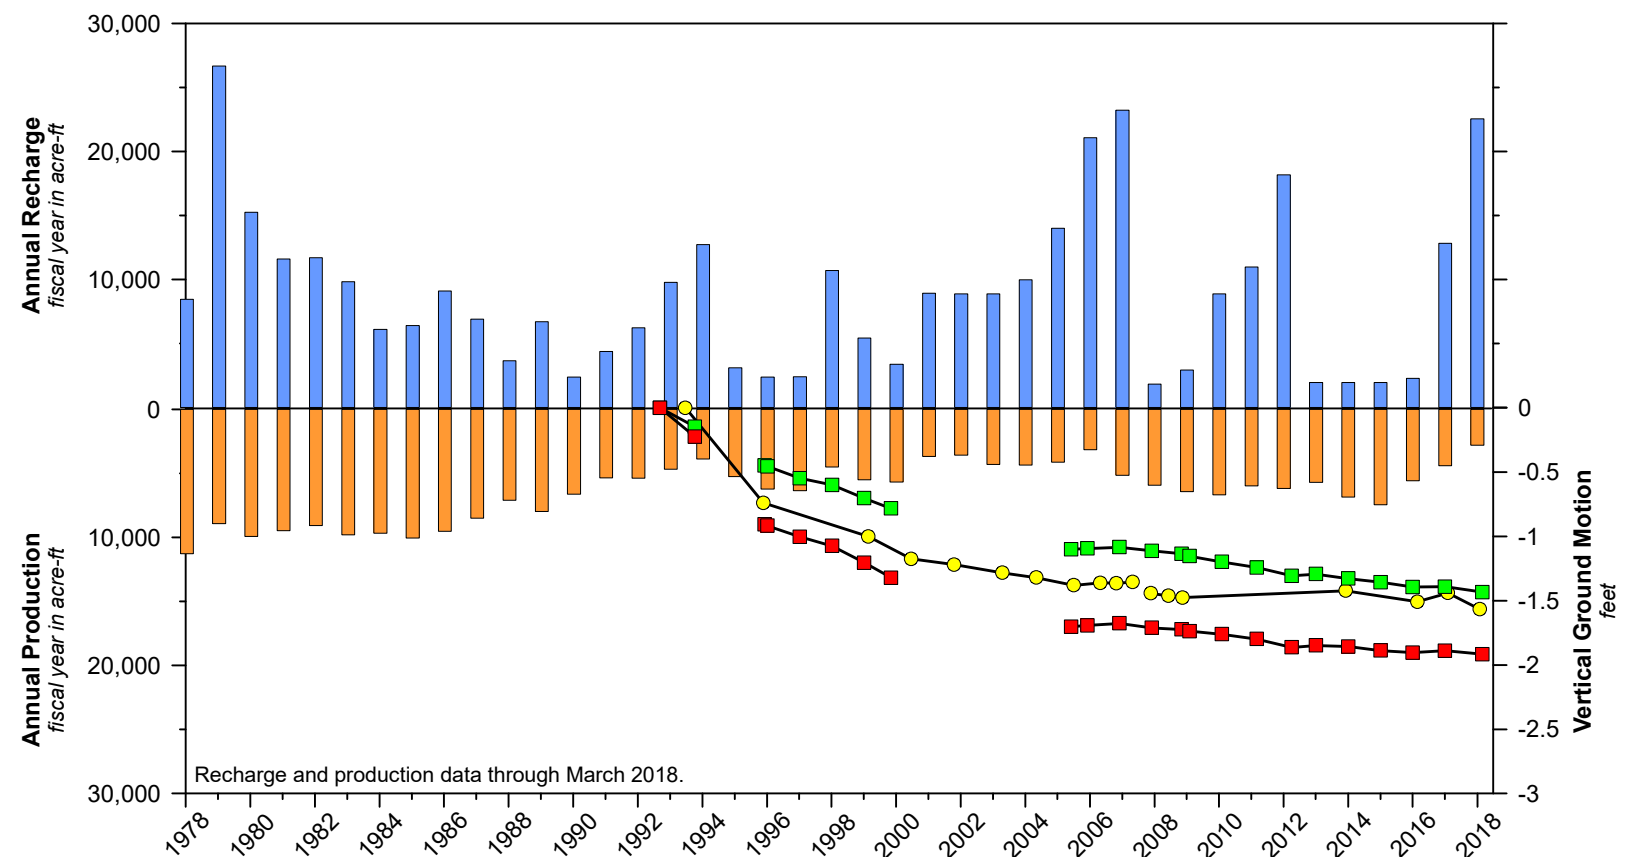
Vertical Ground Motion (Cumulative Displacement)

- InSAR Point B (see inset)
- InSAR Point E (see inset)
- BM 125/49

The History of Land Subsidence in the Central MZ-1 Area
