**Chino Basin
Optimum Basin Management Program**

Management Zone 1
Subsidence Management Plan

October 2007

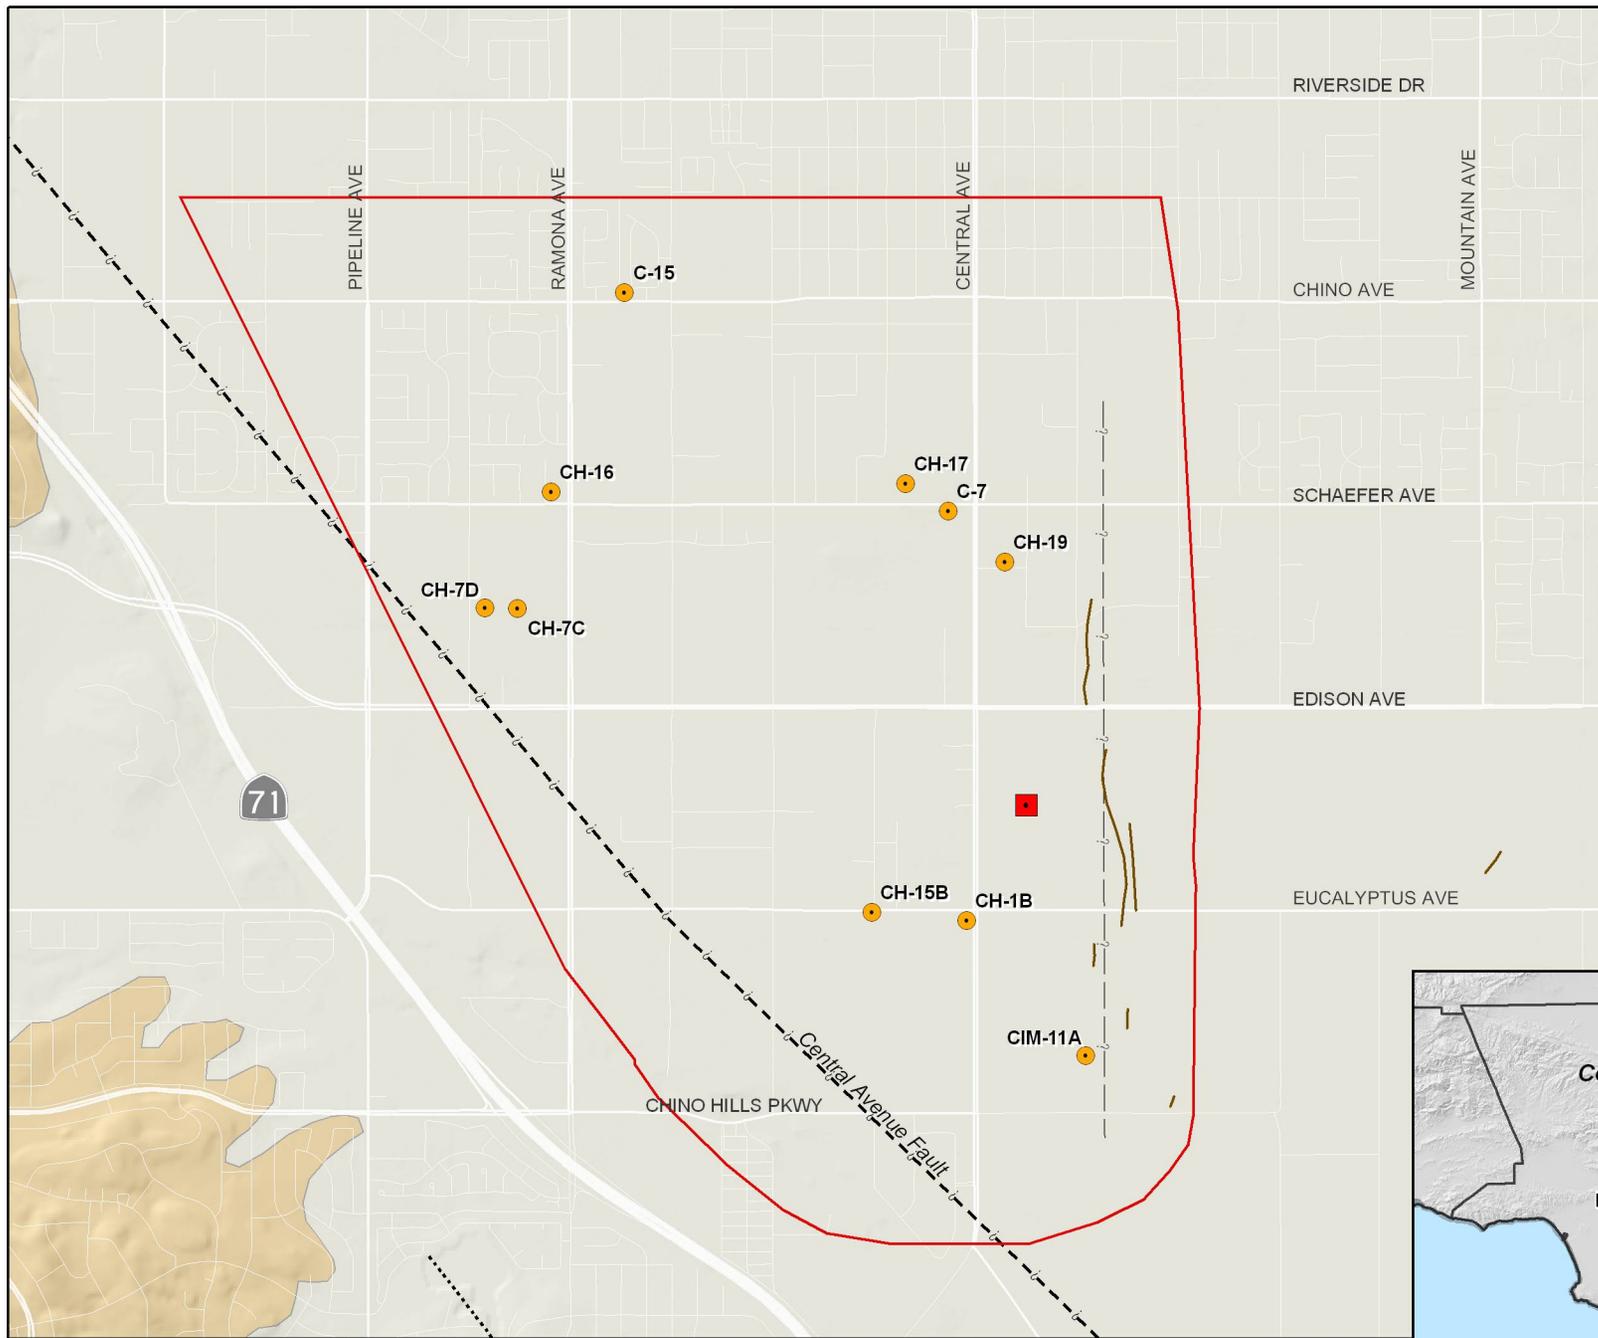
MZ-1 Managed Area and Managed Wells

Table 2-1 lists the existing wells (hereafter the Managed Wells) and their owners (hereafter the Parties) that are currently subject to the MZ-1 Plan. The Parties are the City of Chino, the City of Chino Hills, and the State of California. Figure 2-1 shows the Area of Subsidence Management (hereafter, the Managed Area). Within the boundaries of the Managed Area, other existing wells and/or newly-constructed wells are subject to being classified as Managed Wells.

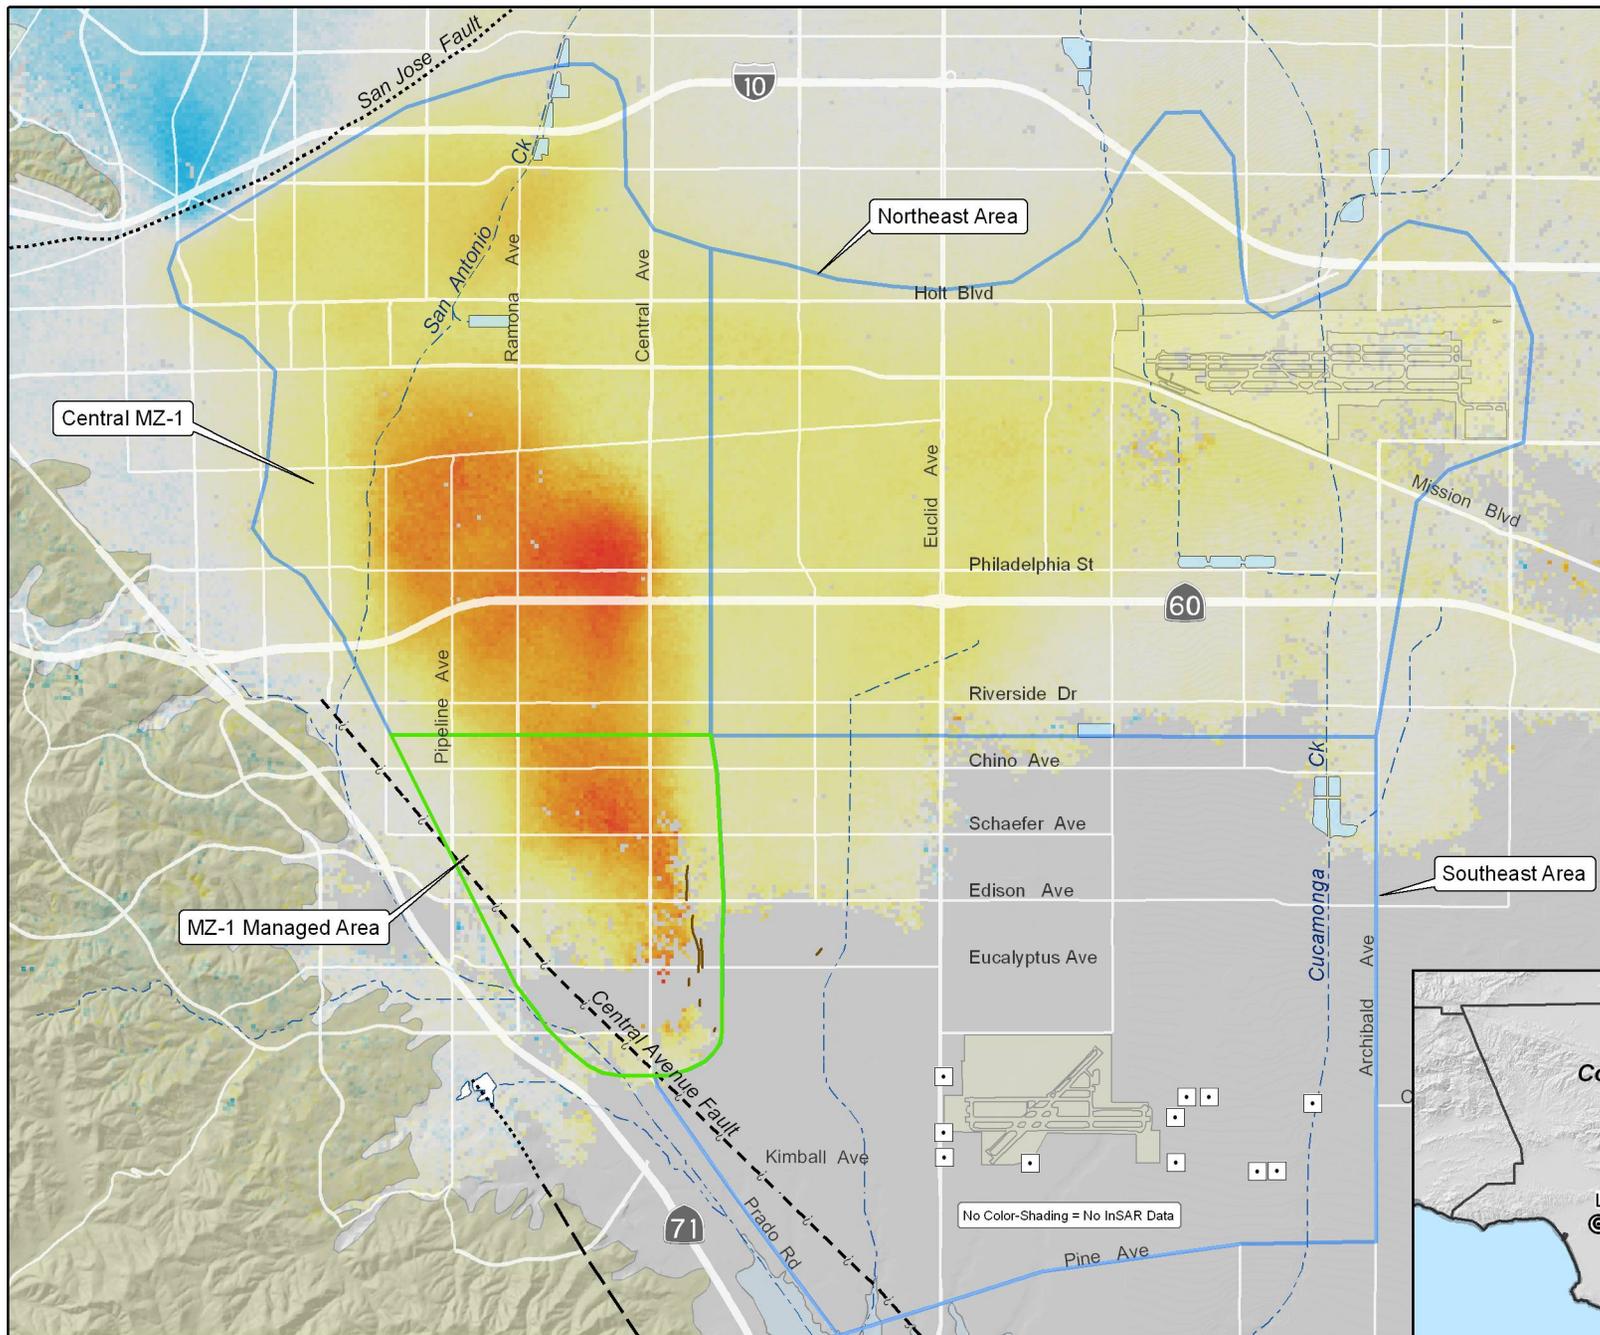
- Area of Subsidence Management
- Areas of Subsidence Concern

Results of InSAR Analysis

Subsidence Management Areas

For these reasons, Watermaster conducts limited monitoring of the aquifer system and land subsidence outside of the Managed Area (hereafter, Areas of Subsidence Concern). Figure 2-2 shows the three Areas of Subsidence Concern: Central MZ-1, Southeast Area, and Northeast Area.
