CHINO BASIN WATERMASTER
 2014 State of the Basin
 Ground-Level Monitoring

Historical Land Surface Deformation in Management Zone 1
 Leveling Surveys (1987 to 1999)
 and InSAR (1993 to 1995)

Vertical Ground Motion as Measured by InSAR

The History of Land Subsidence in the MZ1 Managed Area

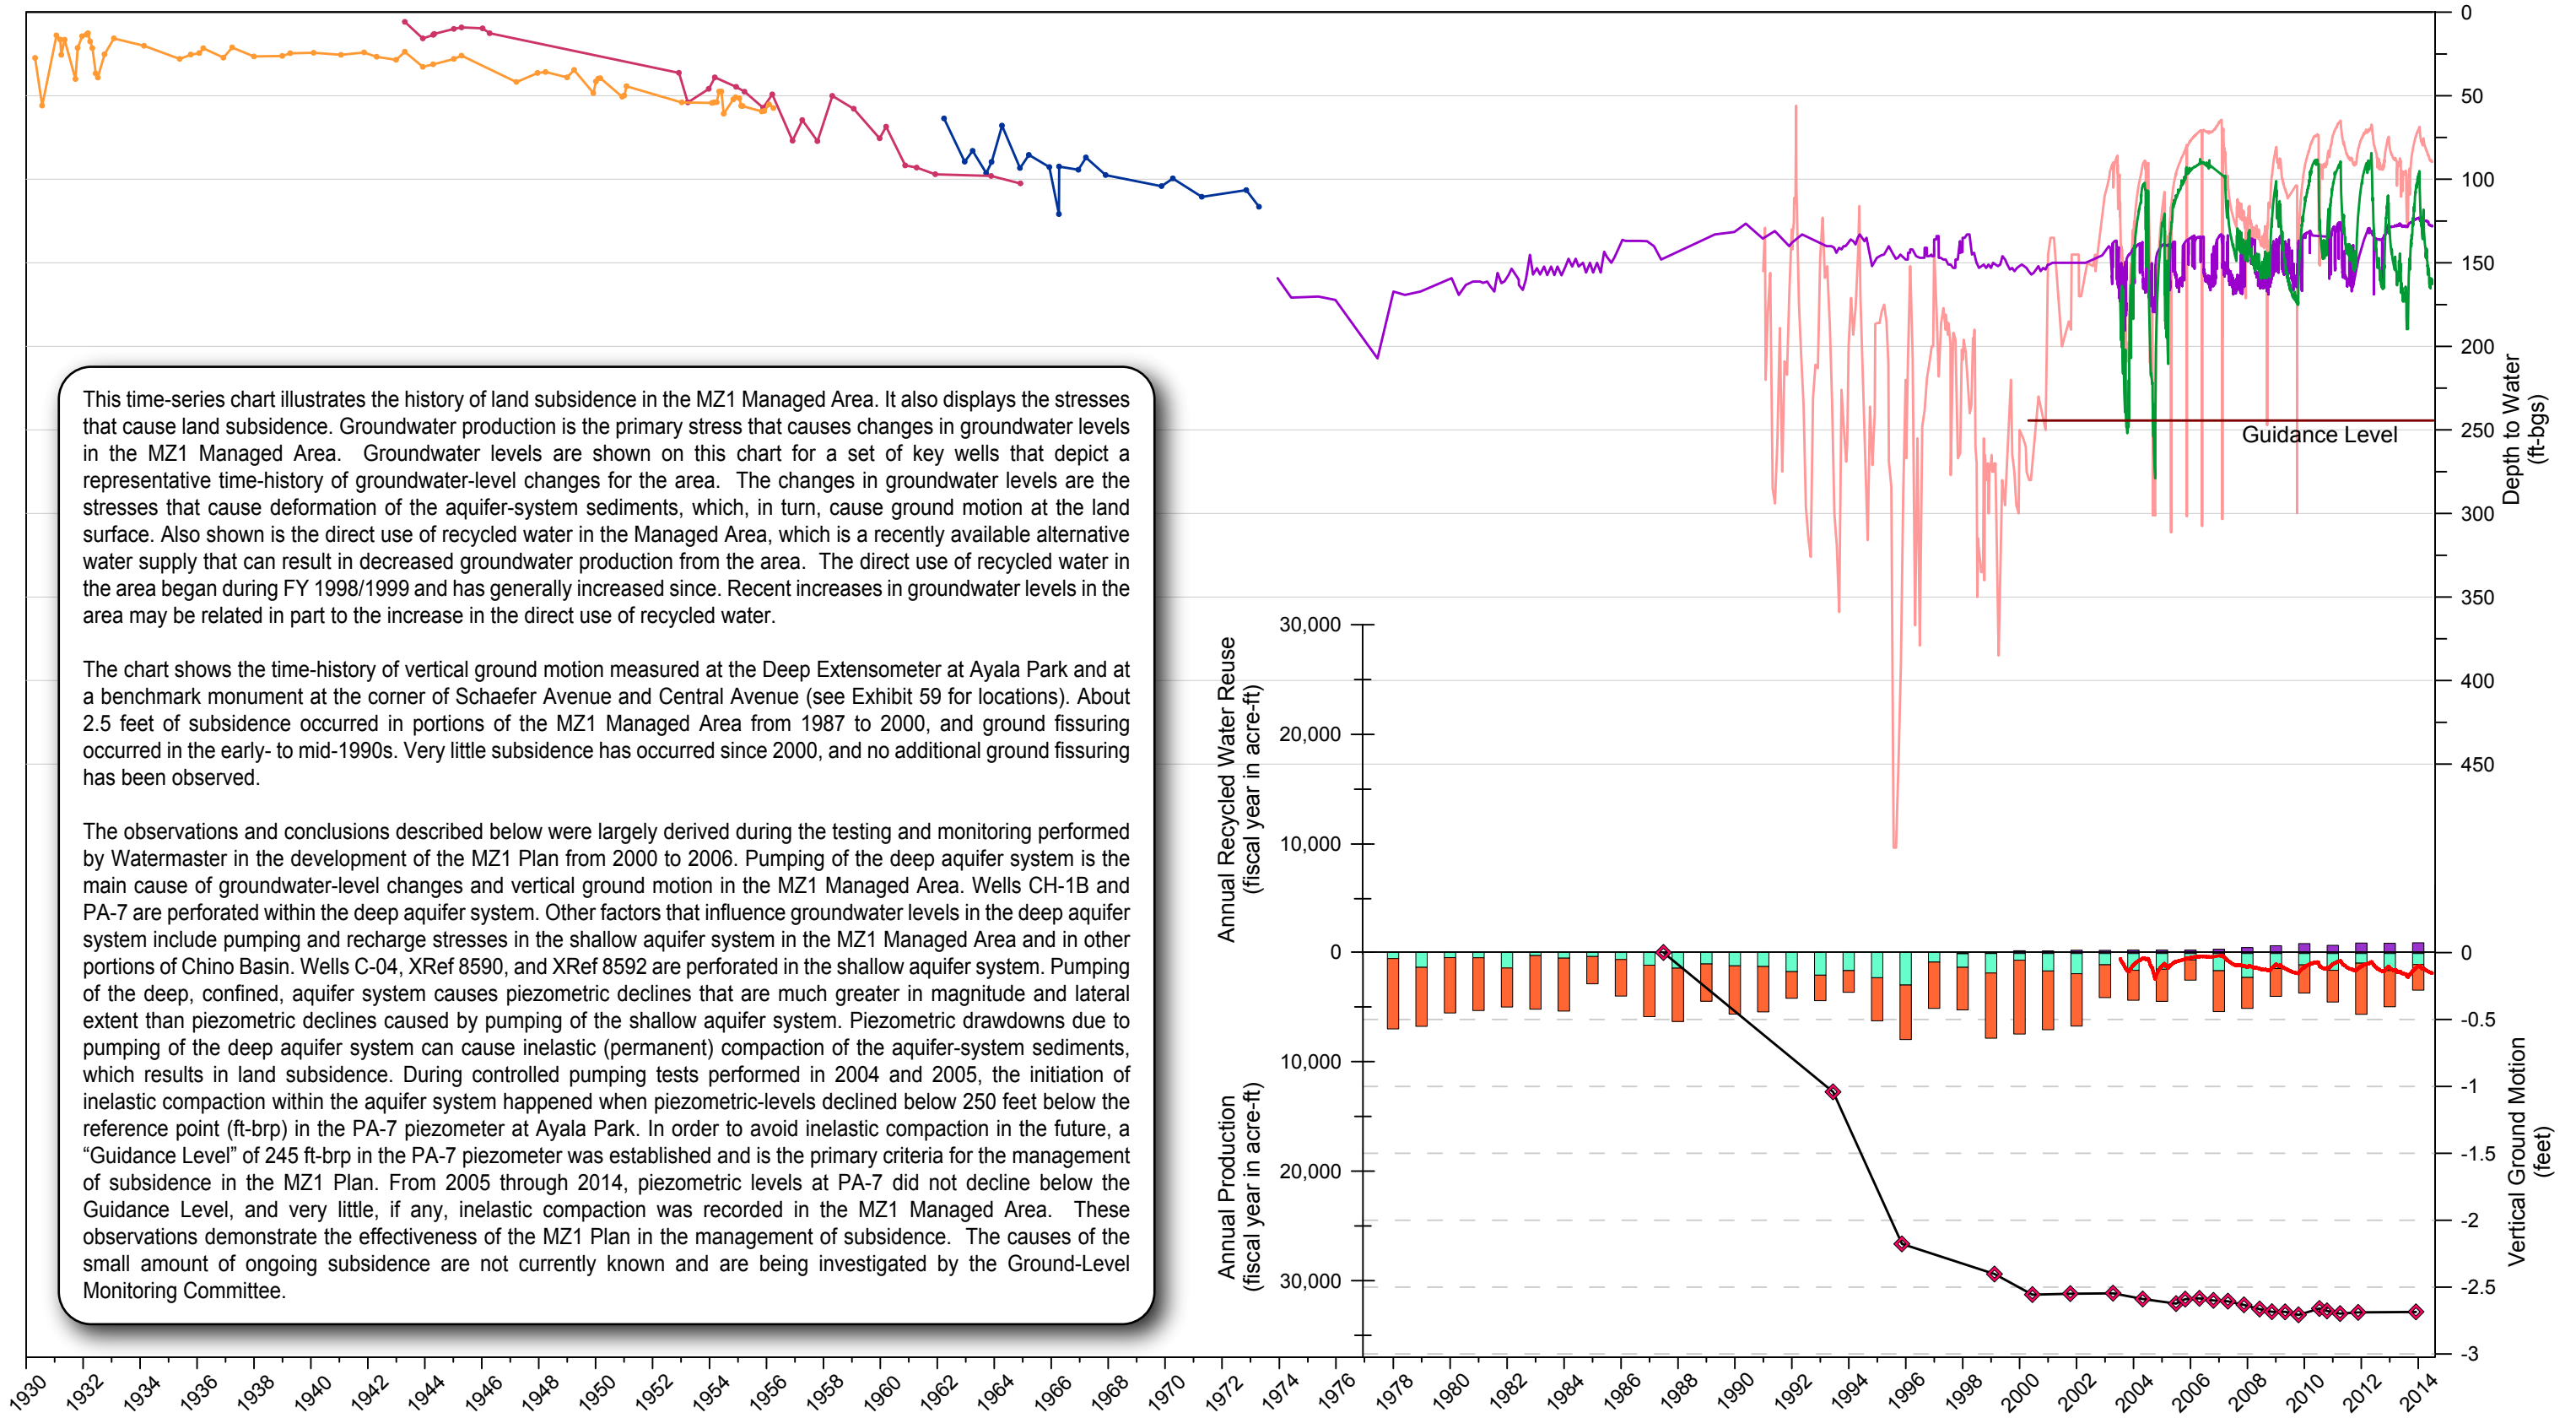
Groundwater Levels at Wells (Top-Bottom Screen Interval)

Vertical Ground Motion

Recharge and Production

The land subsidence that has occurred in the Chino Basin was mainly controlled by changes in groundwater levels, which, in turn, were mainly controlled by pumping and recharge. Exhibits 60 through 64 show the relationships between groundwater pumping, recharge, recycled water reuse, groundwater levels, and vertical ground motion in the MZ1 Managed Area and the other Areas of Subsidence Concern. These graphics reveal cause-and-effect relationships, the current state of vertical ground motion, and the nature of the land subsidence.

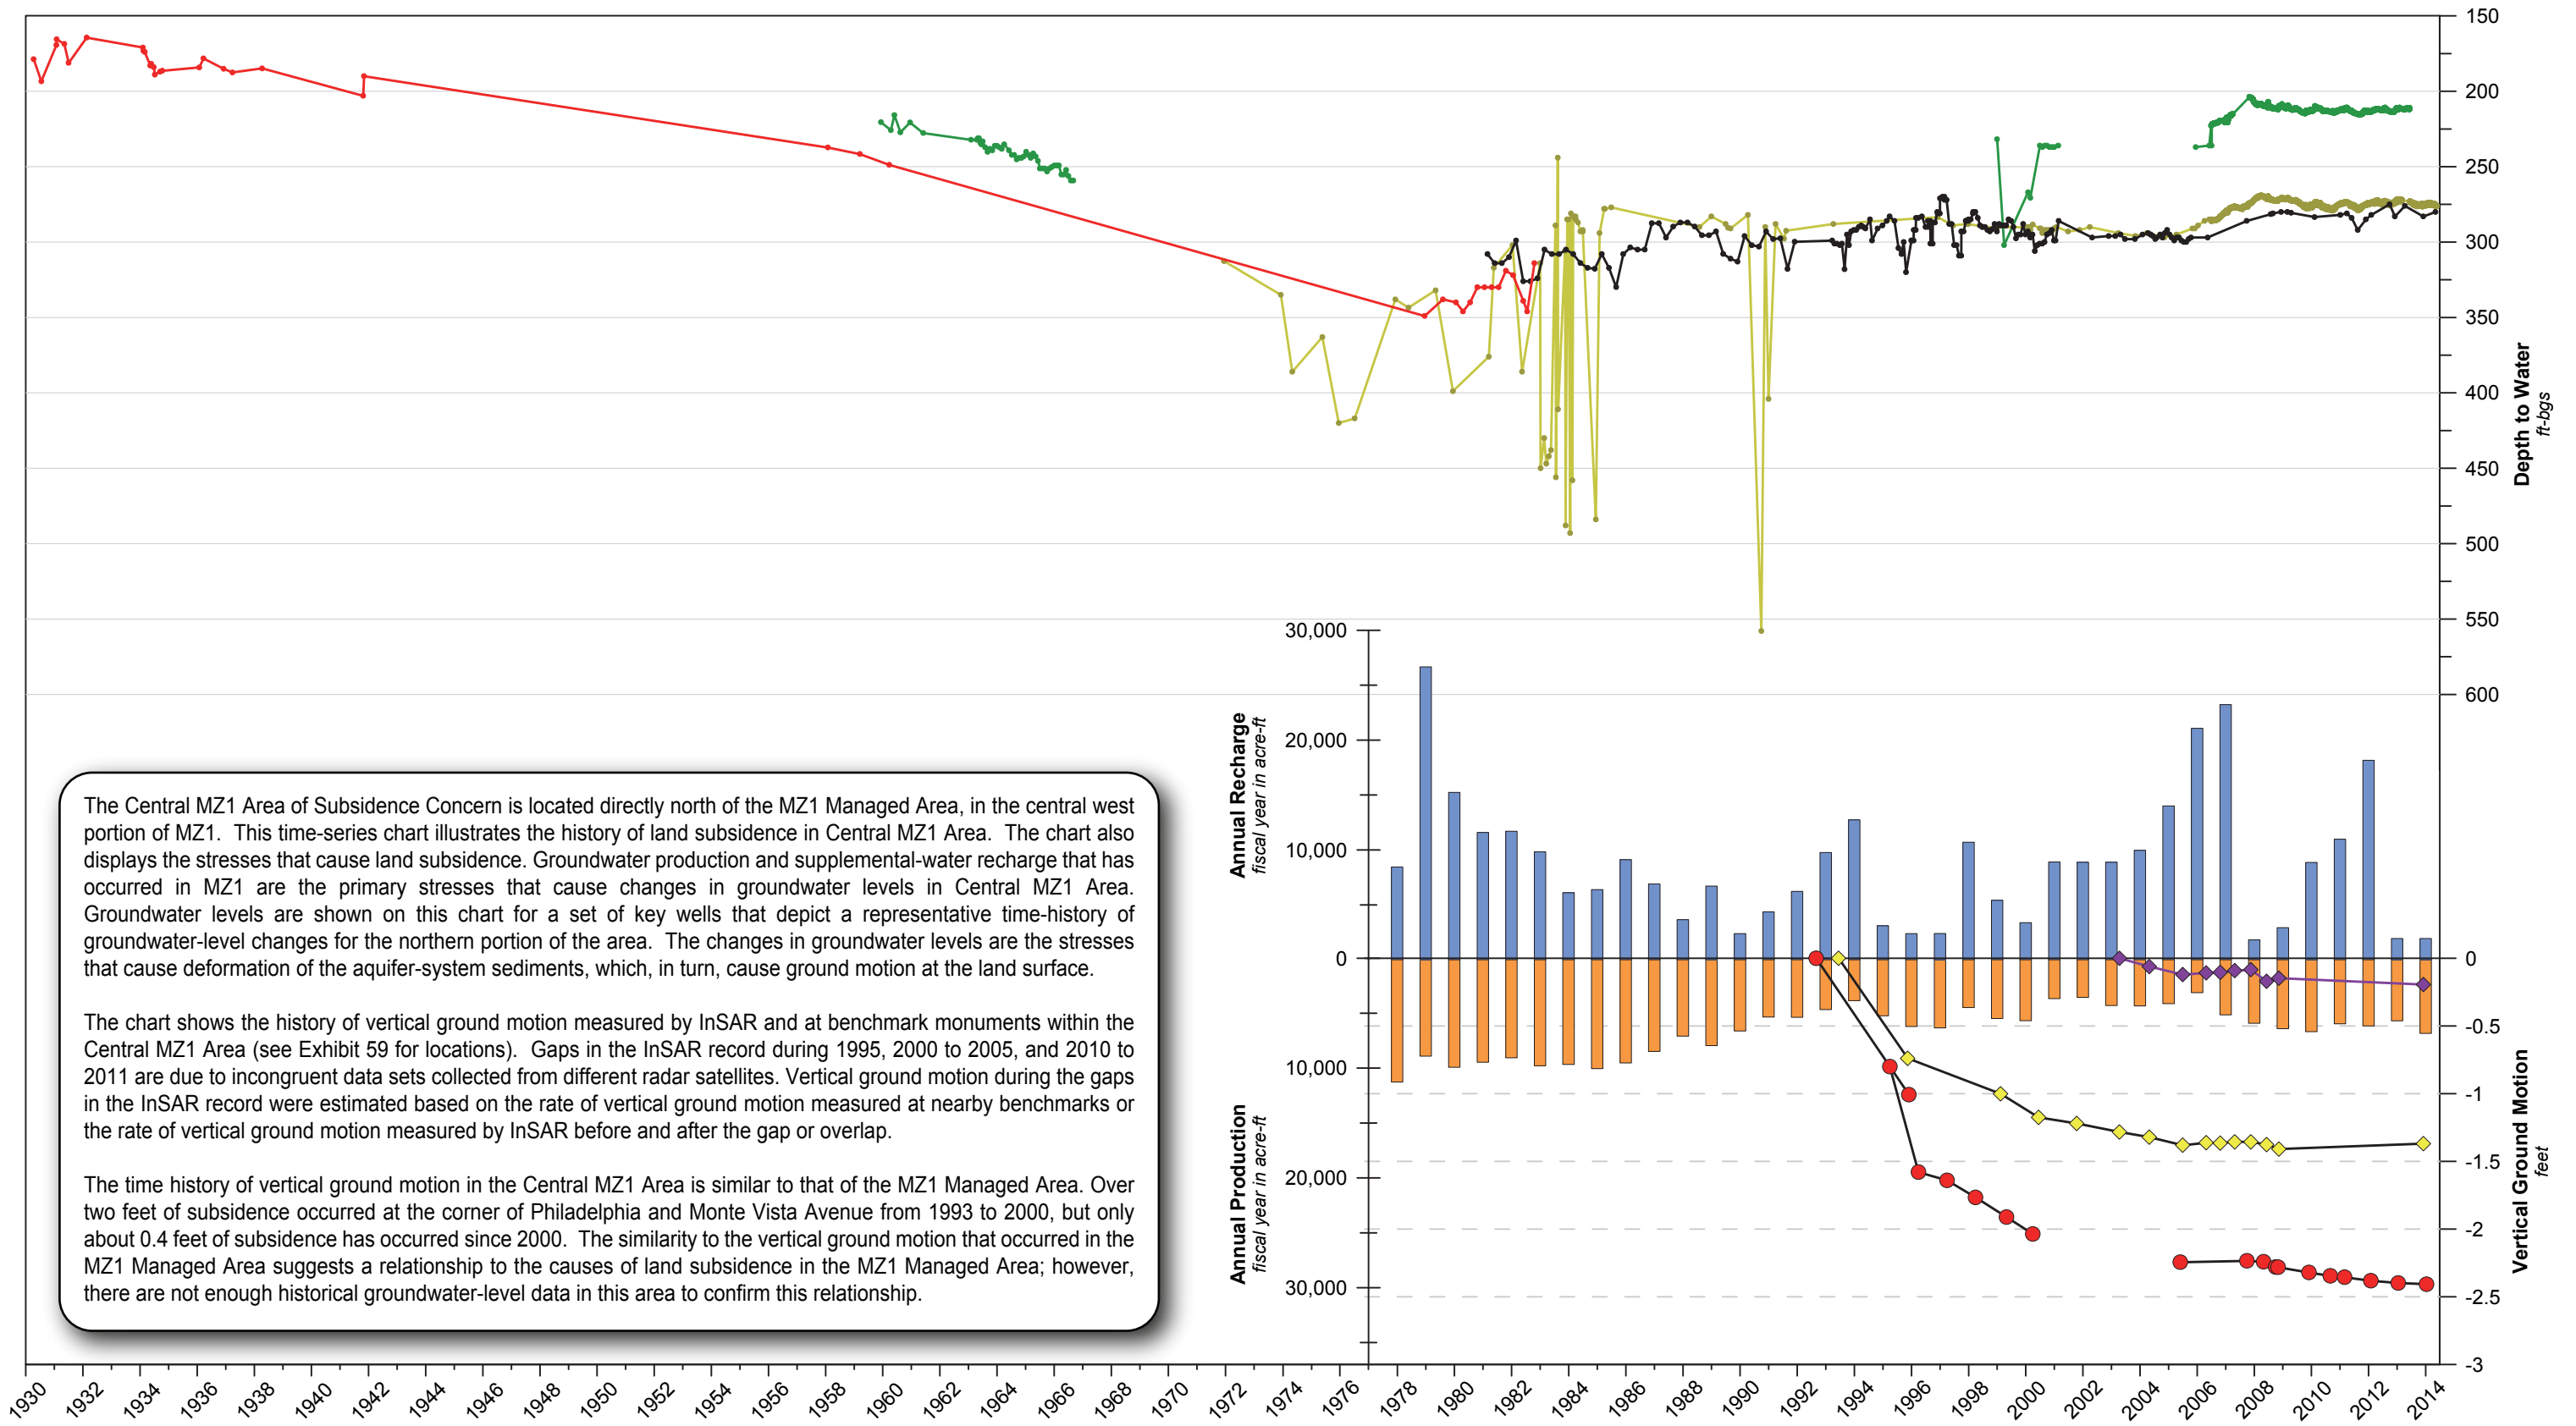
The Central MZ1 Area of Subsidence Concern is located directly north of the MZ1 Managed Area, in the central west portion of MZ1. This time-series chart illustrates the history of land subsidence in Central MZ1 Area. The chart also displays the stresses that cause land subsidence. Groundwater production and supplemental-water recharge that has occurred in MZ1 are the primary stresses that cause changes in groundwater levels in Central MZ1 Area. Groundwater levels are shown on this chart for a set of key wells that depict a representative time-history of groundwater-level changes for the northern portion of the area. The changes in groundwater levels are the stresses that cause deformation of the aquifer-system sediments, which, in turn, cause ground motion at the land surface.

The chart shows the history of vertical ground motion measured by InSAR and at benchmark monuments within the Central MZ1 Area (see Exhibit 59 for locations). Gaps in the InSAR record during 1995, 2000 to 2005, and 2010 to 2011 are due to incongruent data sets collected from different radar satellites. Vertical ground motion during the gaps in the InSAR record were estimated based on the rate of vertical ground motion measured at nearby benchmarks or the rate of vertical ground motion measured by InSAR before and after the gap or overlap.

The time history of vertical ground motion in the Central MZ1 Area is similar to that of the MZ1 Managed Area. Over two feet of subsidence occurred at the corner of Philadelphia and Monte Vista Avenue from 1993 to 2000, but only about 0.4 feet of subsidence has occurred since 2000. The similarity to the vertical ground motion that occurred in the MZ1 Managed Area suggests a relationship to the causes of land subsidence in the MZ1 Managed Area; however, there are not enough historical groundwater-level data in this area to confirm this relationship.

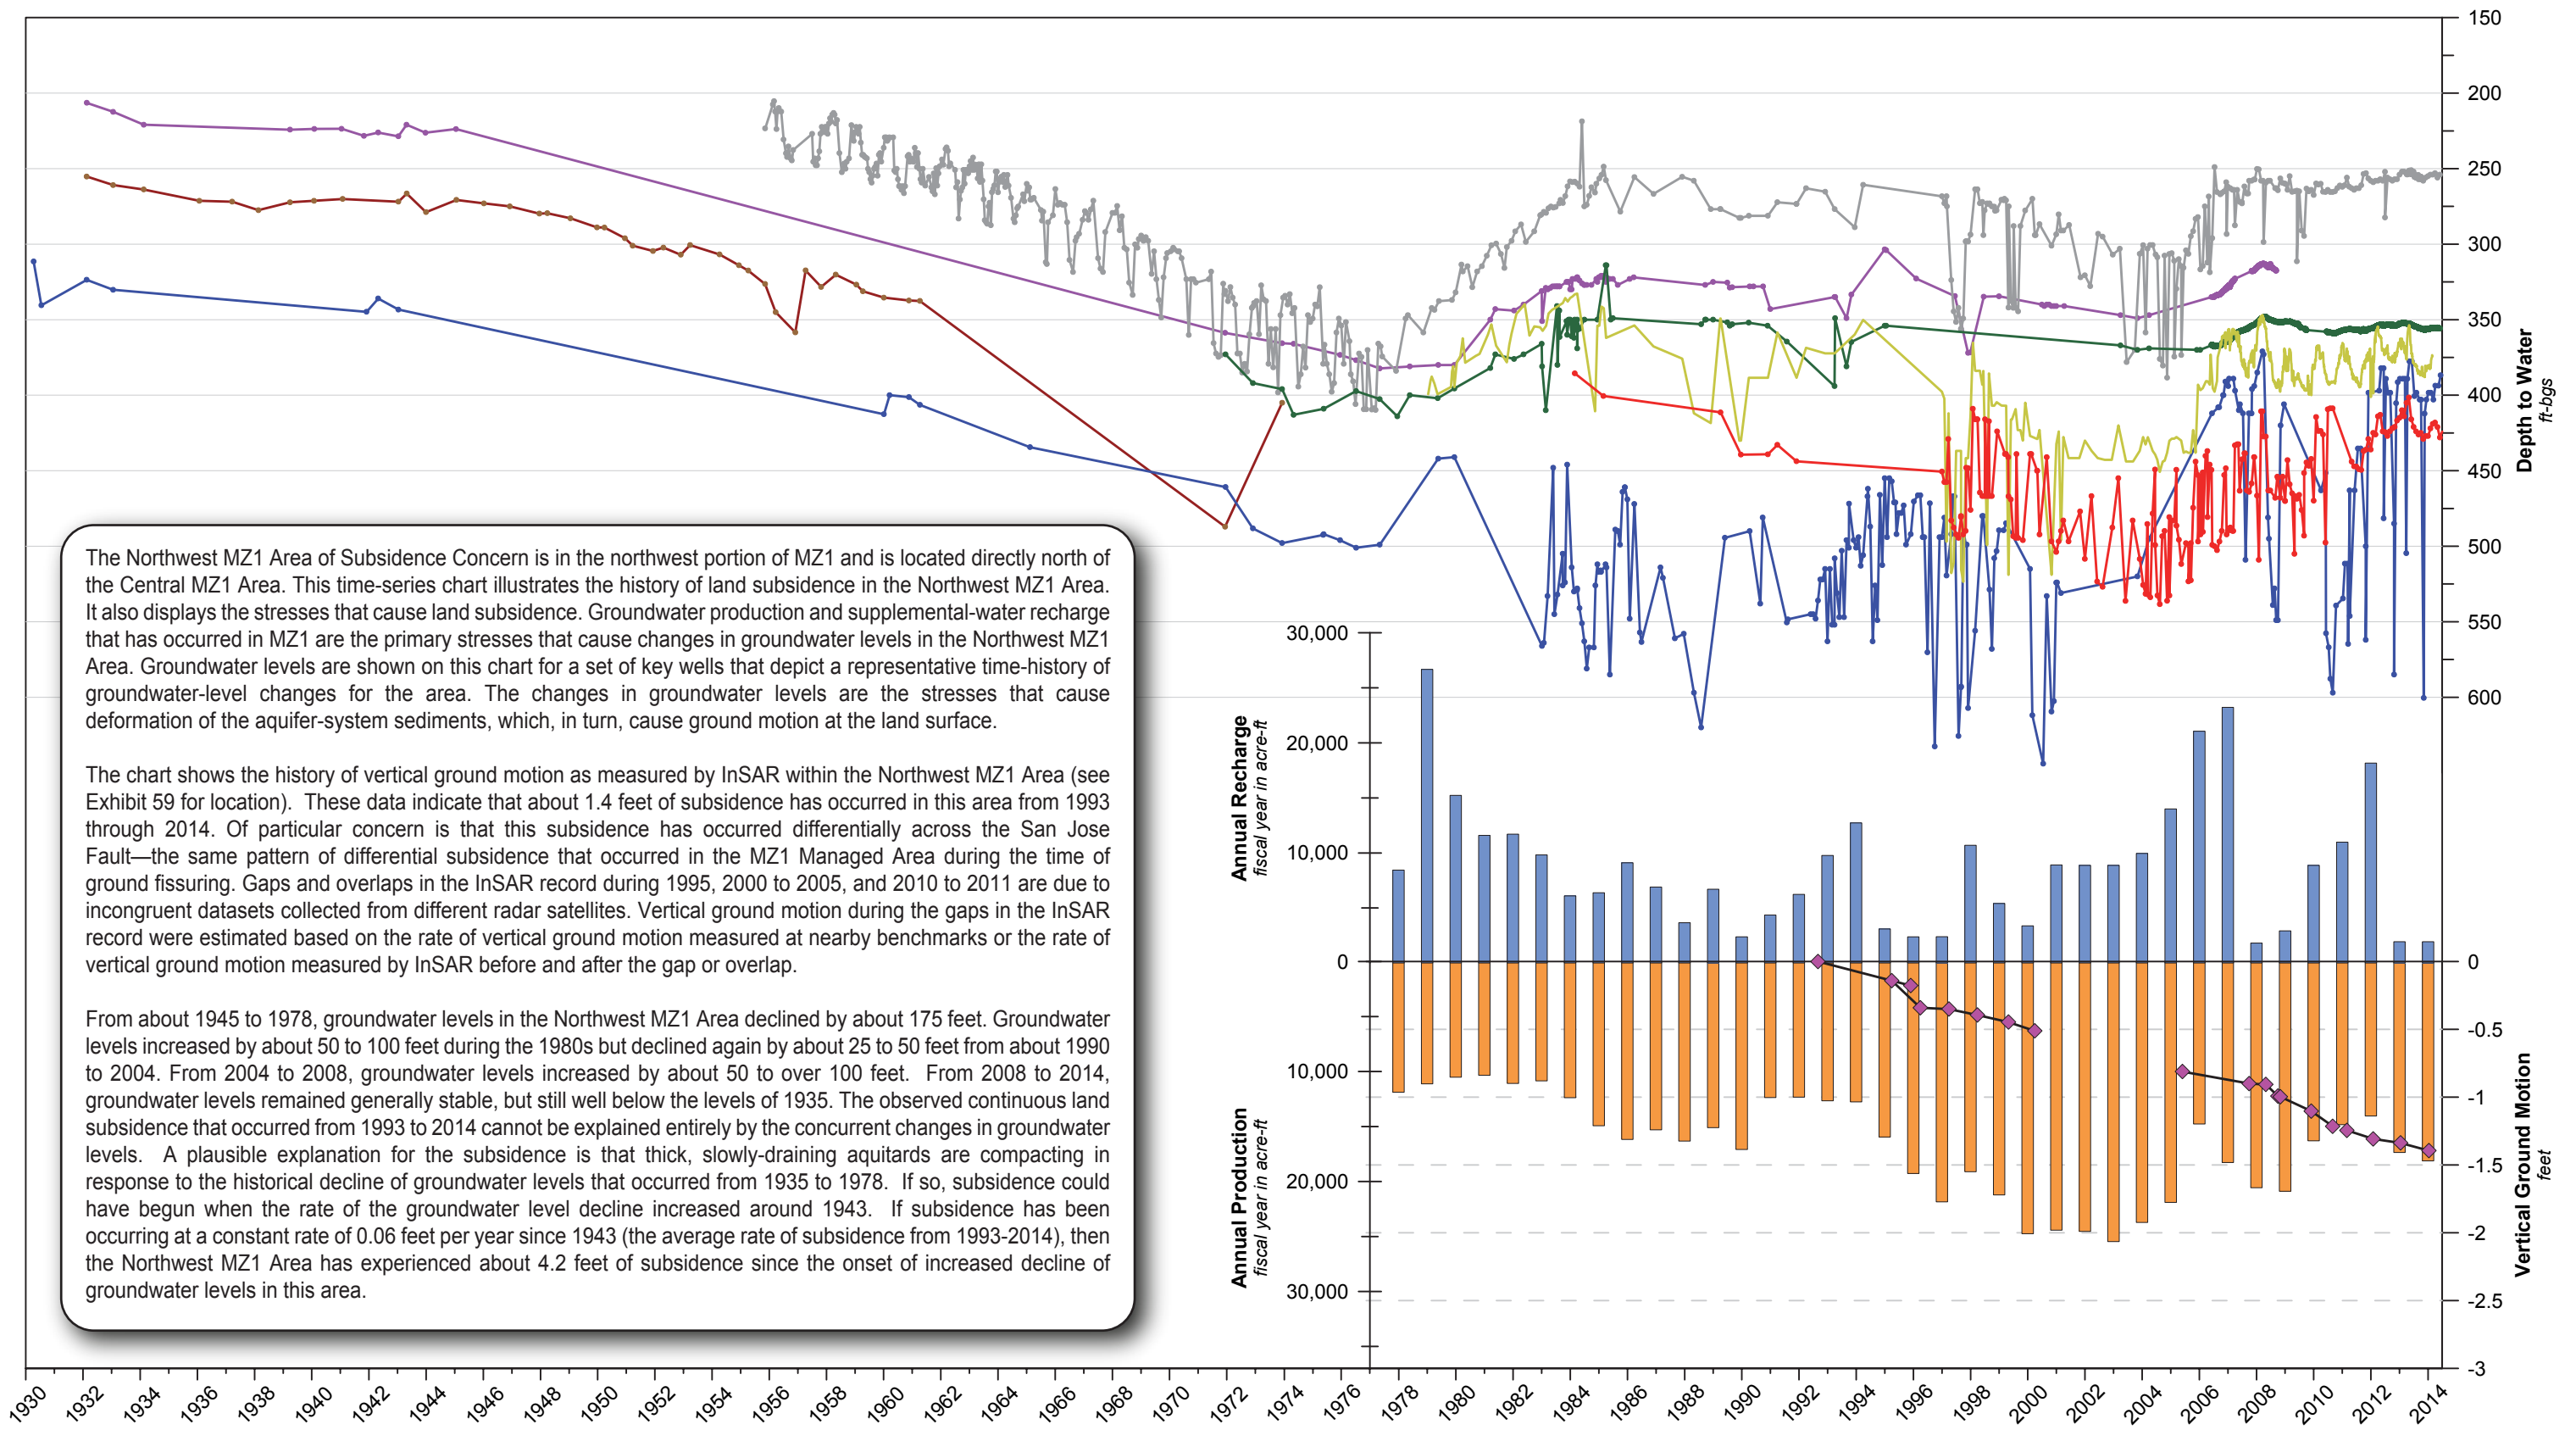
The Northwest MZ1 Area of Subsidence Concern is in the northwest portion of MZ1 and is located directly north of the Central MZ1 Area. This time-series chart illustrates the history of land subsidence in the Northwest MZ1 Area. It also displays the stresses that cause land subsidence. Groundwater production and supplemental-water recharge that has occurred in MZ1 are the primary stresses that cause changes in groundwater levels in the Northwest MZ1 Area. Groundwater levels are shown on this chart for a set of key wells that depict a representative time-history of groundwater-level changes for the area. The changes in groundwater levels are the stresses that cause deformation of the aquifer-system sediments, which, in turn, cause ground motion at the land surface.

The chart shows the history of vertical ground motion as measured by InSAR within the Northwest MZ1 Area (see Exhibit 59 for location). These data indicate that about 1.4 feet of subsidence has occurred in this area from 1993 through 2014. Of particular concern is that this subsidence has occurred differentially across the San Jose Fault—the same pattern of differential subsidence that occurred in the MZ1 Managed Area during the time of ground fissuring. Gaps and overlaps in the InSAR record during 1995, 2000 to 2005, and 2010 to 2011 are due to incongruent datasets collected from different radar satellites. Vertical ground motion during the gaps in the InSAR record were estimated based on the rate of vertical ground motion measured at nearby benchmarks or the rate of vertical ground motion measured by InSAR before and after the gap or overlap.

From about 1945 to 1978, groundwater levels in the Northwest MZ1 Area declined by about 175 feet. Groundwater levels increased by about 50 to 100 feet during the 1980s but declined again by about 25 to 50 feet from about 1990 to 2004. From 2004 to 2008, groundwater levels increased by about 50 to over 100 feet. From 2008 to 2014, groundwater levels remained generally stable, but still well below the levels of 1935. The observed continuous land subsidence that occurred from 1993 to 2014 cannot be explained entirely by the concurrent changes in groundwater levels. A plausible explanation for the subsidence is that thick, slowly-draining aquitards are compacting in response to the historical decline of groundwater levels that occurred from 1935 to 1978. If so, subsidence could have begun when the rate of the groundwater level decline increased around 1943. If subsidence has been occurring at a constant rate of 0.06 feet per year since 1943 (the average rate of subsidence from 1993-2014), then the Northwest MZ1 Area has experienced about 4.2 feet of subsidence since the onset of increased decline of groundwater levels in this area.

Based on the data collected and analyzed for the ground-level monitoring program, the Ground-Level Monitoring Committee has become increasingly concerned with the occurrence of persistent differential subsidence within the Northwest MZ1 Area. Watermaster, consistent with the recommendation of the Ground-
