Contours of Relative Change in Land Surface Altitude as Estimated by Leveling Surveys 1987 to 1999

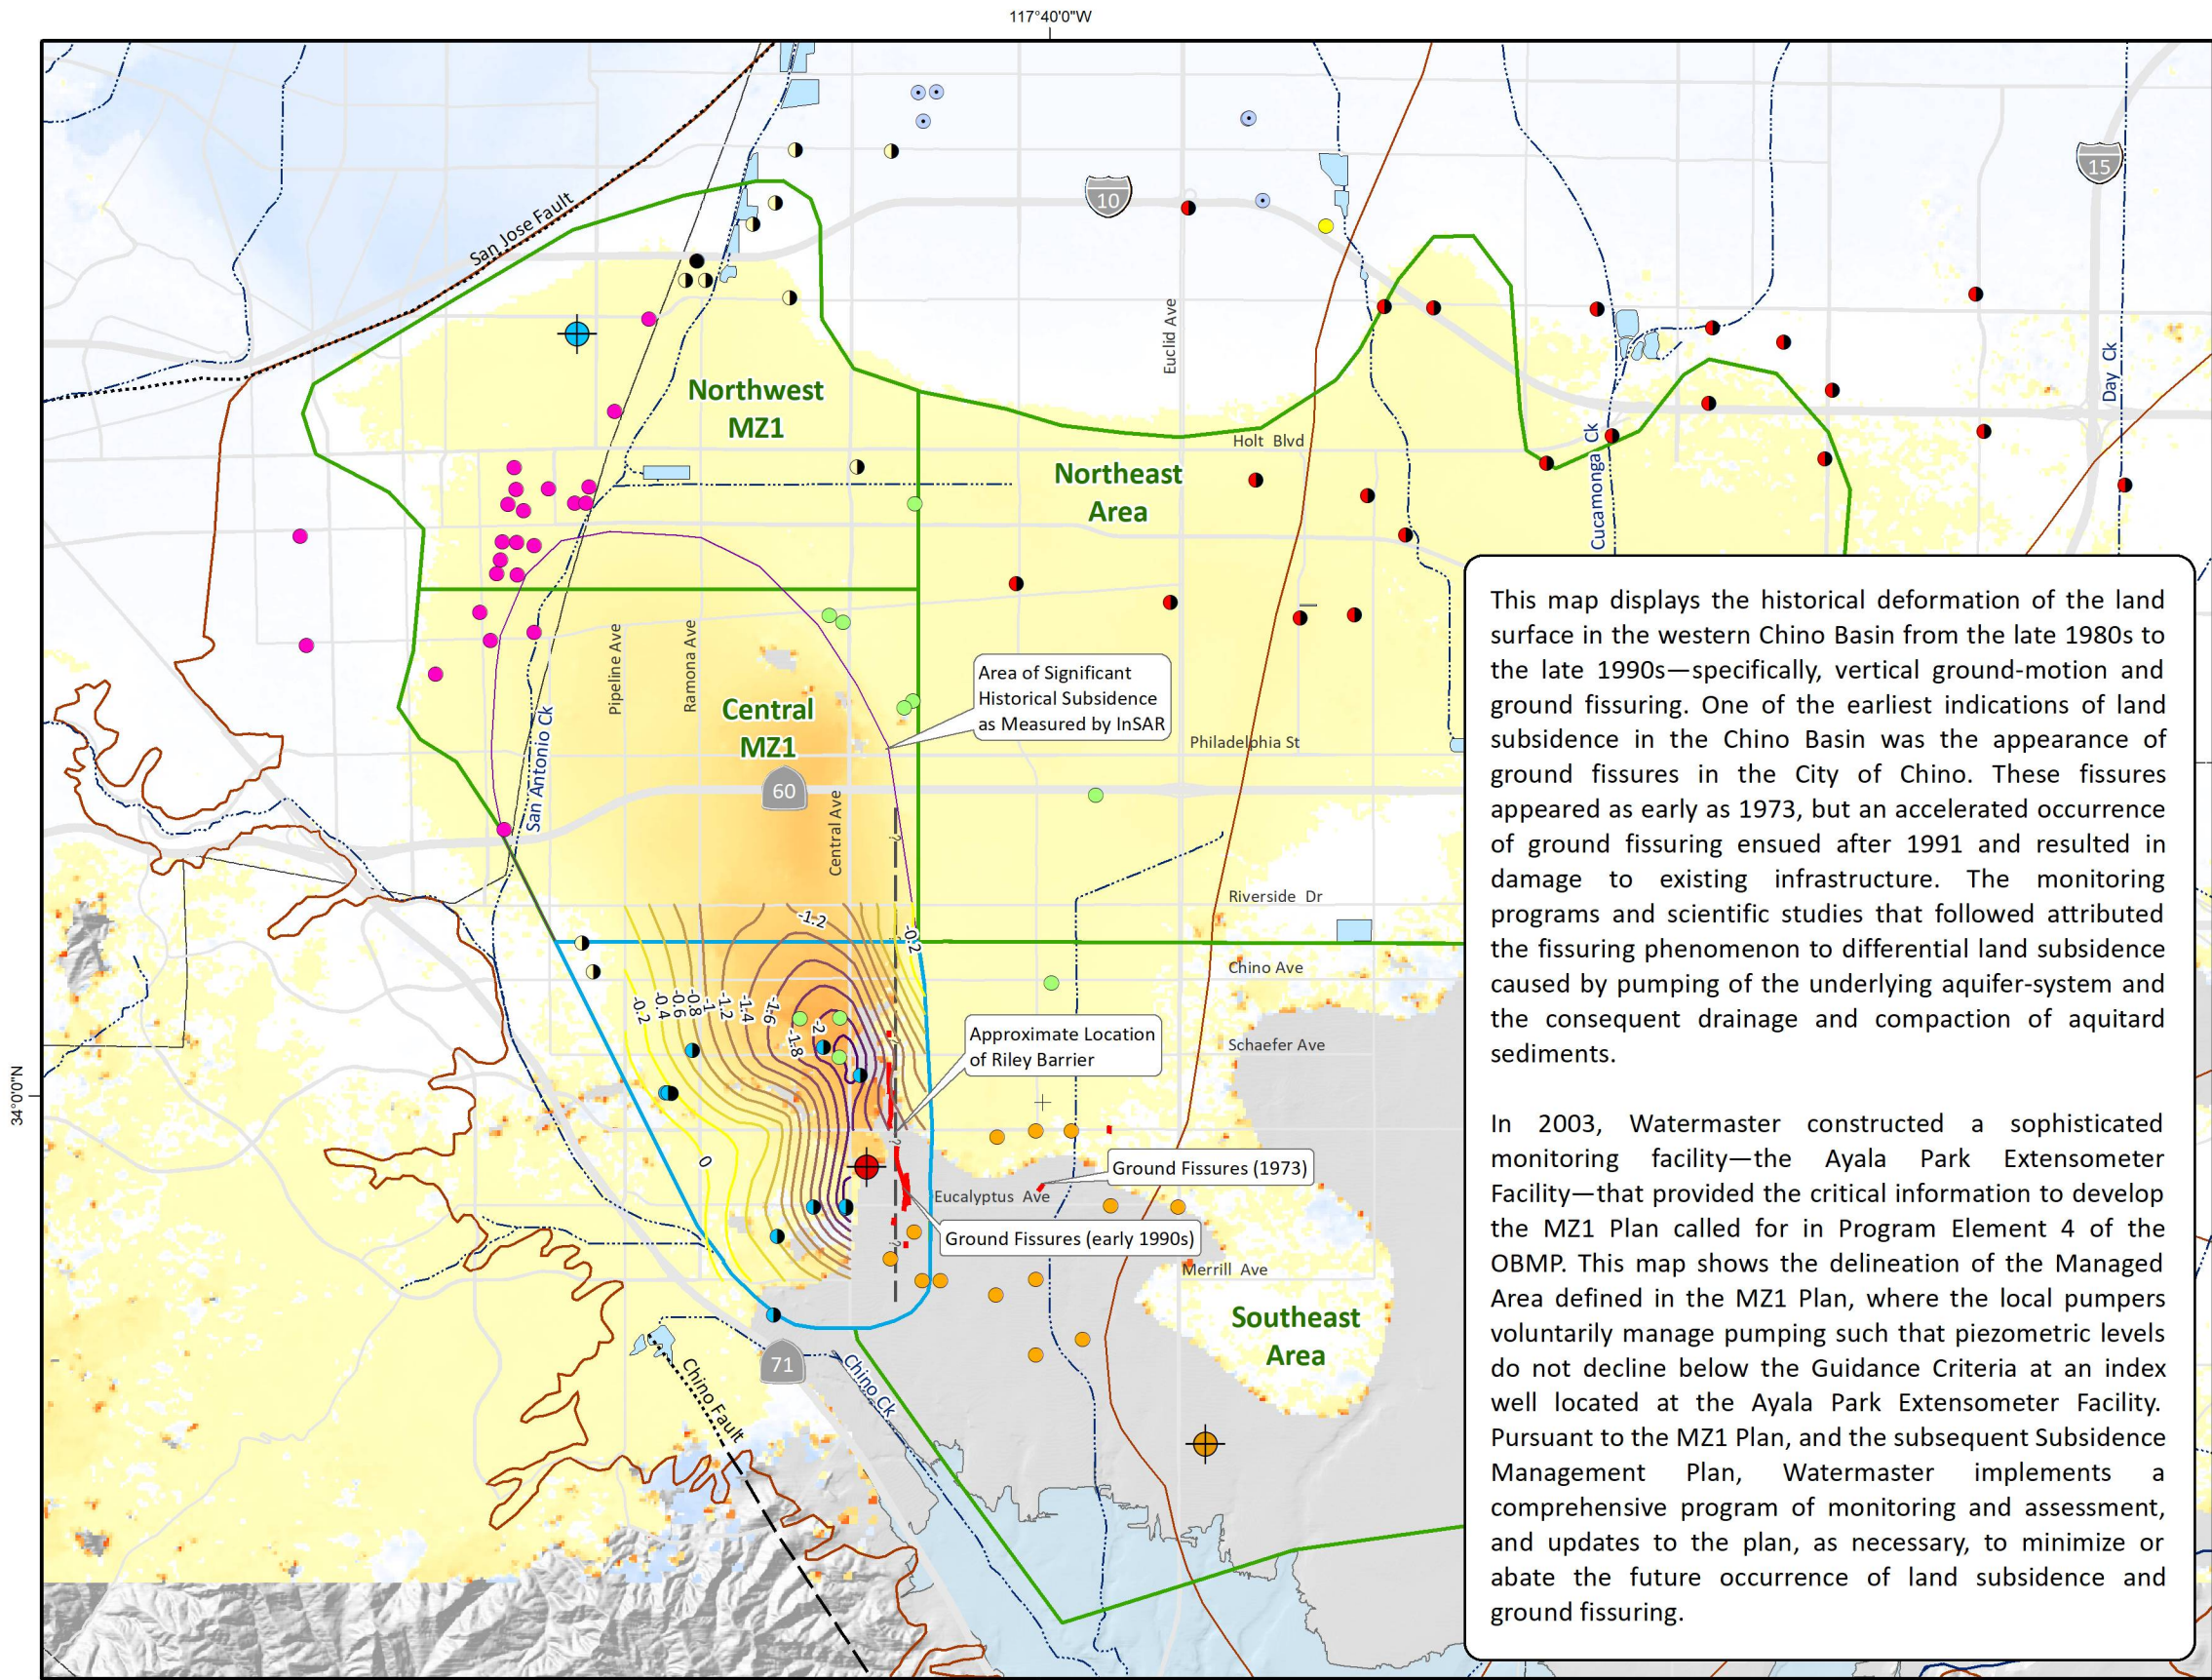
Relative Change in Land Surface Altitude as Measured by InSAR October 1993 to December 1995

This map displays the historical deformation of the land surface in the western Chino Basin from the late 1980s to the late 1990s—specifically, vertical ground-motion and ground fissuring. One of the earliest indications of land subsidence in the Chino Basin was the appearance of ground fissures in the City of Chino. These fissures appeared as early as 1973, but an accelerated occurrence of ground fissuring ensued after 1991 and resulted in damage to existing infrastructure. The monitoring programs and scientific studies that followed attributed the fissuring phenomenon to differential land subsidence caused by pumping of the underlying aquifer-system and the consequent drainage and compaction of aquitard sediments.

In 2003, Watermaster constructed a sophisticated monitoring facility—the Ayala Park Extensometer Facility—that provided the critical information to develop the MZ1 Plan called for in Program Element 4 of the OBMP. This map shows the delineation of the Managed Area defined in the MZ1 Plan, where the local pumpers voluntarily manage pumping such that piezometric levels do not decline below the Guidance Criteria at an index well located at the Ayala Park Extensometer Facility. Pursuant to the MZ1 Plan, and the subsequent Subsidence Management Plan, Watermaster implements a comprehensive program of monitoring and assessment, and updates to the plan, as necessary, to minimize or abate the future occurrence of land subsidence and ground fissuring.
