Hydrogeology Fundamentals of the Chino Basin

- General Setting
- Geology
- Recharge and Discharge
- Groundwater Quality
- Groundwater Desalting
- Groundwater Levels and Flow
- Land Subsidence

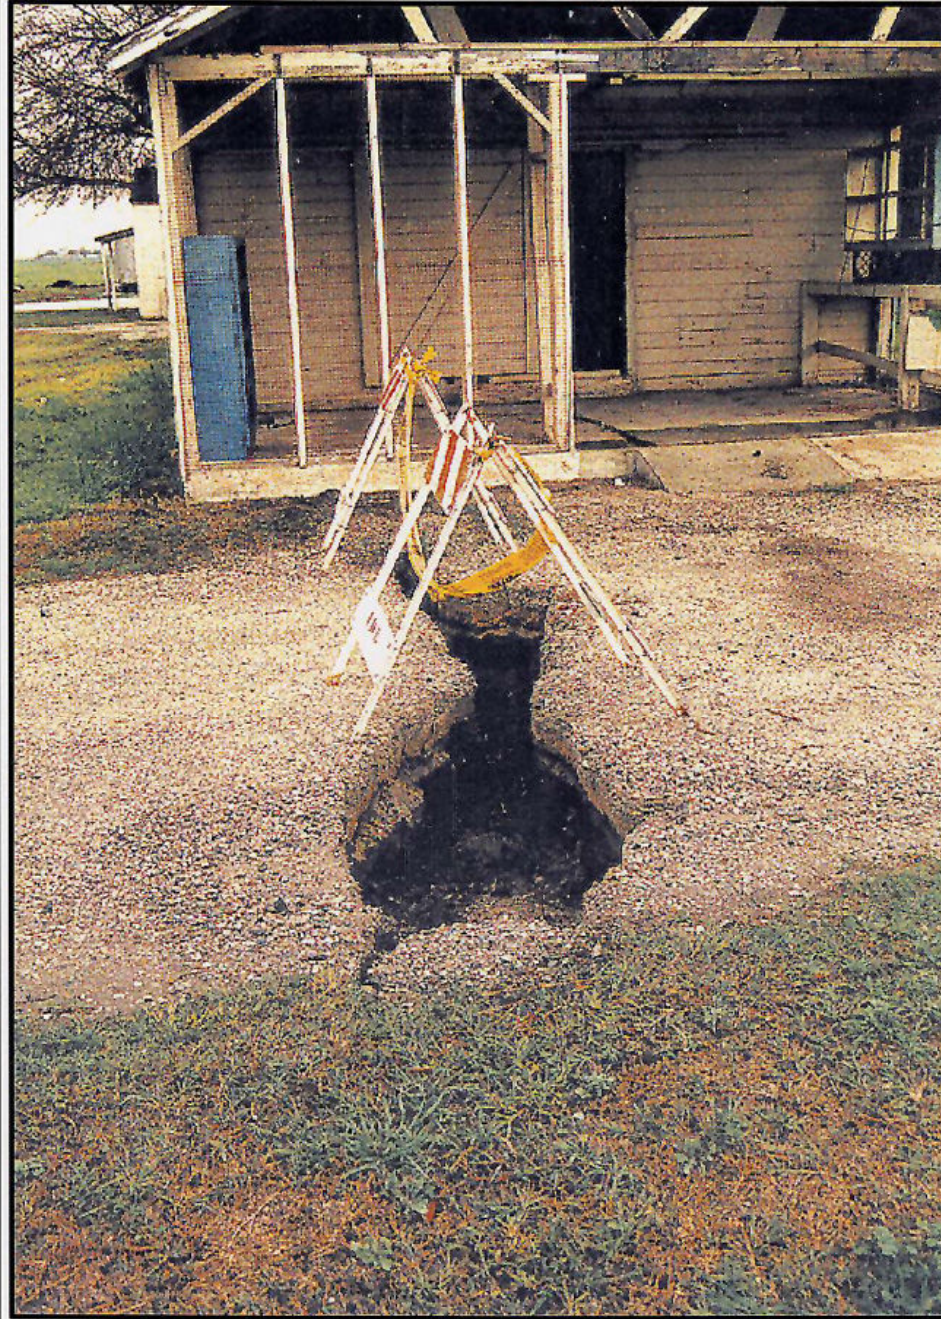
View of a fissure that developed beneath CIM facility in December 1992
