# Land Subsidence Monitoring Program

*FY 2014-15*

**Land Subsidence Committee**  
 2014 Annual Report

# Update of the Subsidence Management Plan

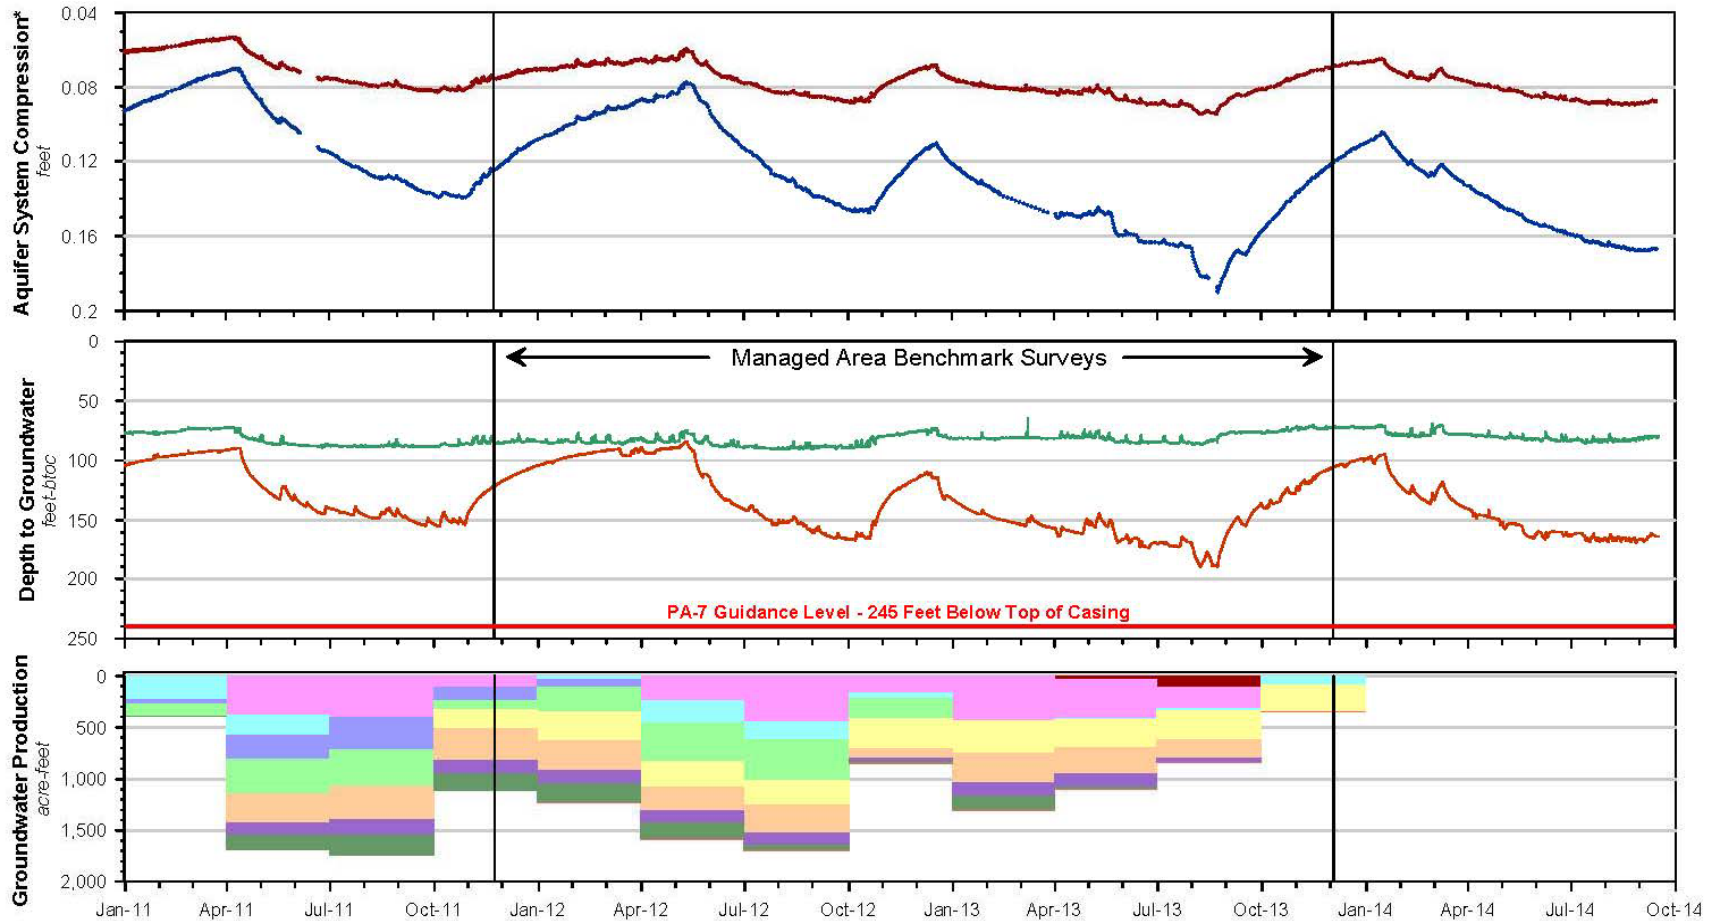
**Figure 3-2**

**Shallow Aquifer System**

- Aquifer System Deformation (Extensometer Depth Interval)
  - Shallow Extensometer (30-550 ft-bgs)
- Depth to Groundwater (Perforated Depth Interval)
  - PA-10 Piezometer (213-233 ft-bgs)
- Groundwater Production (Top-Bottom Screen Interval)
  - C-4 (160-275 ft-bgs)
  - C-6 (200-375 ft-bgs)
  - CIM-1 (118-357 ft-bgs)
  - CH-1A (166-317 ft-bgs)
  - CH-7A (135-290 ft-bgs)
  - CH-7B (120-360 ft-bgs)
  - XRef 8730 (unknown)

**Deep Aquifer System**

- Aquifer System Deformation (Extensometer Depth Interval)
  - Deep Extensometer (30-1,400 ft-bgs)
- Depth to Groundwater (Perforated Depth Interval)
  - PA-7 Piezometer (438-448 ft-bgs)
- Groundwater Production (Top-Bottom Screen Interval)
  - CH-15B (360-900 ft-bgs)
  - CH-17 (300-980 ft-bgs)
  - CIM-11A (174-465\*\* ft-bgs)

**Stress and Strain within the Managed Area**

\*Positive compression values represent compression of soils, negative compression values represent expansion of soils

\*\*The original casing was perforated from 135-148, 174-187, 240-283, 405-465, 484-512, 518-540 ft-bgs. This casing collapsed below 470 ft-bgs in 2011. A liner was installed to 470.5 ft-bgs with screen interval from 155 to 470 ft-bgs.

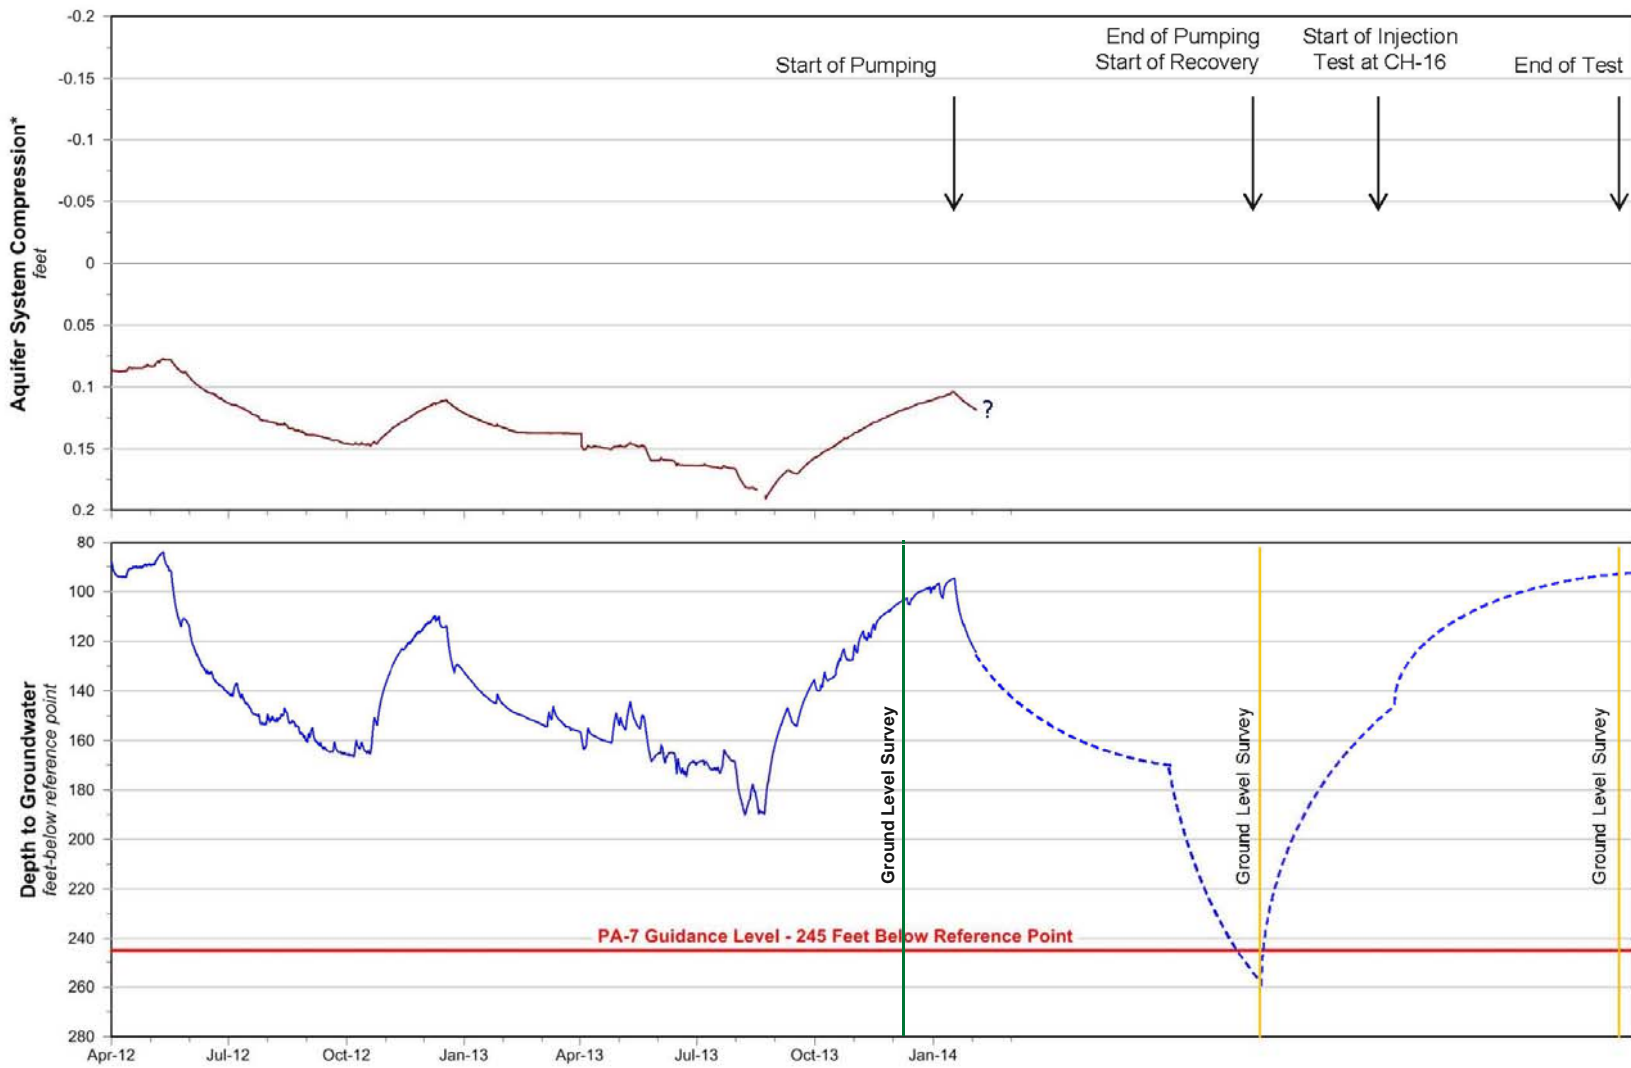
Figure 4-2

- Aquifer System Compression (Aquifer System Depth Interval)
  - Ayala Park Deep Extensometer (30-1,400 feet-bgs)
- Groundwater Levels at Wells (Perforated Depth Interval)
  - PA-7 (438-448 feet-bgs)
  - - - Predicted Record for PA-7 During Test

\*Positive compression values represent compression of soils, negative compression values represent expansion of soils.

Long-Term Pumping Test  
Managed Area

- Pumping at CH-15 has not commenced, and there is no time table for start up. It is unlikely that the Guidance Level will be tested this fiscal year.
- Should the Watermaster conduct the surveys in the Managed area in fall 2014 if drawdown at PA-7 does not fall below the Guidance Level?
  - Managed Area Fall surveys: 2001, 2003, 2005, 2006, 2007, 2008, 2009, 2010, 2011, 2013
  - Fall 2014 survey = \$34,770 (if conducted with SE Area survey)
  - Spring 2015 survey = \$36,600

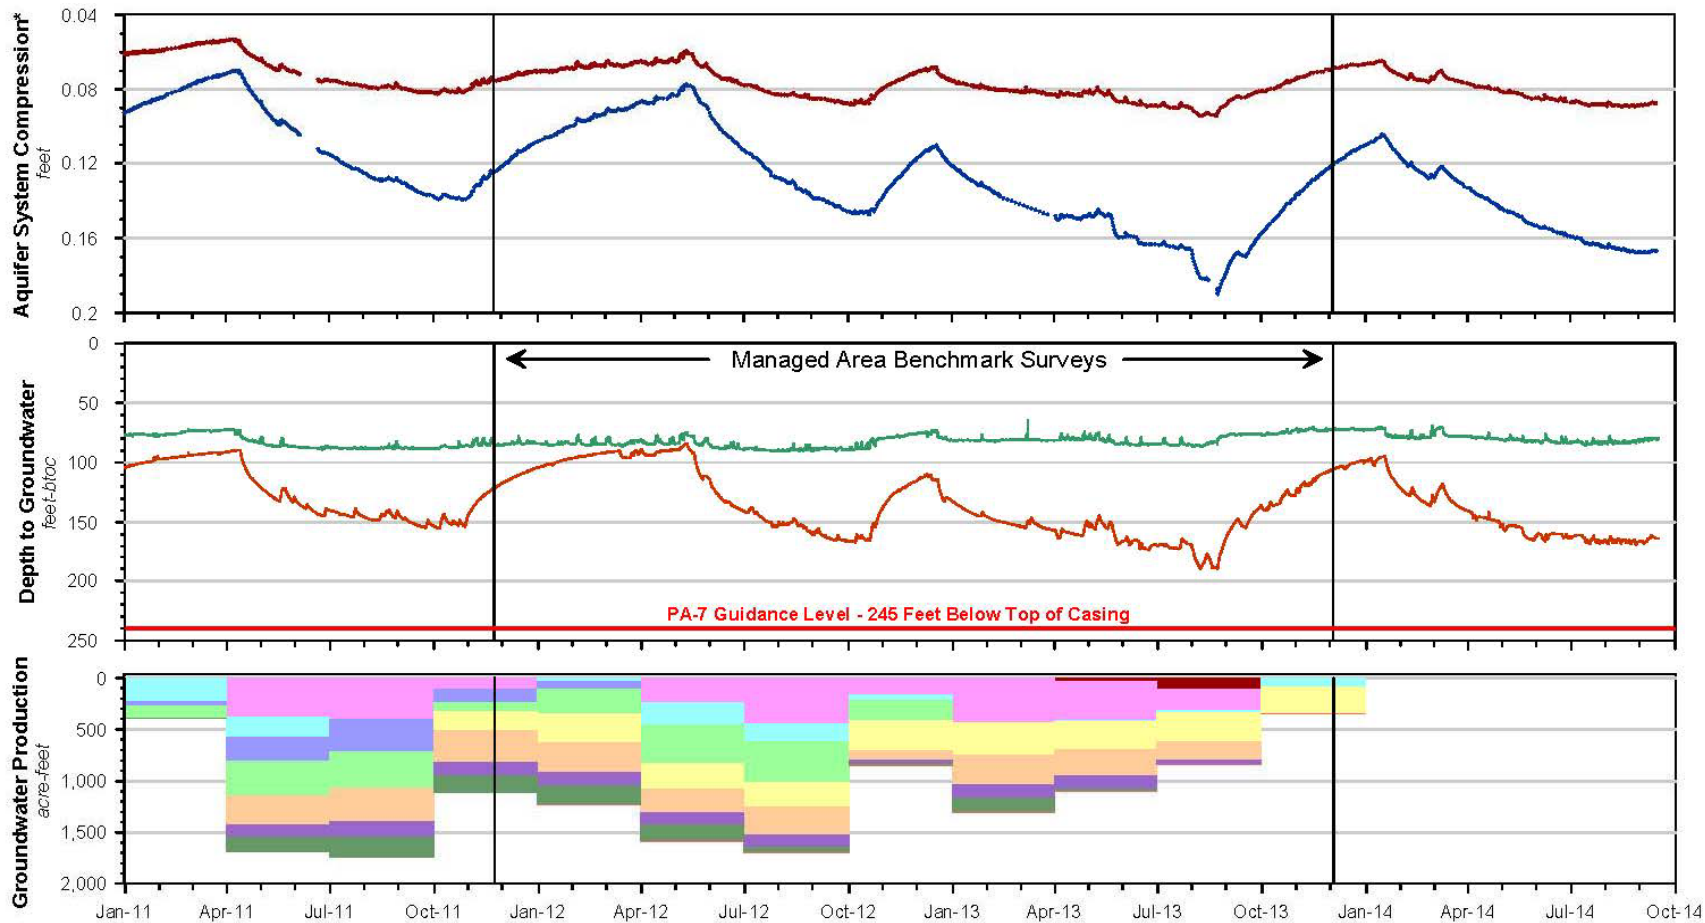
**Figure 3-2**

**Shallow Aquifer System**

- Aquifer System Deformation (Extensometer Depth Interval)
  - Shallow Extensometer (30-550 ft-bgs)
- Depth to Groundwater (Perforated Depth Interval)
  - PA-10 Piezometer (213-233 ft-bgs)
- Groundwater Production (Top-Bottom Screen Interval)
  - C-4 (160-275 ft-bgs)
  - C-6 (200-375 ft-bgs)
  - CIM-1 (118-357 ft-bgs)
  - CH-1A (166-317 ft-bgs)
  - CH-7A (135-290 ft-bgs)
  - CH-7B (120-360 ft-bgs)
  - XRef 8730 (unknown)

**Deep Aquifer System**

- Aquifer System Deformation (Extensometer Depth Interval)
  - Deep Extensometer (30-1,400 ft-bgs)
- Depth to Groundwater (Perforated Depth Interval)
  - PA-7 Piezometer (438-448 ft-bgs)
- Groundwater Production (Top-Bottom Screen Interval)
  - CH-15B (360-900 ft-bgs)
  - CH-17 (300-980 ft-bgs)
  - CIM-11A (174-465\*\* ft-bgs)

**Stress and Strain within the Managed Area**

\*Positive compression values represent compression of soils, negative compression values represent expansion of soils  
 \*\*The original casing was perforated from 135-148, 174-187, 240-283, 405-465, 484-512, 518-540 ft-bgs. This casing collapsed below 470 ft-bgs in 2011. A liner was installed to 470.5 ft-bgs with screen interval from 155 to 470 ft-bgs.

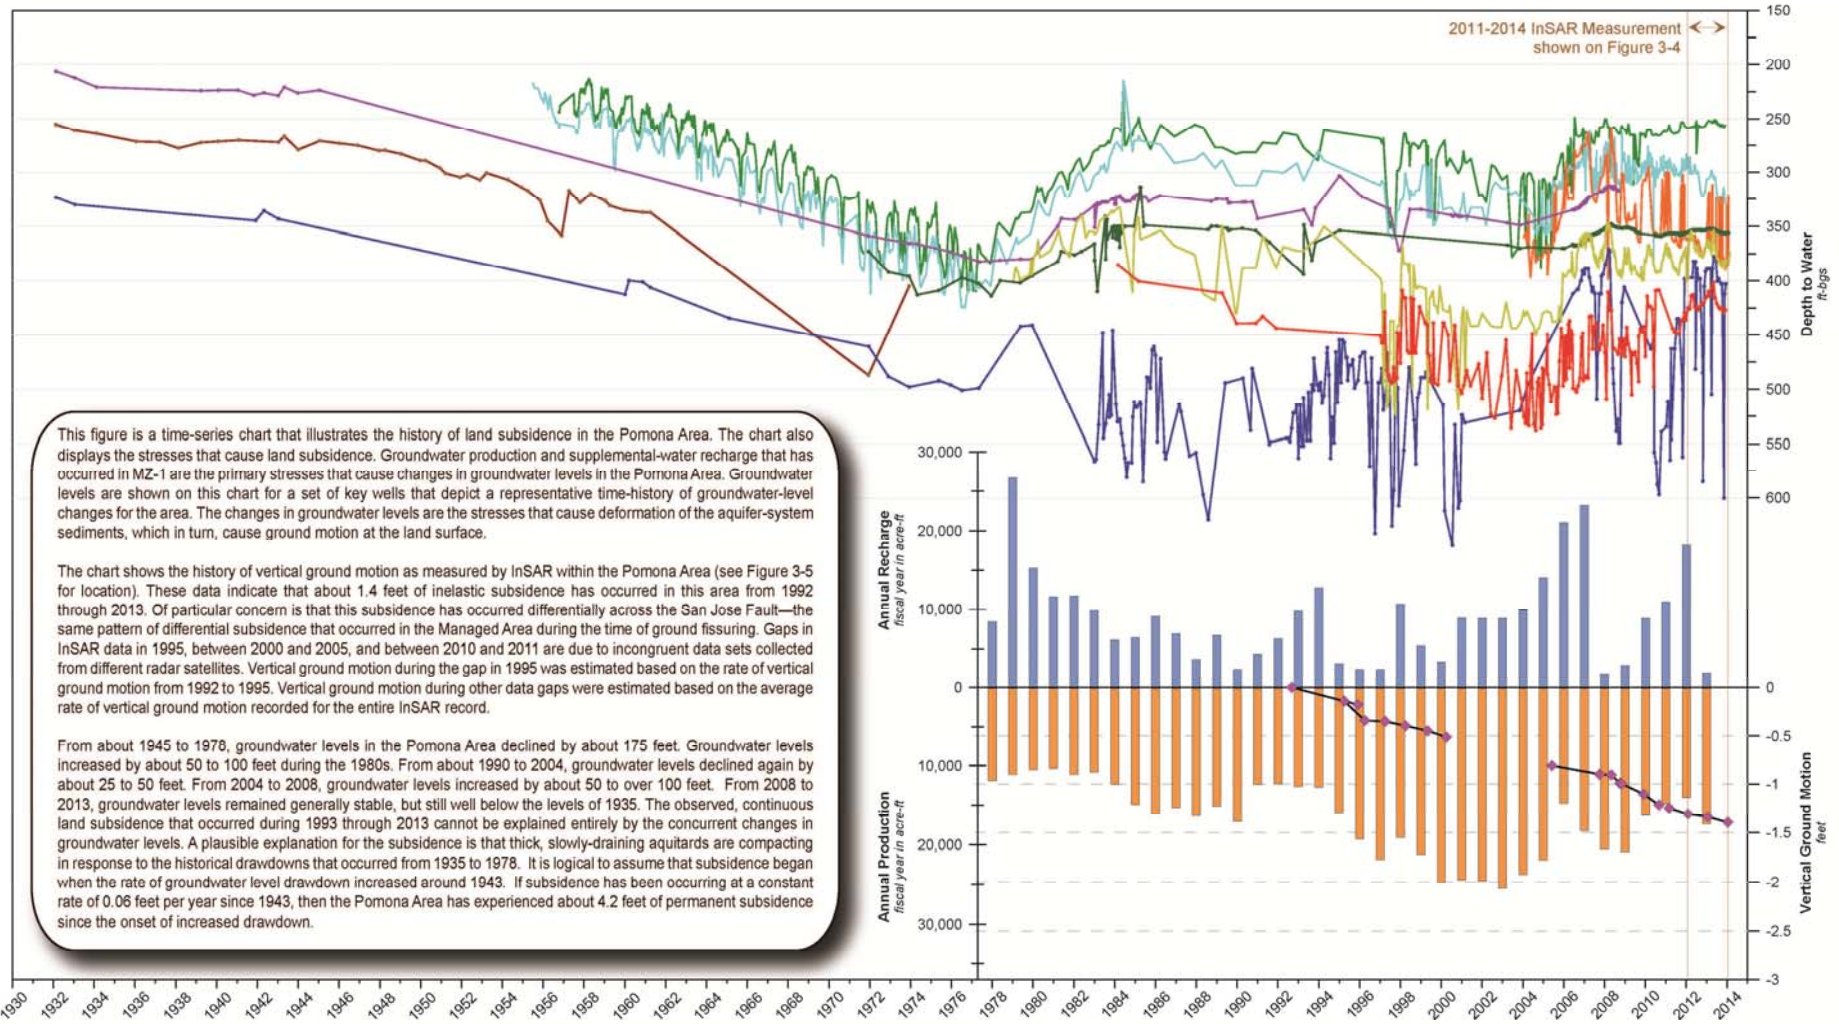
**Figure 3-10**

- Groundwater Levels at Wells (Perforated Depth Interval)**
- MV-01 (245-472 ft-bgs)
  - MV-08 (225-447 ft-bgs)
  - MV-10 (520-1084 ft-bgs)
  - MV-13 (203-475 ft-bgs)
  - P-5B (457-615 ft-bgs)
  - P-16 (270-328 ft-bgs)
  - P-18 (307-660 ft-bgs)
  - P-27 (472-849 ft-bgs)
  - P-30 (565-875 ft-bgs)

**Vertical Ground Motion**  
 Pomona Area InSAR

- Recharge and Production**
- Recharge of Recycled Water, Storm Water\*, and Imported Water at the College Heights, Upland, Montclair, and Brooks Basins, and at MWD ASR Wells
  - \*Storm Water is an estimated amount prior to Fiscal Year 04/05
  - Groundwater Production from Wells in the Pomona Area

**The History of Land Subsidence in the Pomona Area**

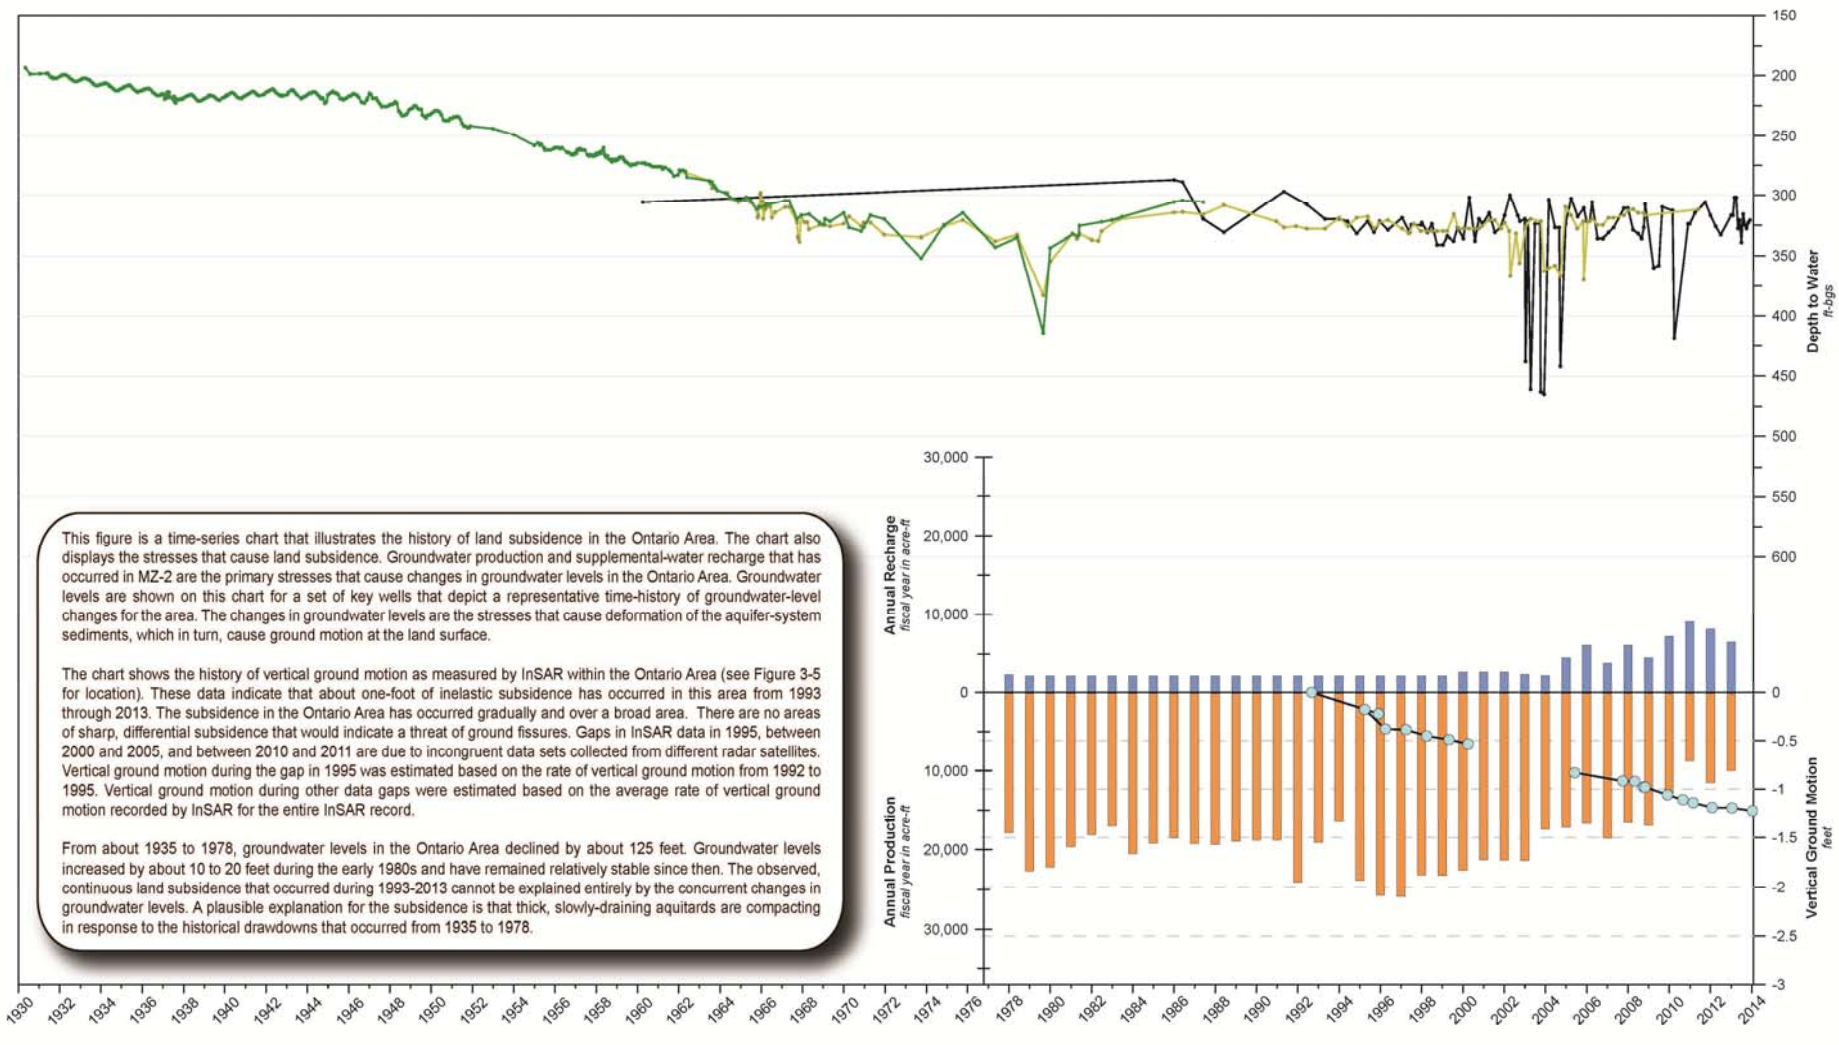
Figure 3-11

Groundwater Levels at Wells  
 (Top-Bottom Screen Interval)

- O-05 (360-470 ft.-bgs)
- O-15 (474-966 ft.-bgs)
- O-34 (522-1092 ft.-bgs)

Vertical Ground Motion

- Ontario Area InSAR

Recharge and Production

- Recharge of Recycled, Storm Water\*, and Imported Water at the Ely, Grove, Turner, 7th Street, 8th Street, and 15th Street Basins \*Storm Water is an estimated amount prior to Fiscal Year 04/05
- Groundwater Production from Wells in the Ontario Area

**The History of Land Subsidence in the Ontario Area**

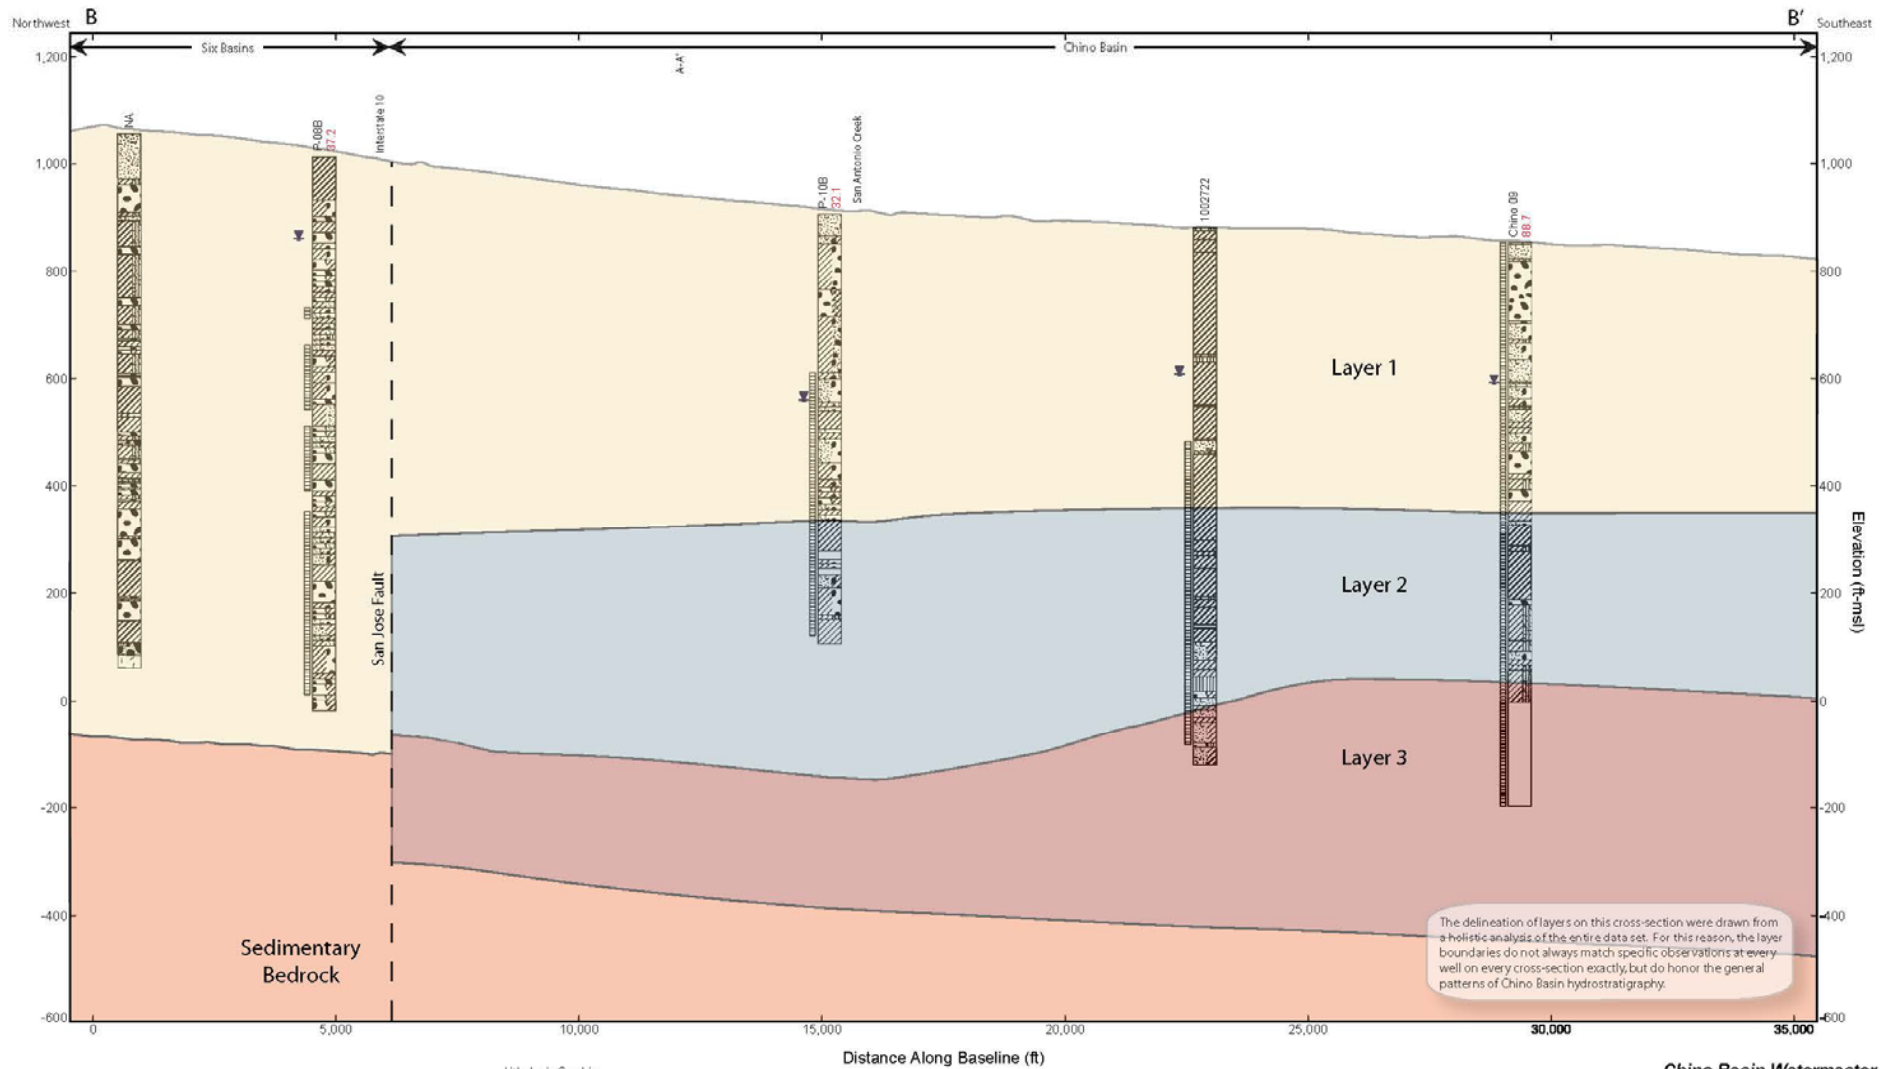
Figure 2

- Lithologic Graphics
- Gravel
  - Sand
  - Silt
  - Clay
  - Granite
  - Decomposed Granite
  - Topsoil
  - Interbedded Sandstone/Siltstone

Cross-Section B-B'
