DEPTH TO WATER FOR 1997 AND ARTESIAN AREA IN 1902

FIGURE 4.5-19

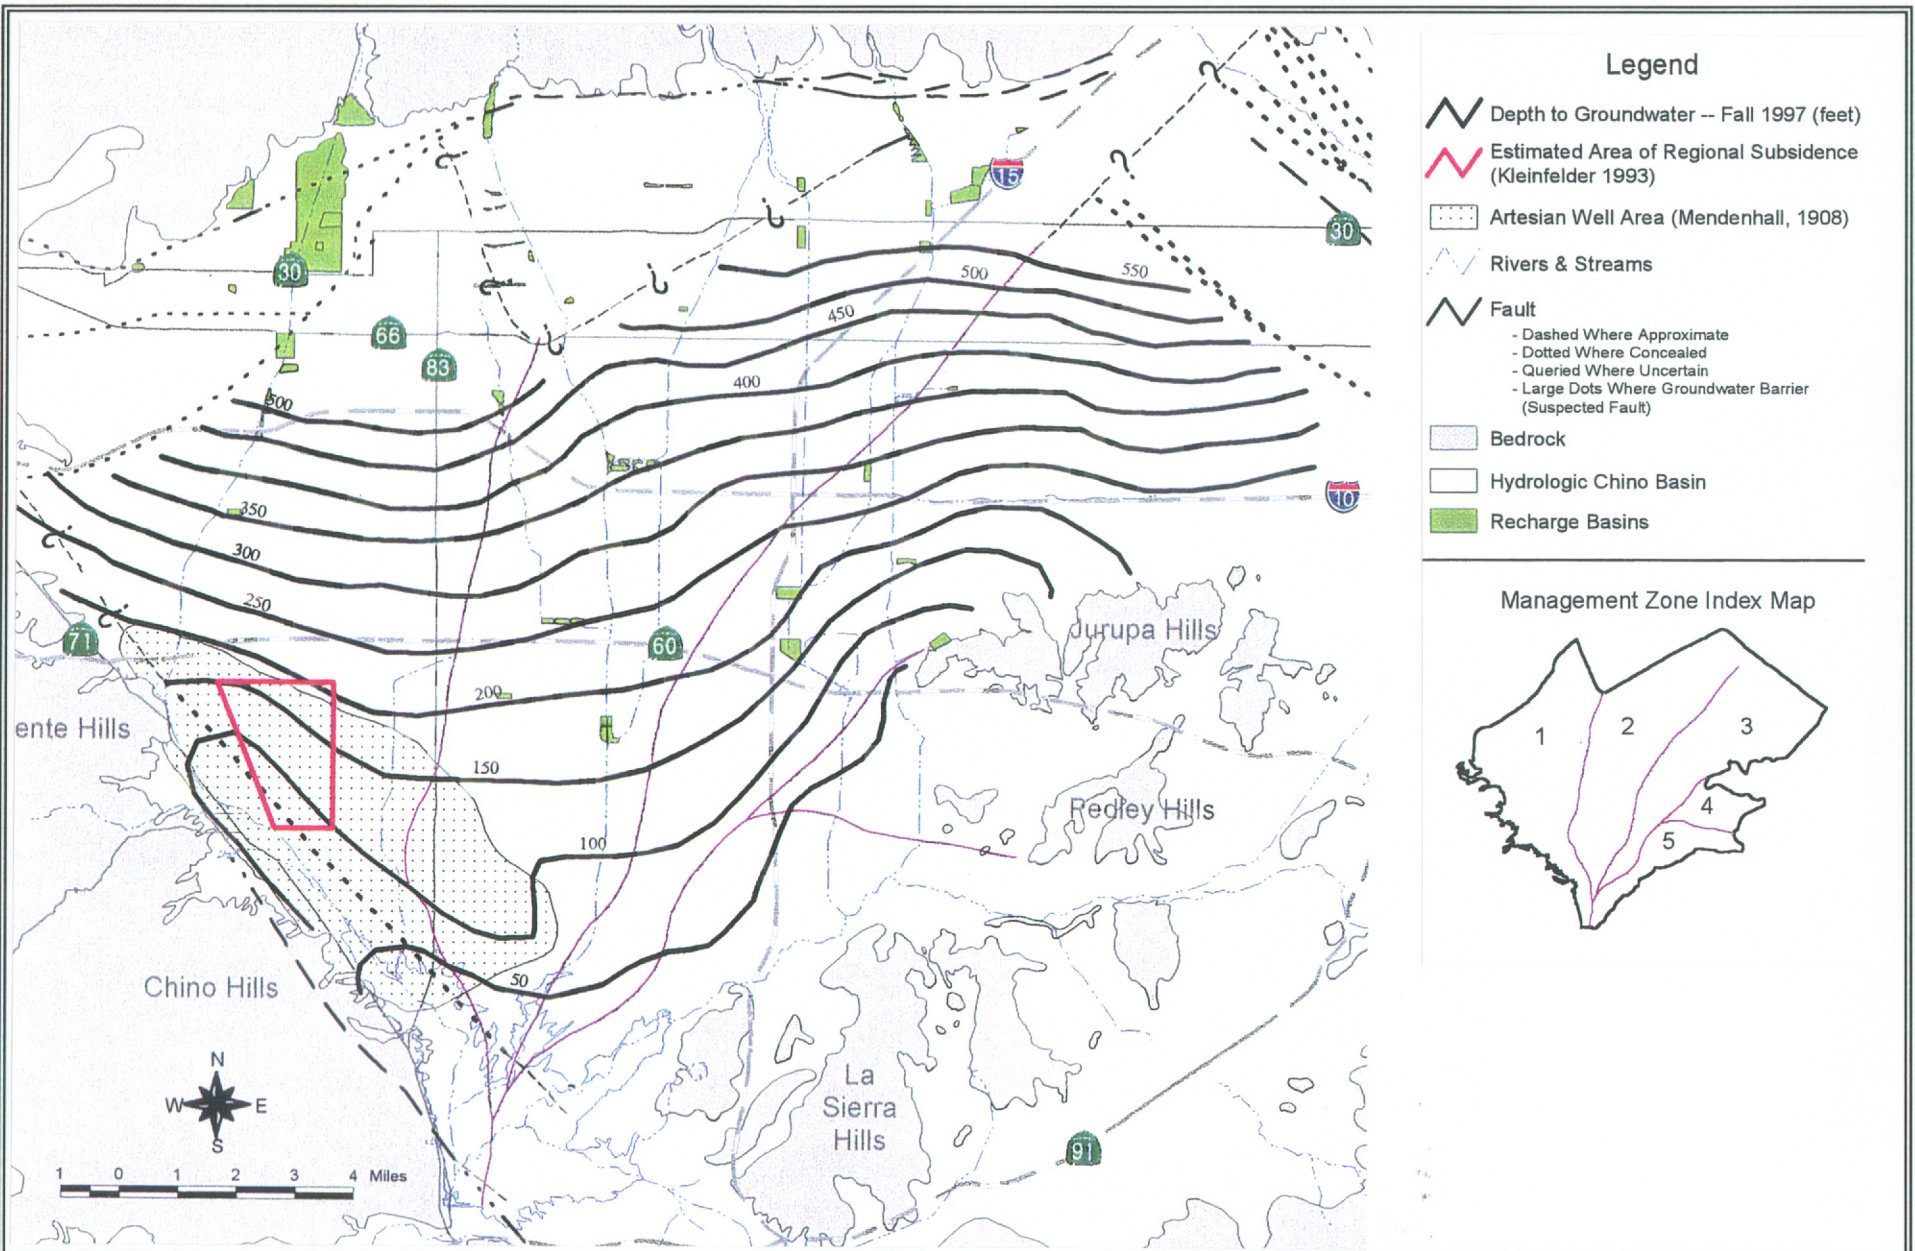
Source: OBMP Phase I Report, Figure 2-23
